First Shield Home Inspections

567 Here Ave, Los Angeles, CA,

Prepared For: J Smith

Date of Inspection: 1/1/2024

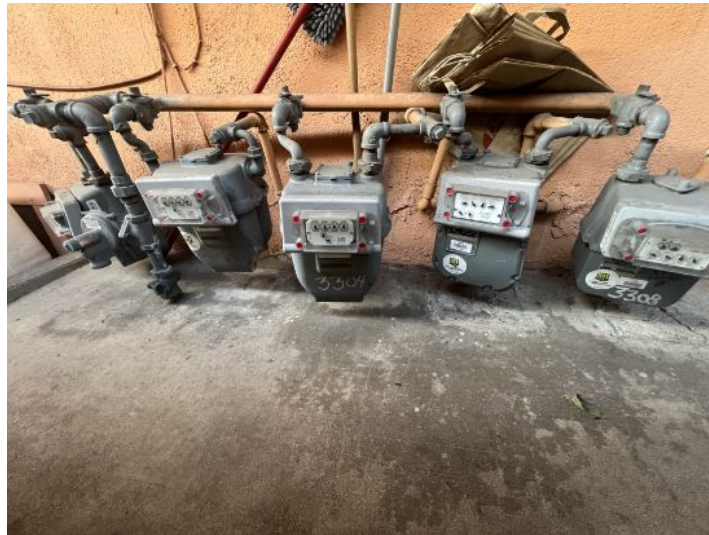
There is no automatic seismic gas shut-off valve on the main gas line. This may need to be installed before the close of escrow

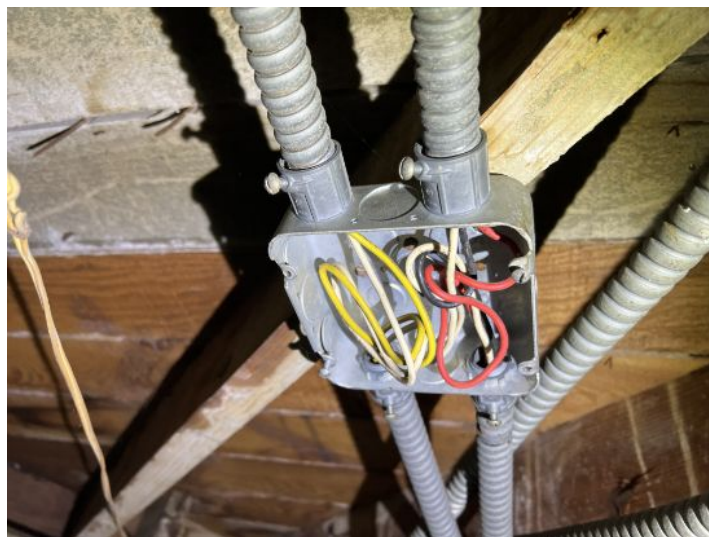
There are open junction boxes in the crawl space with wires exposed. These need to have covers installed over them

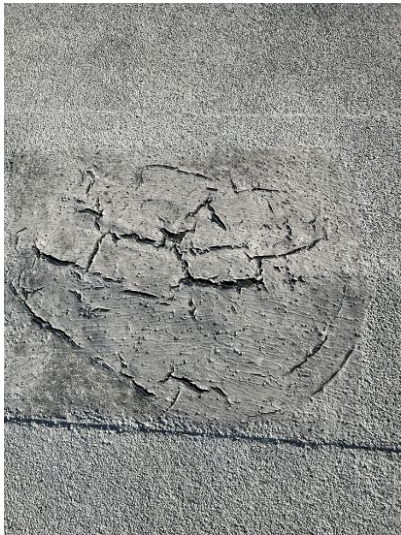
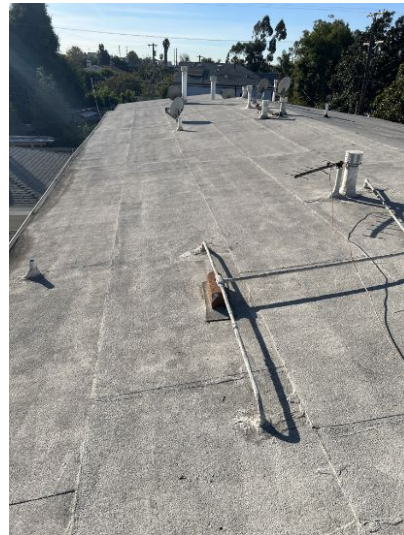
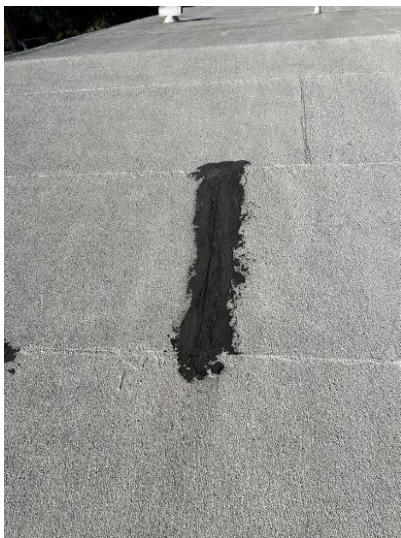
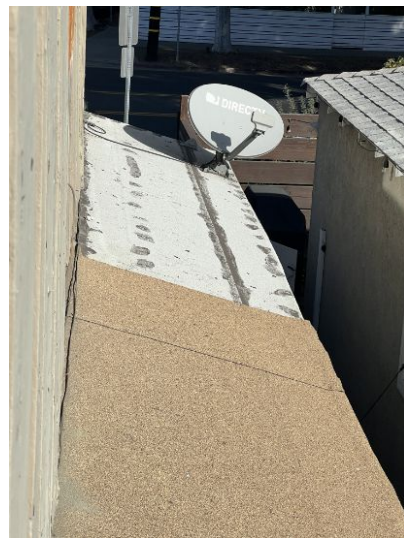
There are patches on the roof, these are a possible indication that there have been problems with the roof at some point in time. The seller could be consulted on the past of this area.

The composition shingles are older, deteriorating, and losing their surface granules. It is nearing the time to replace this roof covering, on the 1st level section (above the back patio area).

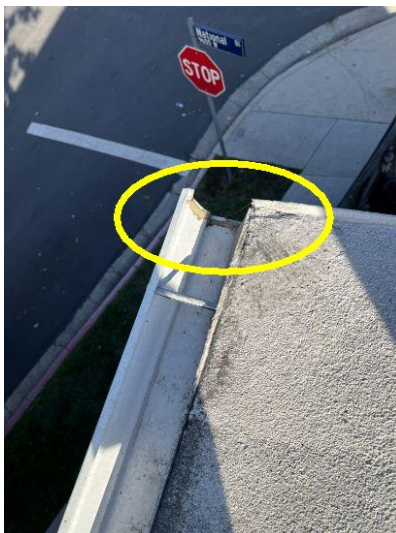
The downspouts do not all route the water away from the building but instead deposit it next to the structure which can cause problems to the foundation over time

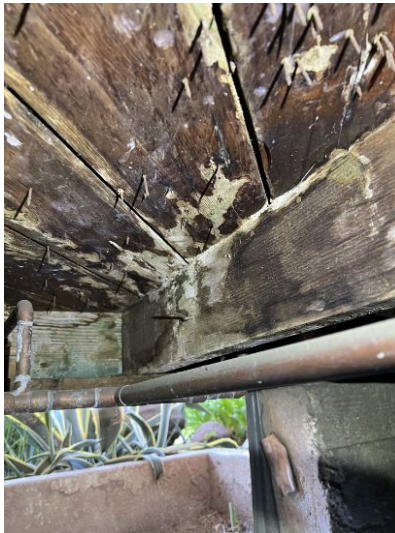
There are stained areas of floor framing - it is advisable to consult the structural pest control operator report for more information on this situation

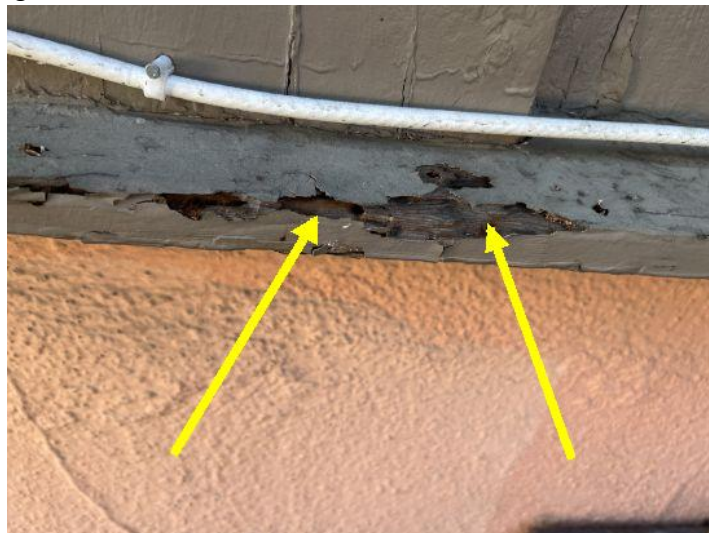
The exterior trim is damaged in areas.

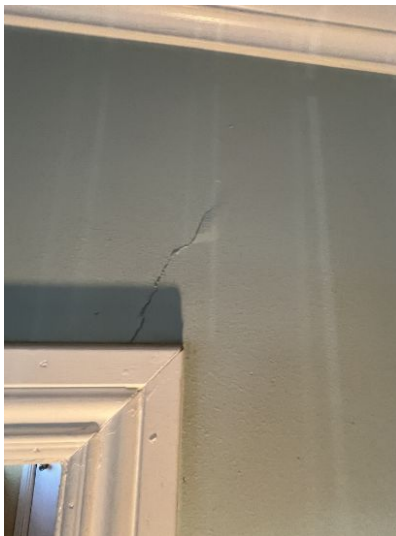
There are areas of stress cracks in the walls

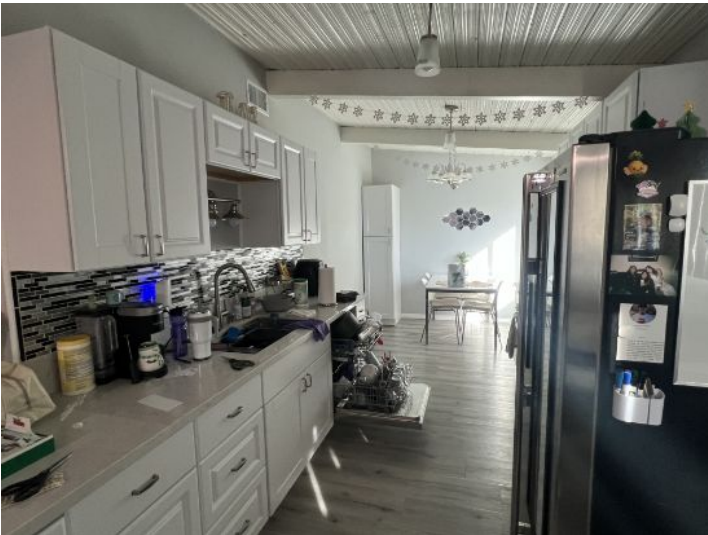
The cabinet area below the sink has damage/deterioration which appears to have been caused by moisture.

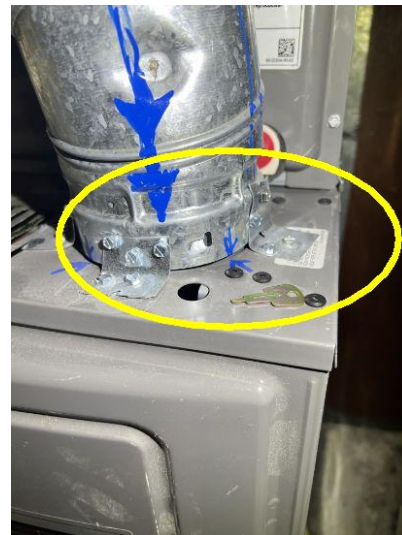
There is ducting that is crushed

Air is leaking at the duct connections. These should be checked and sealed for energy conservation.

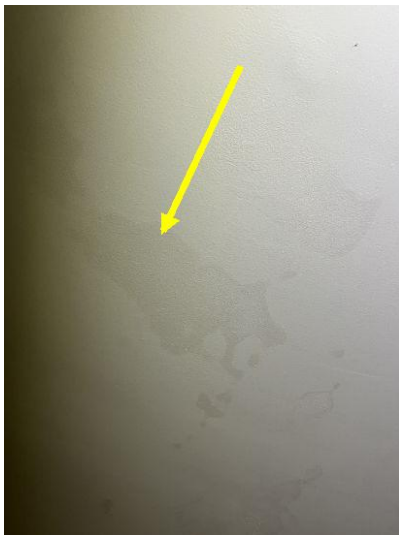
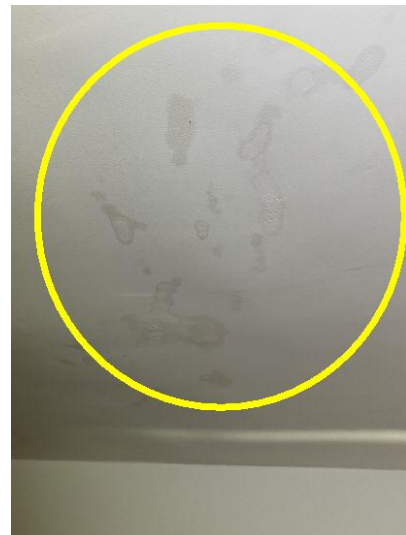
There are areas of stains on the ceiling. These were tested with a thermal camera and moisture meter and showed no evidence of moisture.

Stains

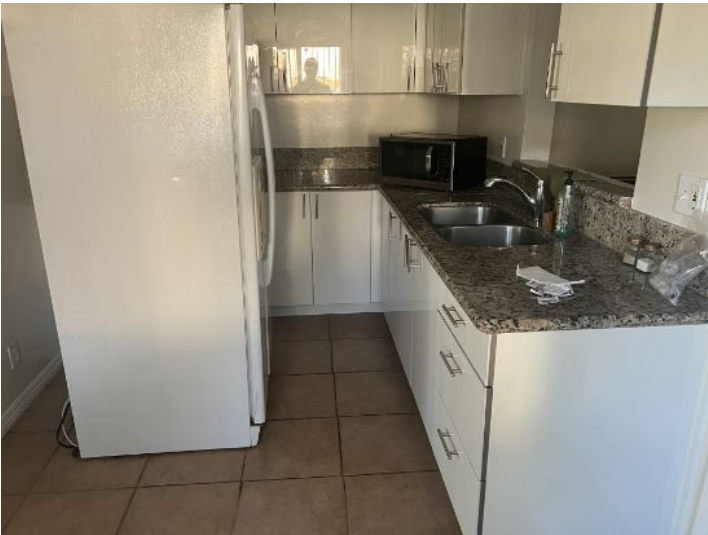
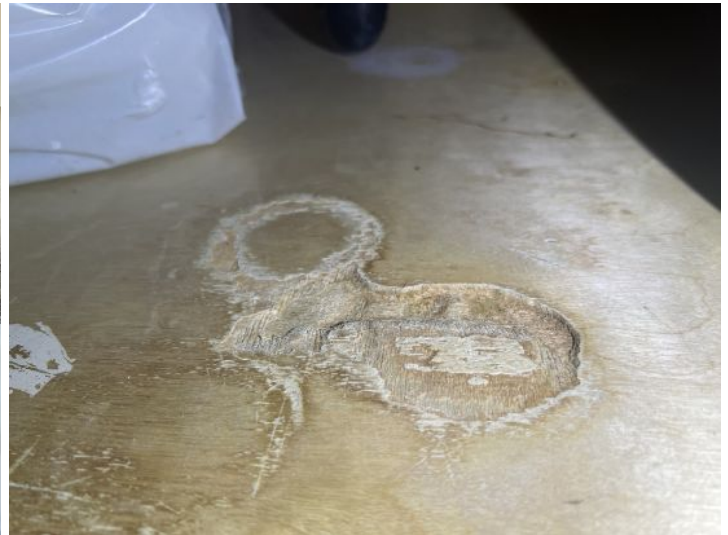
The cabinet area below the sink has damage/deterioration which appears to have been caused by moisture.

Moisture damage

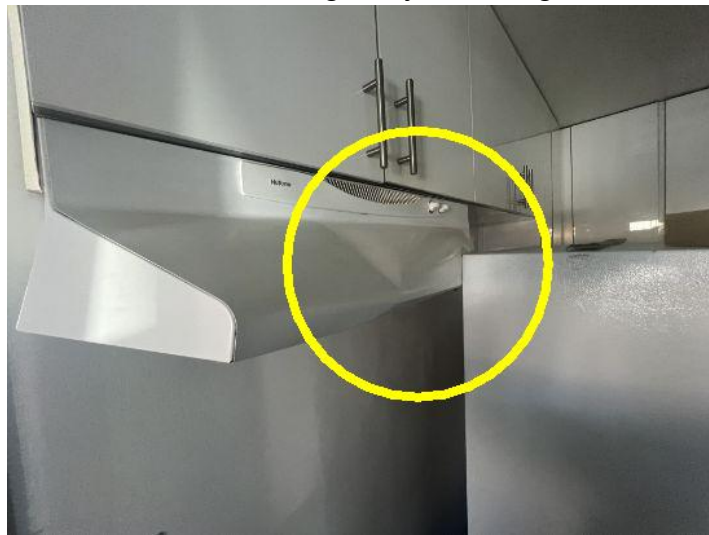
VENTILATION FAN - the hood has been damaged by the refrigerator.

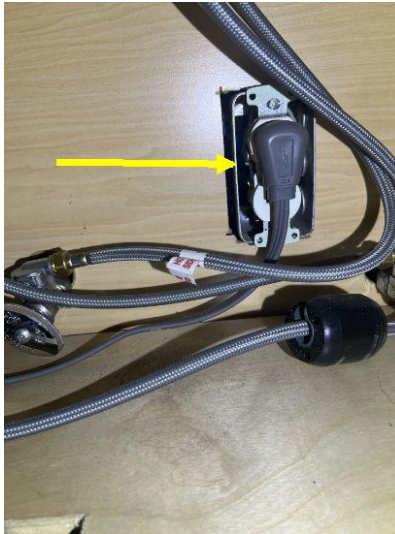
The panel cover is missing inside the electrical box and the live wiring and circuits are exposed when the outside cover is opened

Missing cover plate under sink

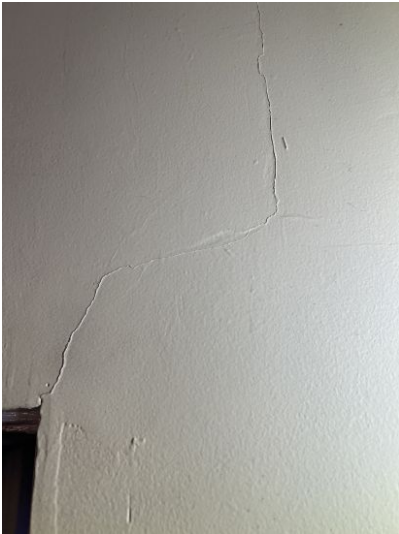
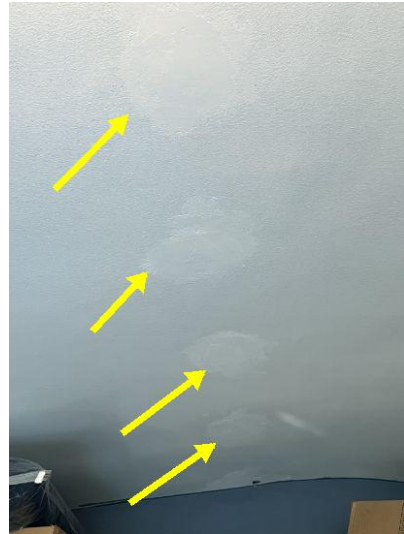
There are areas of stress cracks in the walls

There are areas of past patching and painting. The seller could be consulted.

Patching in bedroom ceiling

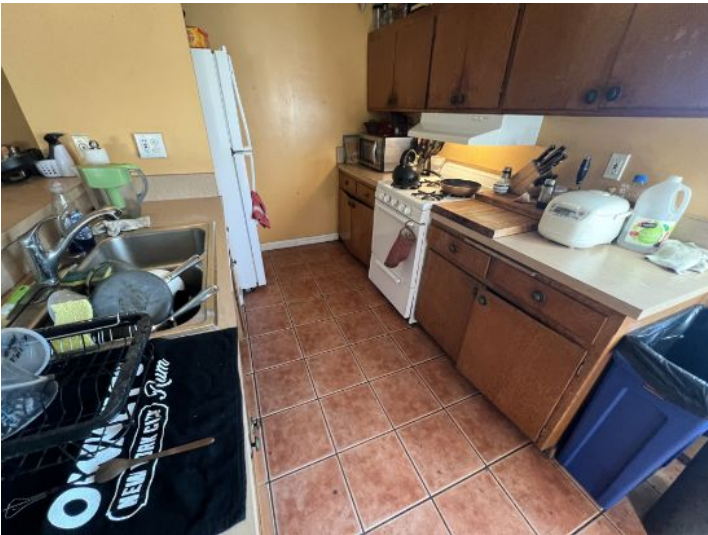
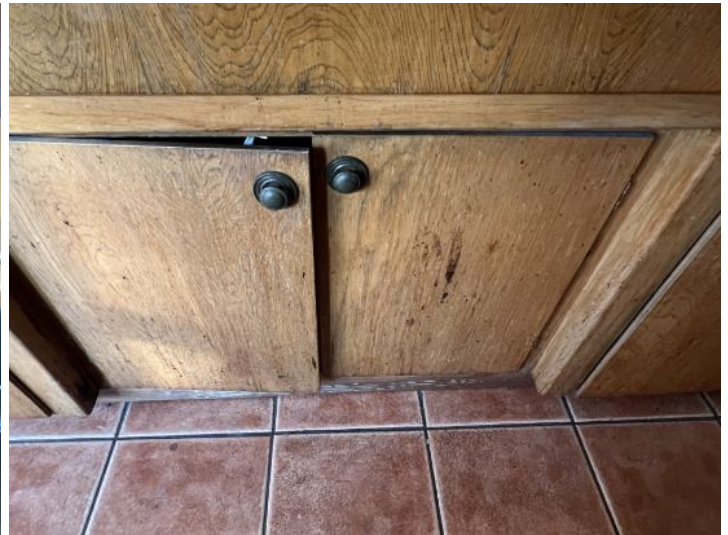
There are areas of wear to the counter.

There are areas of wear to the cabinets.

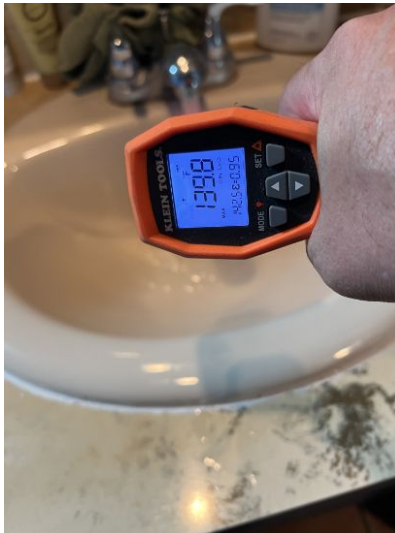
Water temperature at bathroom sink was 139 deg F. This is a scalding hazard. Typically, the water temperature should be no hotter than 120 deg F.

139 deg F

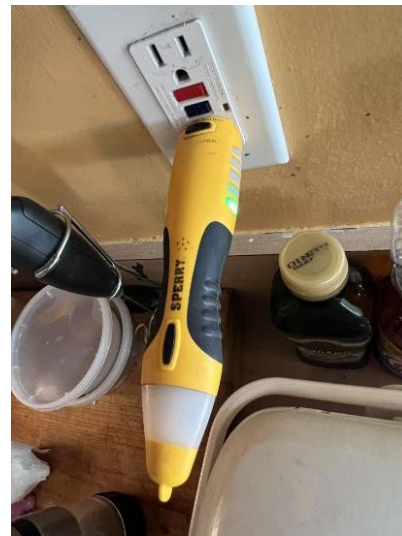
The Ground Fault Circuit Interrupter (GFCI) outlet in the kitchen did not reset when tested

Kitchen - GFCI DID NOT RESET

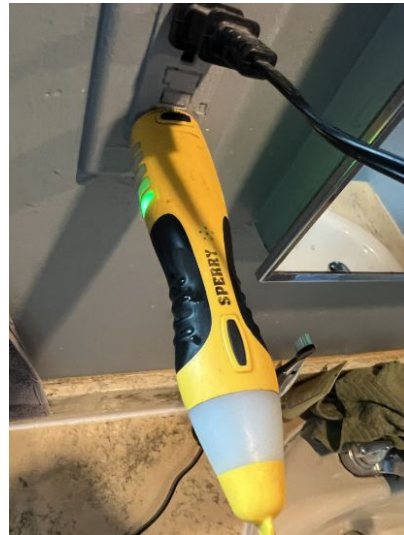
The Ground Fault Circuit Interrupter (GFCI) outlet in the bathroom did not reset when tested

Bathroom - GFCI DID NOT RESET

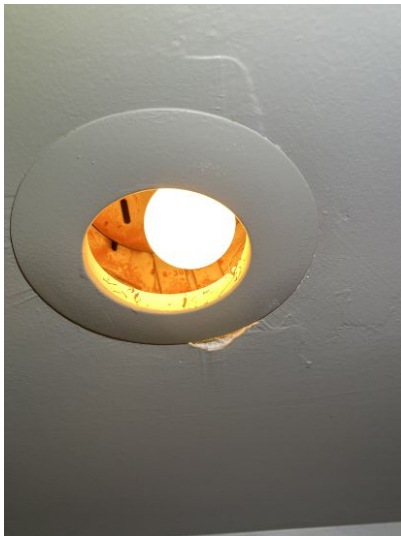
Light fixture in bathroom is missing a protective cover.

Bathroom - missing its protective cover
