First Shield Home Inspections

789 Place, Los Angeles, CA,

Prepared For: Mr and Mrs Purchaser

Date of Inspection: 1/1/2024

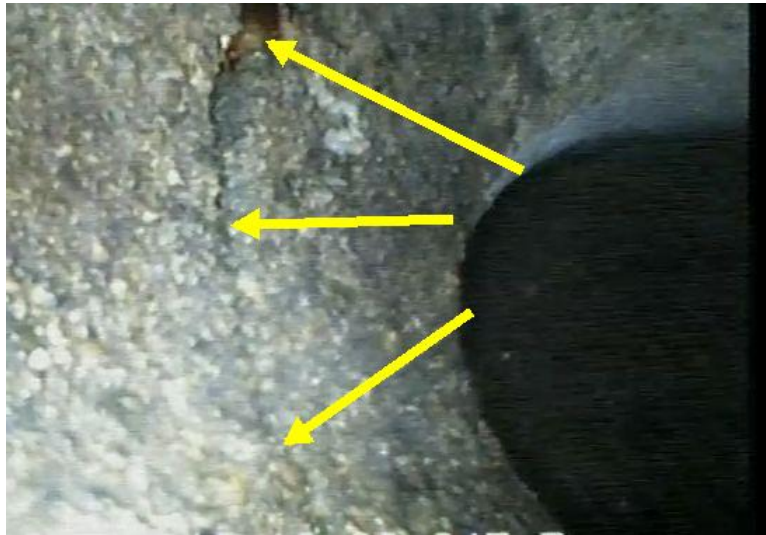
There are cracks noted in the piping near the city connection.

47' from access point

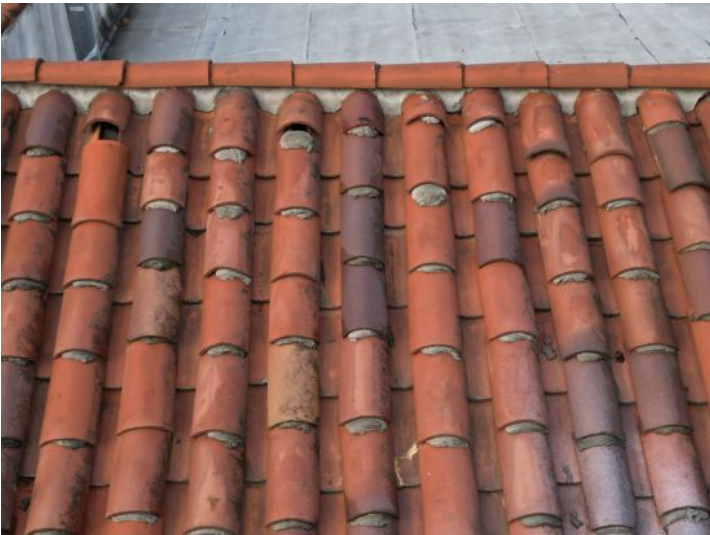
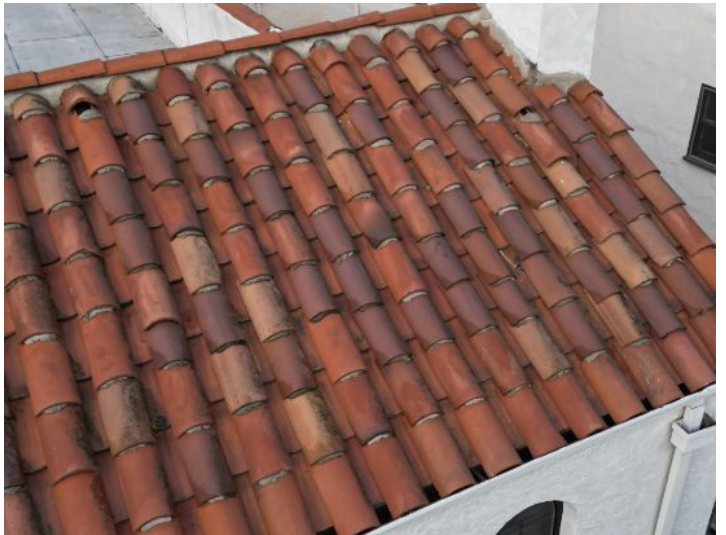
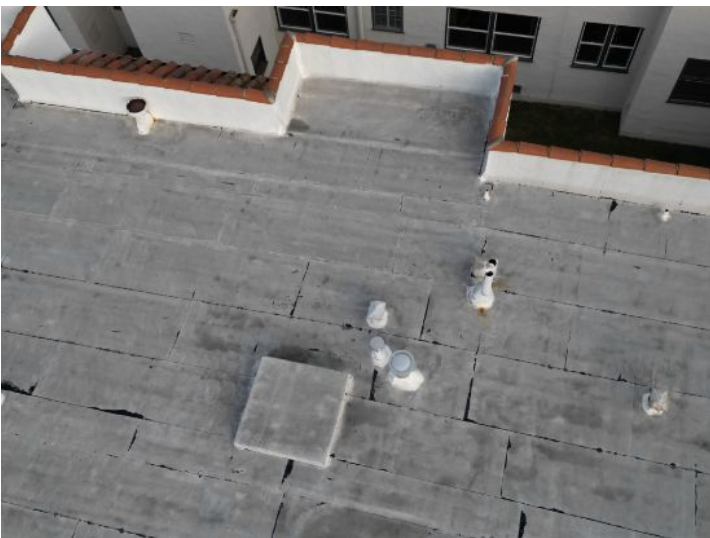
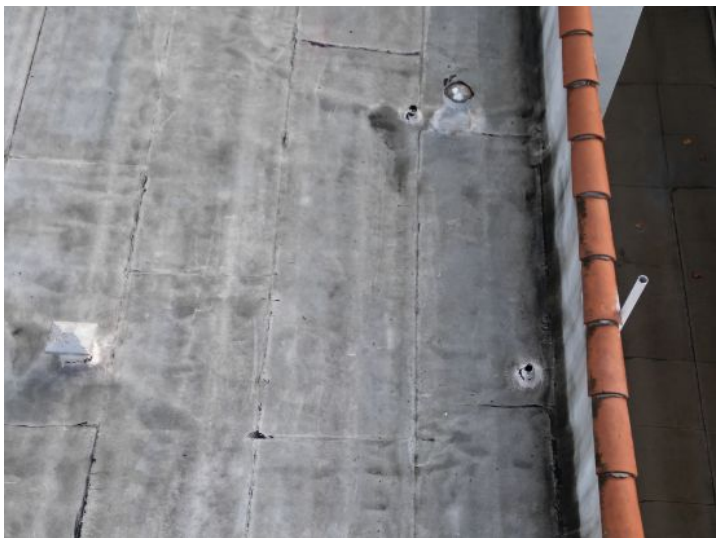
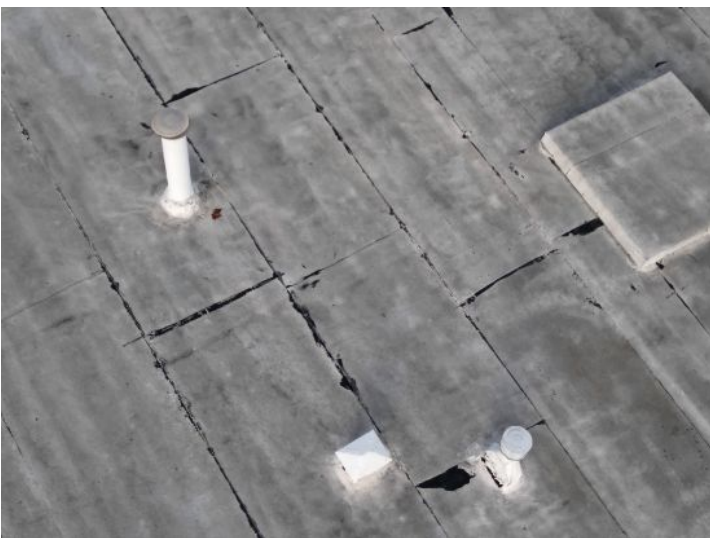
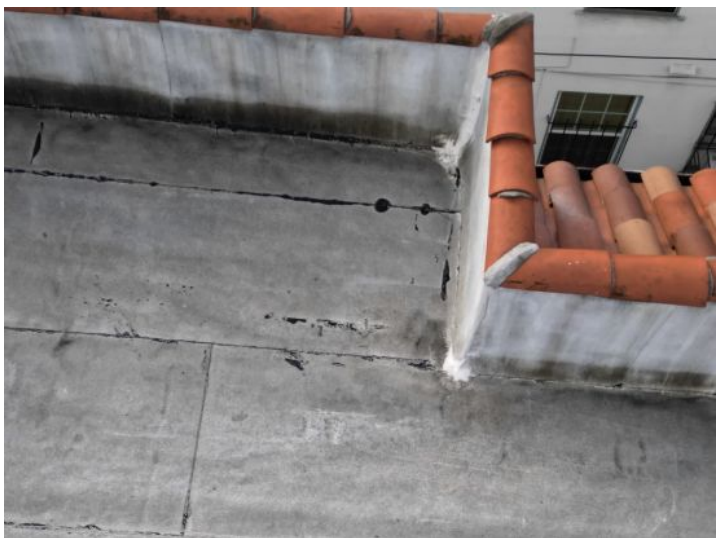
There are displaced tiles that have slipped down and are no longer in the correct location. This allows sunlight to deteriorate the exposed underlayment. These should be repaired.

There are areas of pooling water.

Pooling water

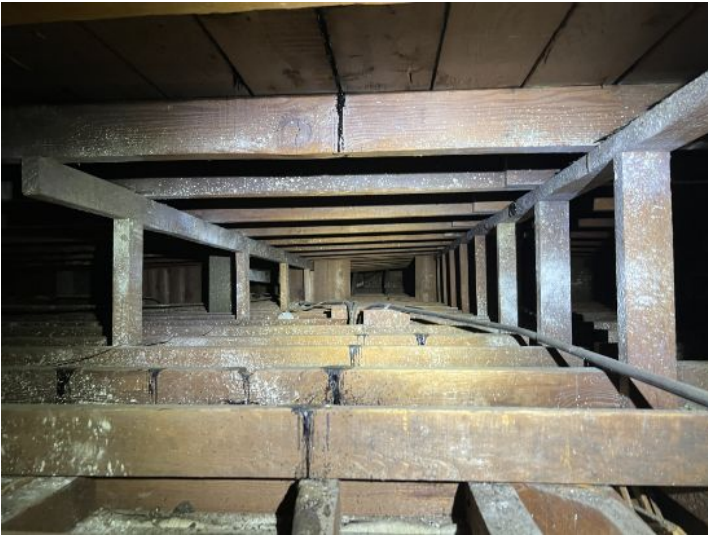
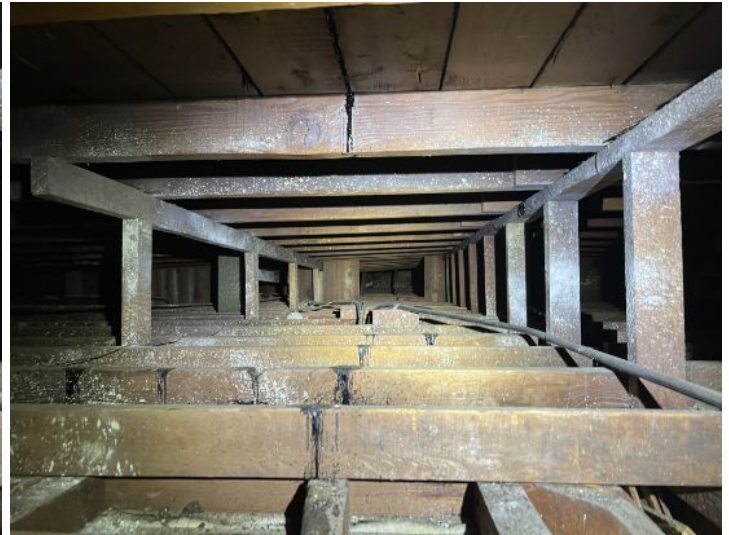
There is not a complete firewall separating each unit's attic space as is recommended to reduce any risk of fire.

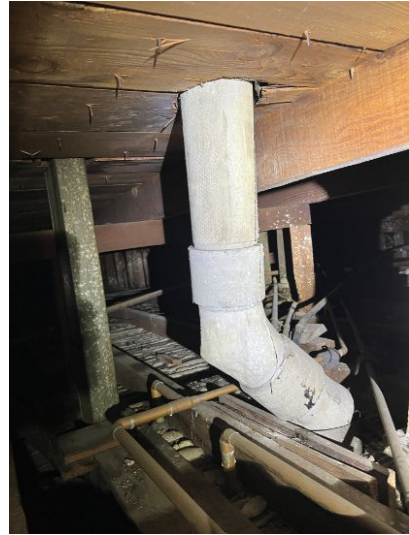
Possible asbestos

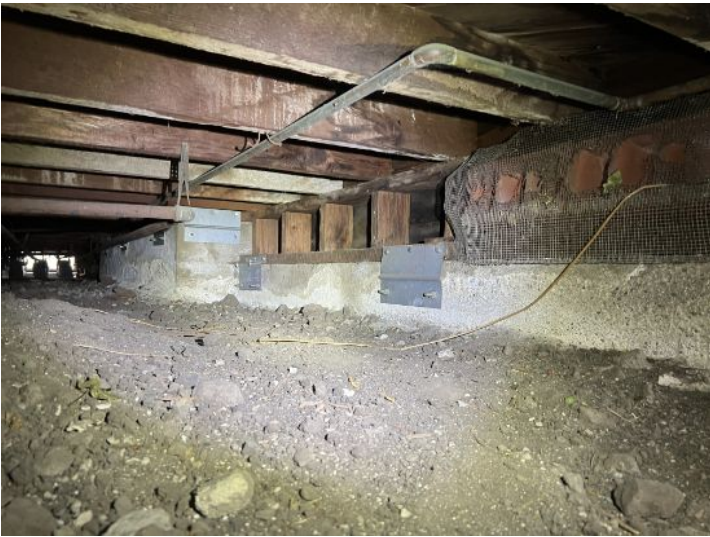
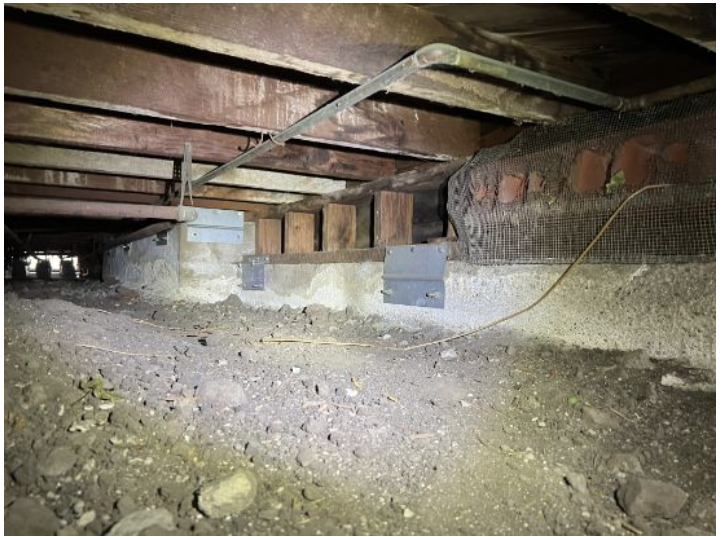
The crawlspace has debris in it, it is advisable to have it removed and the area cleaned up. Wood especially should be removed to help prevent future infestations

Possible asbestos materials were in the crawlspace. These would have to be tested by an independent lab to confirm the presence of asbestos.

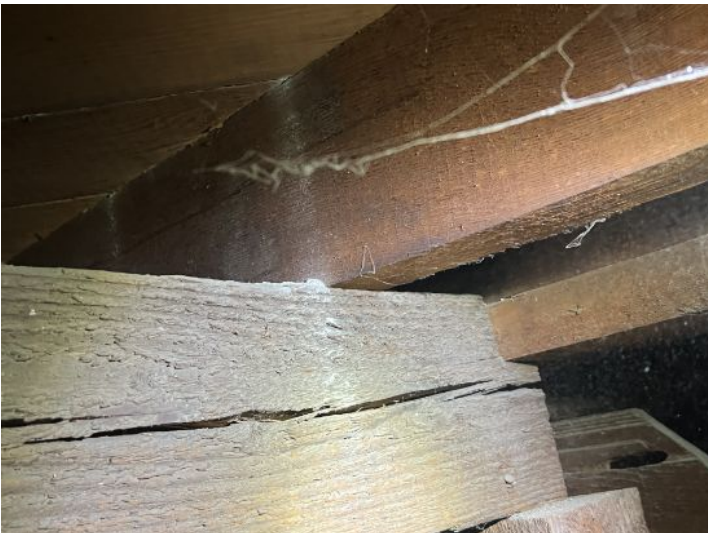
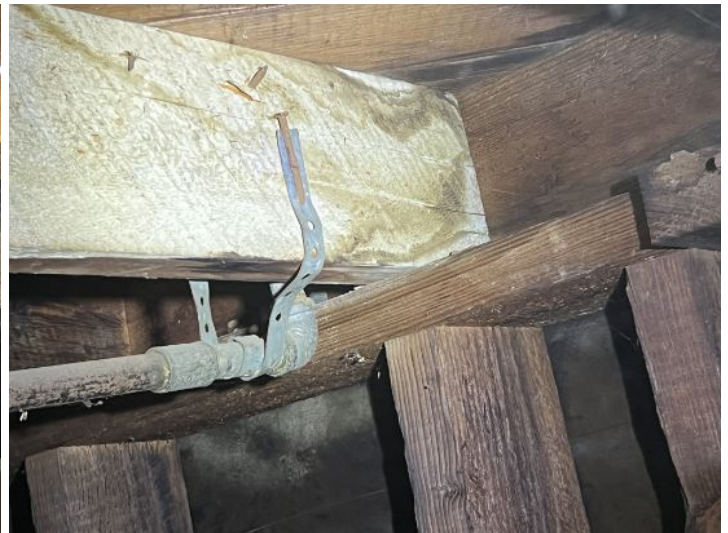
There are damaged and deteriorated areas of floor framing.

There are stained areas of floor framing - it is advisable to consult the structural pest control operator report for more information on this situation

Staining

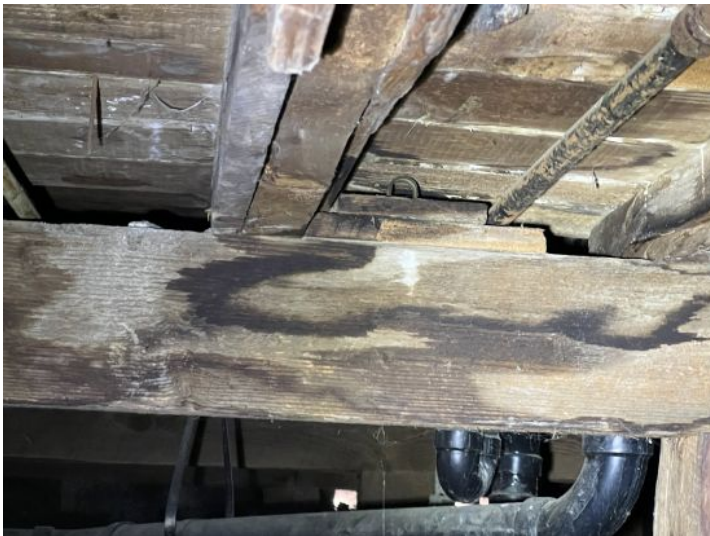
Staining

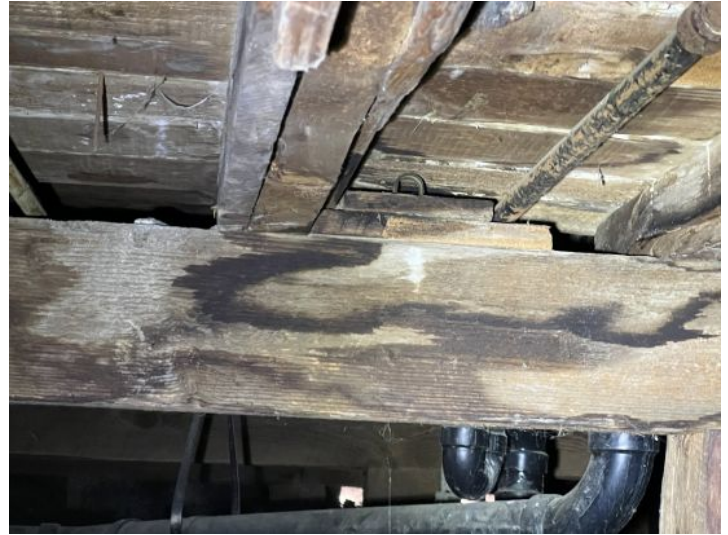
Staining

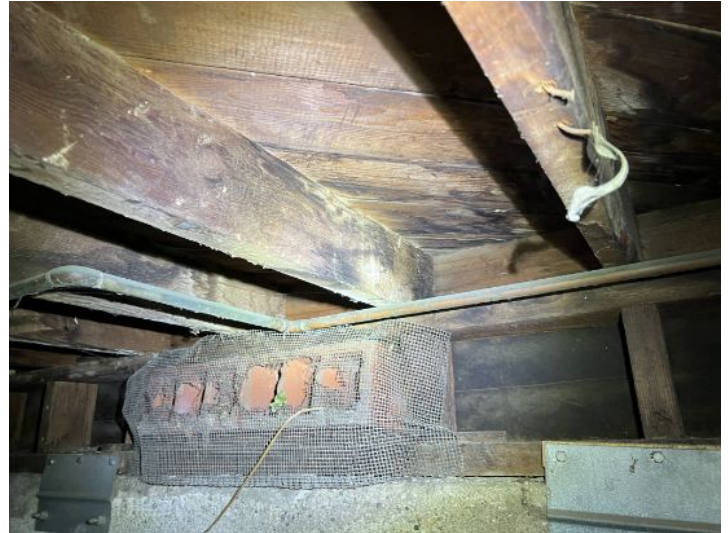
There are missing fresh air vent screens. These will allow animals and insects to enter

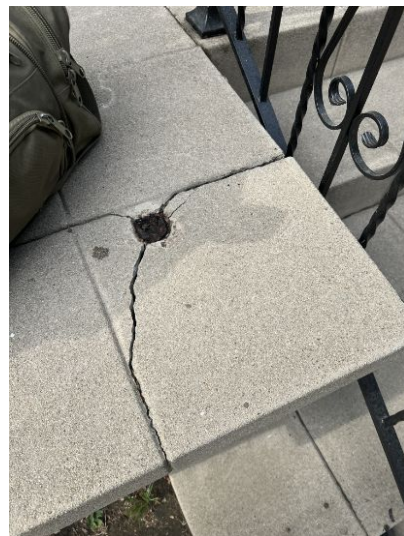
Cracked cement tile near the front stairs.

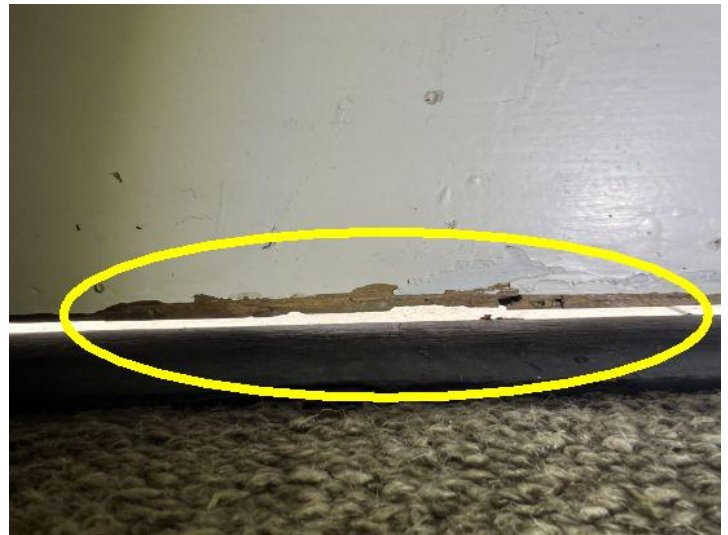
There is a gap at the bottom of the door. A sweep or seal should be installed to help improve the energy efficiency of the home.

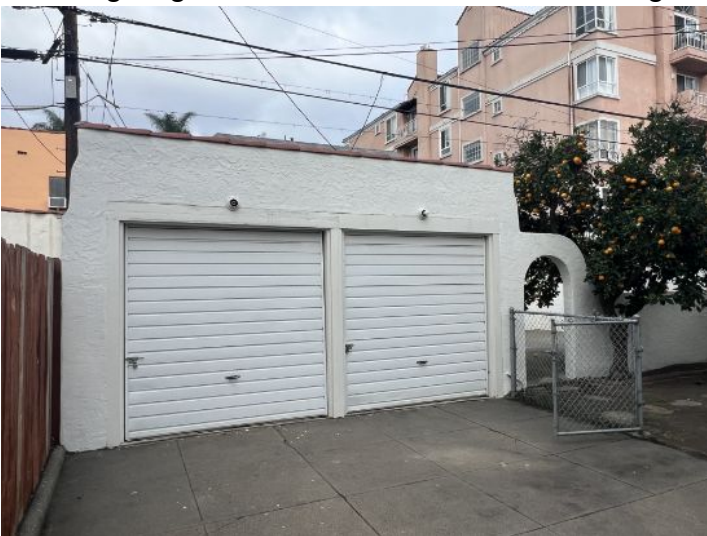
Unit 1 (left side)

Some garages have windows that are missing the glass. They are boarded up.

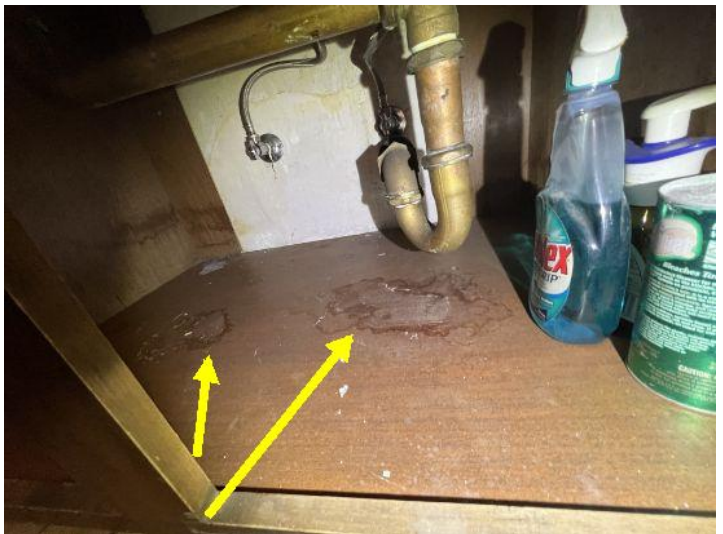
The cabinet area below the sink has damage/deterioration which appears to have been caused by moisture.

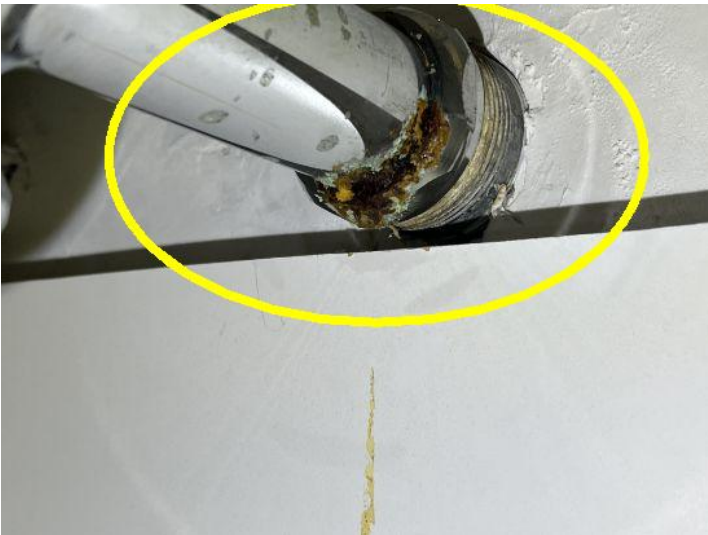
The drain line is corroded and leaking.

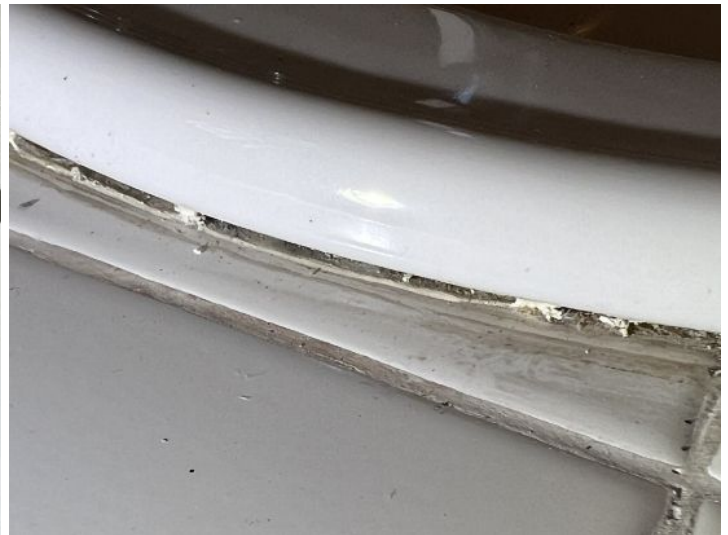
Sink seal is deteriorated.

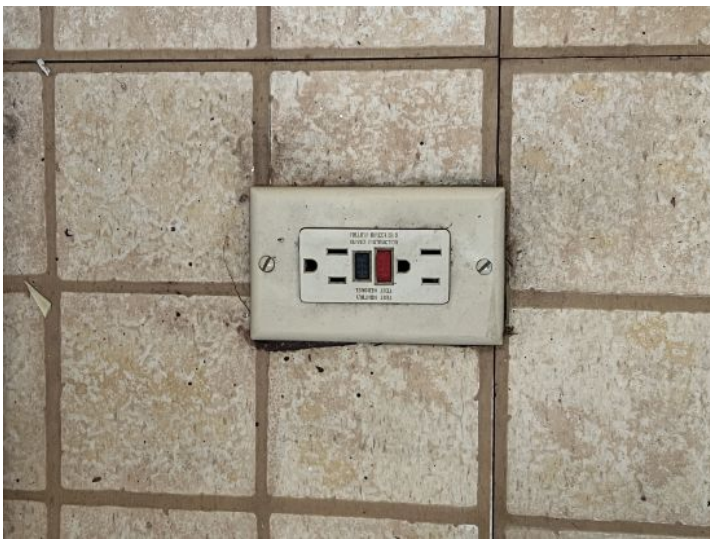
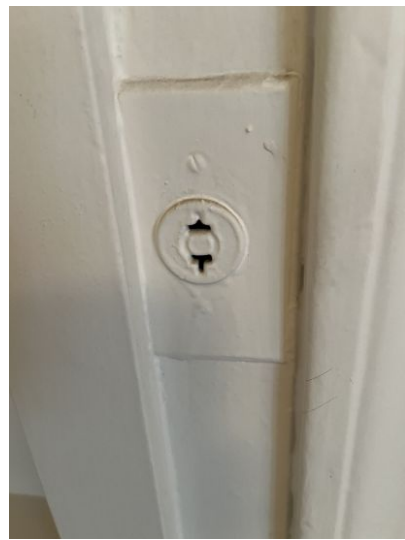
GFCI outlet located in the floor of the kitchen. This style of outlet is not meant to be in the floor. There is no protection to prevent outlet damage.

There are no GFCI outlets in areas that require them, such as the kitchen, bathrooms or any area exposed to a water source.

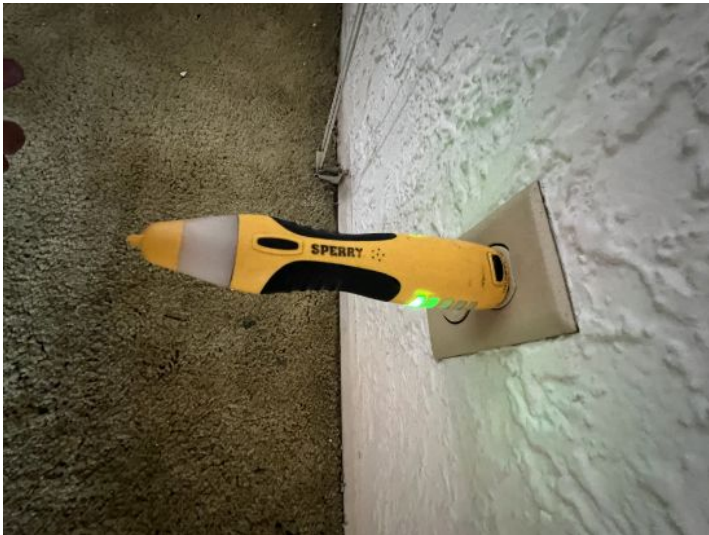
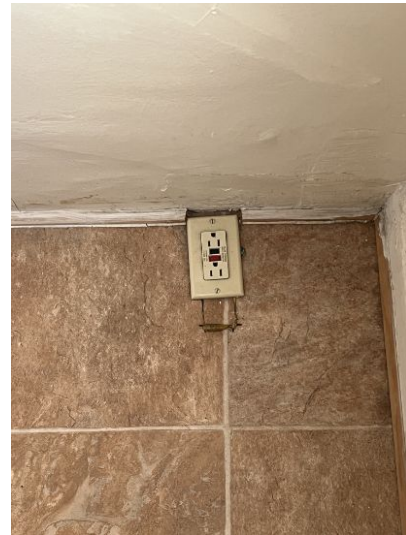
GFCI outlet located in the floor of the kitchen. This style of outlet is not meant to be in the floor. There is no protection to prevent outlet damage.

There are no GFCI outlets in areas that require them, such as the kitchen, bathrooms or any area exposed to a water source.

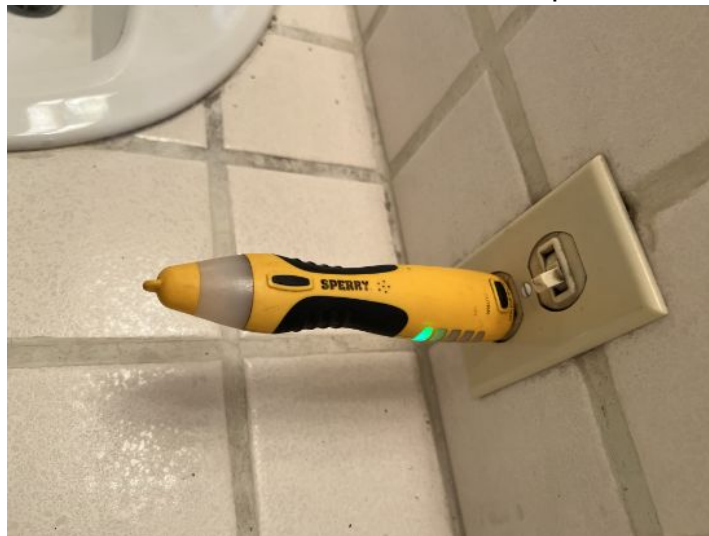
Bathroom - NO GFCI

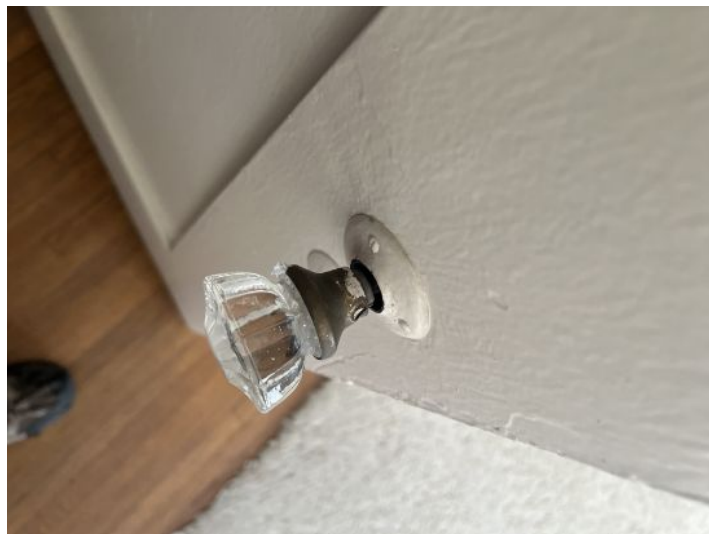
The interior doors do not always work well and are out of adjustment. They would need repairs to operate properly.

Door handle loose

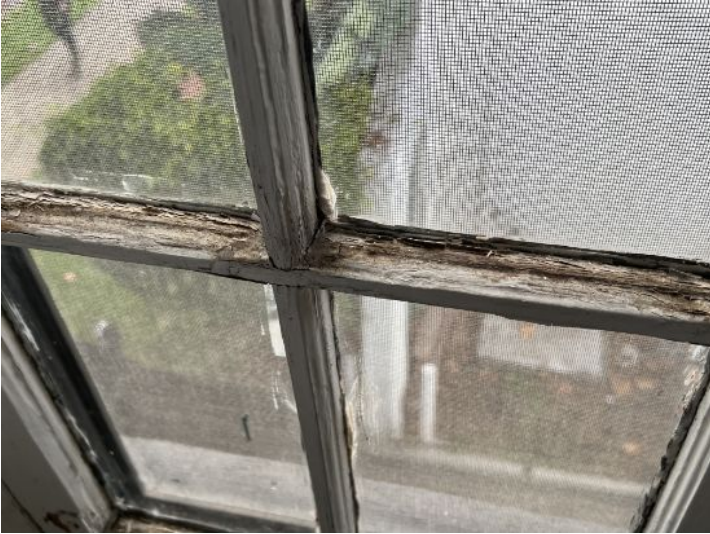
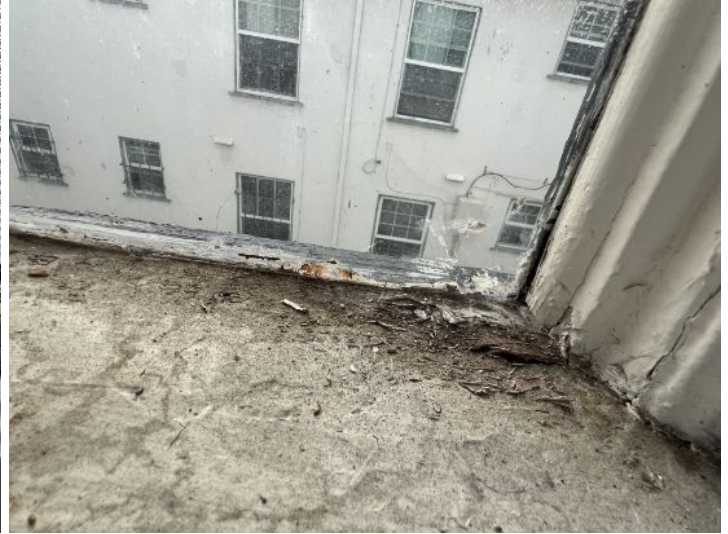
There are areas of deterioration to the exterior of the windows

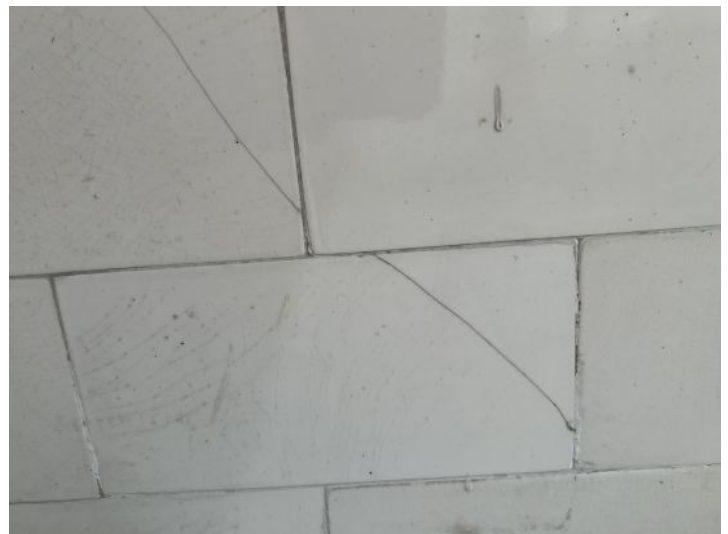
The bathroom floor tile is cracked in areas

Cracked tiles
