First Shield Home Inspections

456 - Any Street, Any Town, CA, 90000

Date of Inspection: 8/14/2023

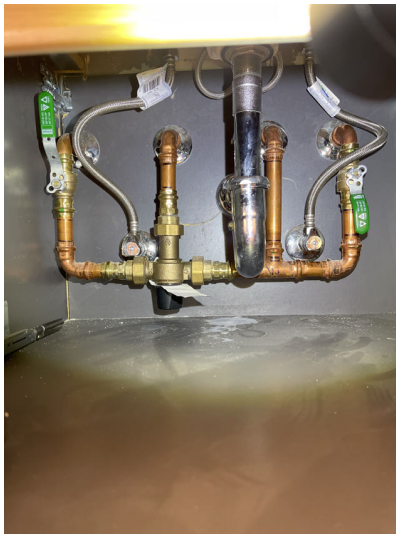
There are shutoff valves under the master bathroom sink. It is unclear what they control. Please confirm with the seller about what these are.

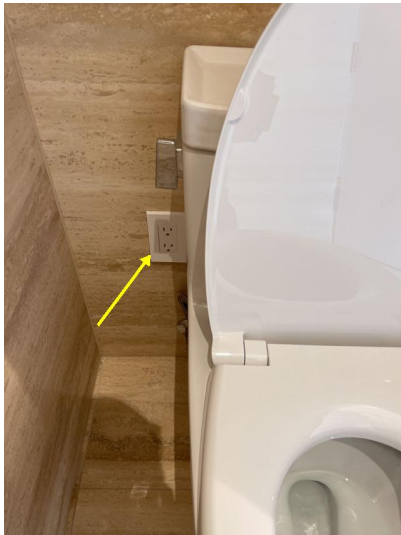
Master bath.

There are no **GFCI** outlets in areas that require them, such as the kitchen, bathrooms or any area exposed to a water source. - Bathrooms

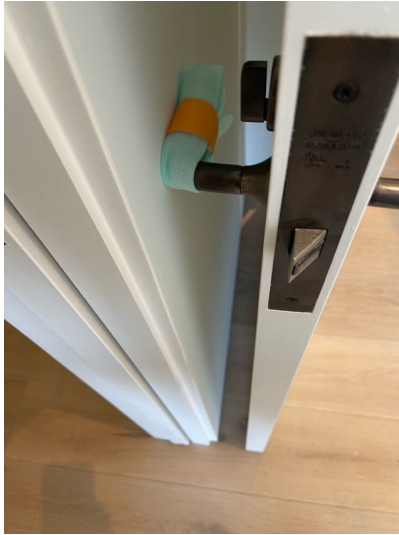
Most of the swinging doors in the unit do not have door stops to prevent them from damaging the wall. It is advised to add door stops to these doors.

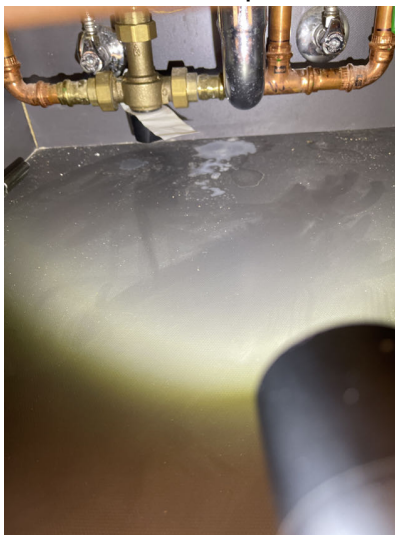
There is evidence of a previous leak. Please follow up with the seller.

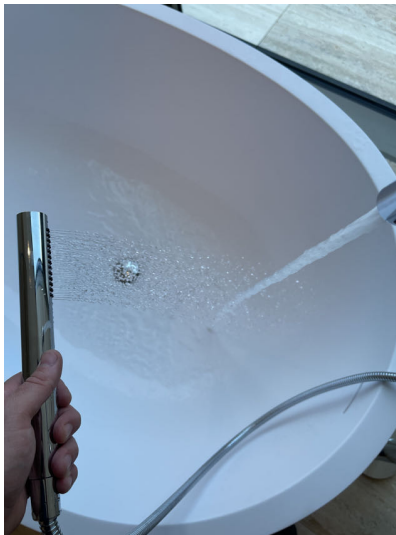
The bathtub diverter did not divert all water to either the handheld shower or tub spigot. There was water flowing from both areas at the same time.

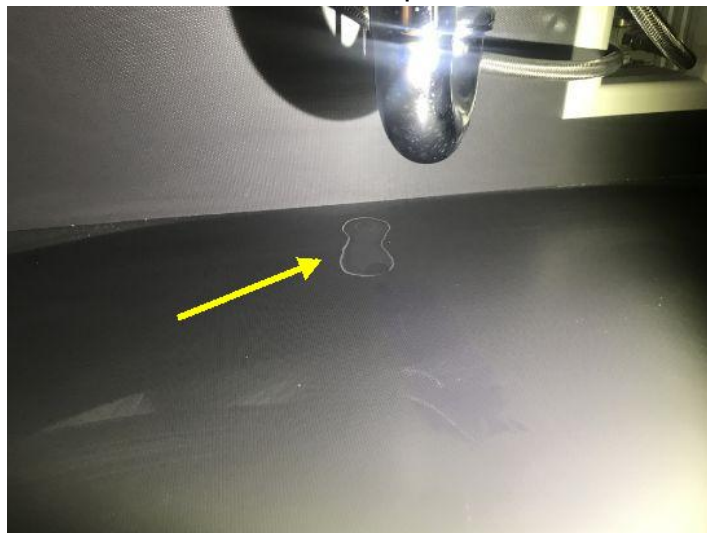
There is evidence of a previous leak. Please follow up with the seller.
