# First Shield Home Inspections

**12345 Anyplace, Lancaster, CA,**

**Date of Inspection: 1/10/2024**

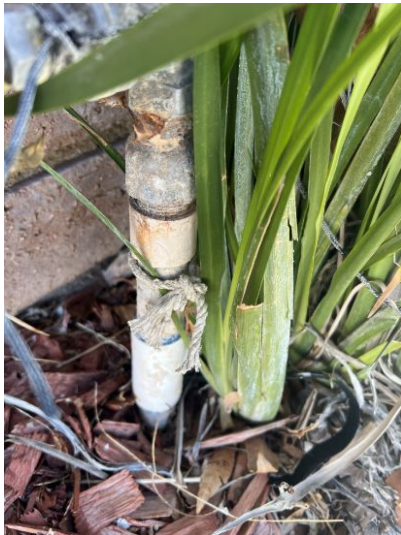
Rusting pipe

There are areas where the galvanized steel pipes are rusting and corroding. These are signs of excessive deterioration and could lead to reduced water flow in areas and / or system failure.

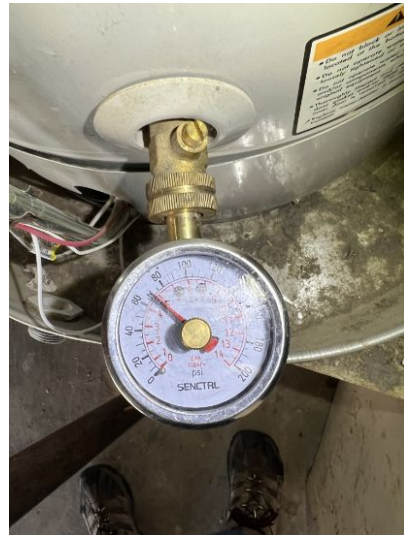
The home water supply pressure was approximately 70 PSI at the time of inspection. This is within the recommended range of 40 – 80 PSI.

70 PSI

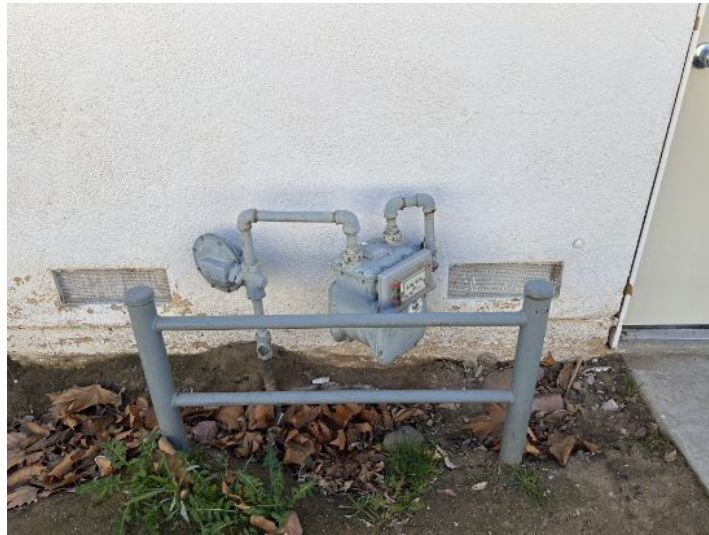
There is no automatic seismic gas shut-off valve on the main gas line. This may not need to be installed in this municipality at the time of sale.

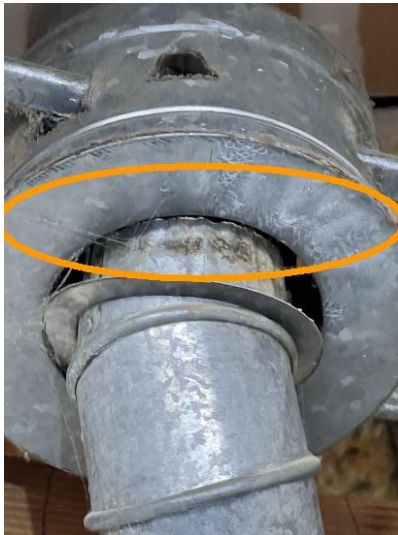
The vent line is disconnected and exhaust gases from the water heater are escaping. This is a safety hazard and needs to be repaired.

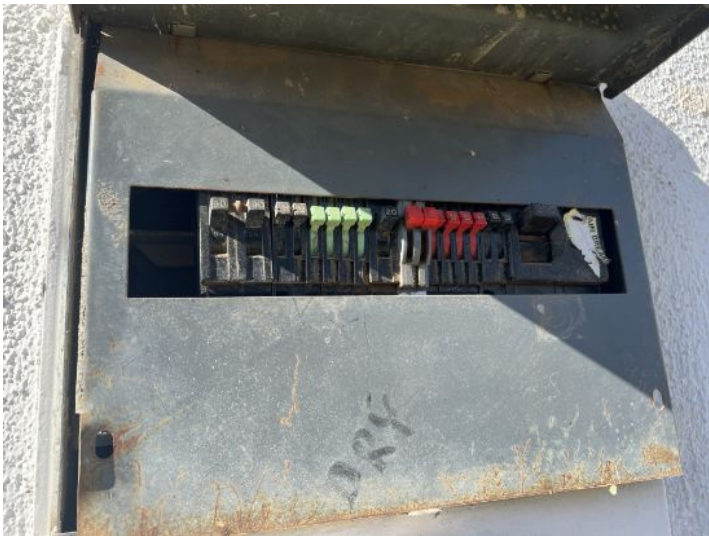
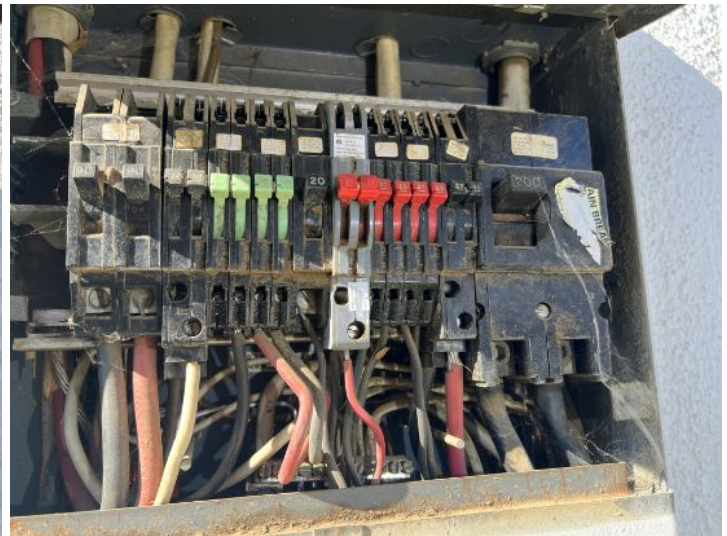
**There are knock-outs missing in the main electric panel leaving open spaces in the dead front cover which leaves exposed live electrical items as a result. This is an inexpensive fix to correct but should be repaired to make the panel more safe.**

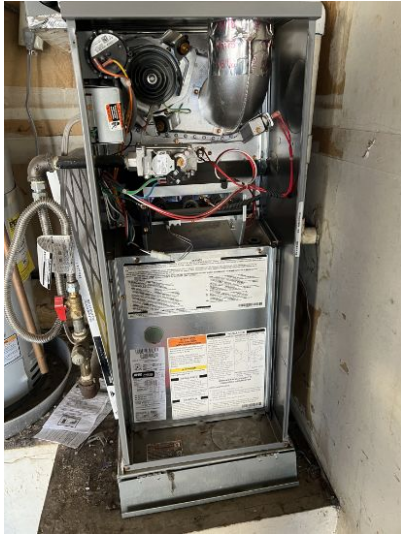
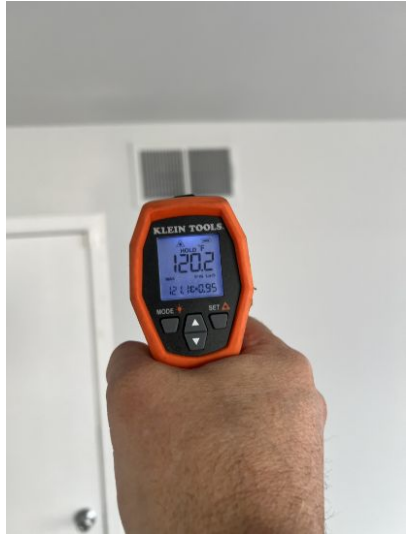
There is no sediment trap on the gas line coming into the furnace. Please see the glossary for an explanation of a Sediment Trap.

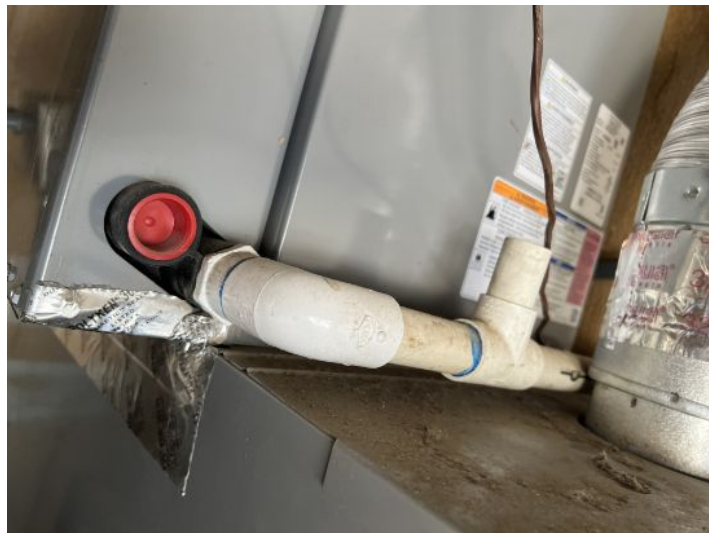
The condensate drain line does not have a proper trap installed. This should be added for improved efficiency and operation of the condensate drain line.

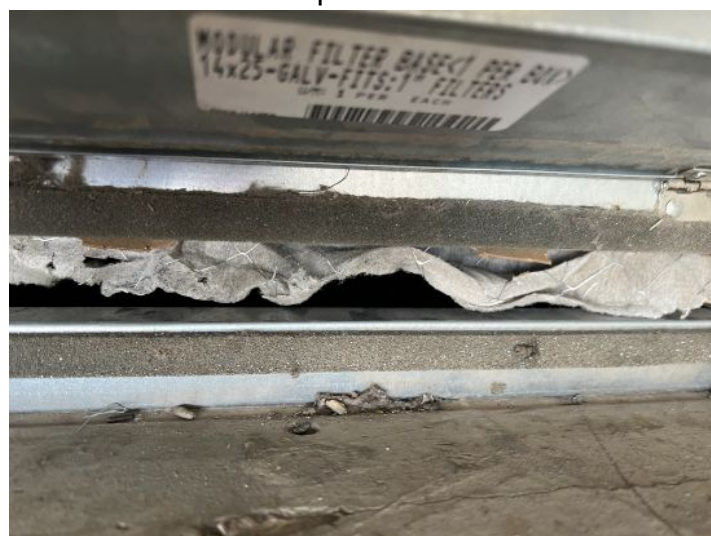
The air filter is damaged and will need to be replaced with a new filter.

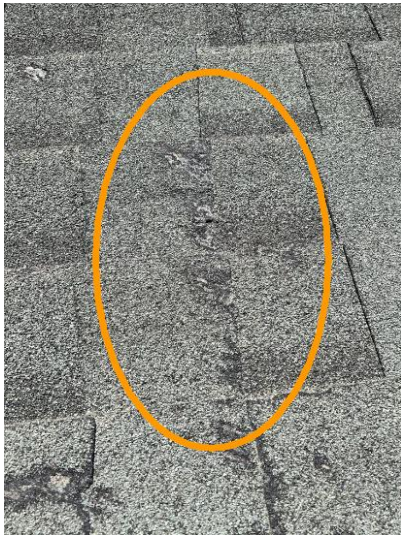
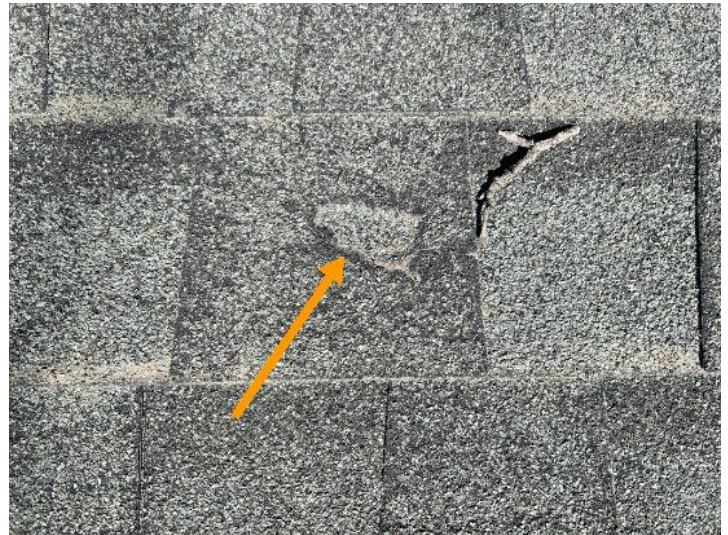
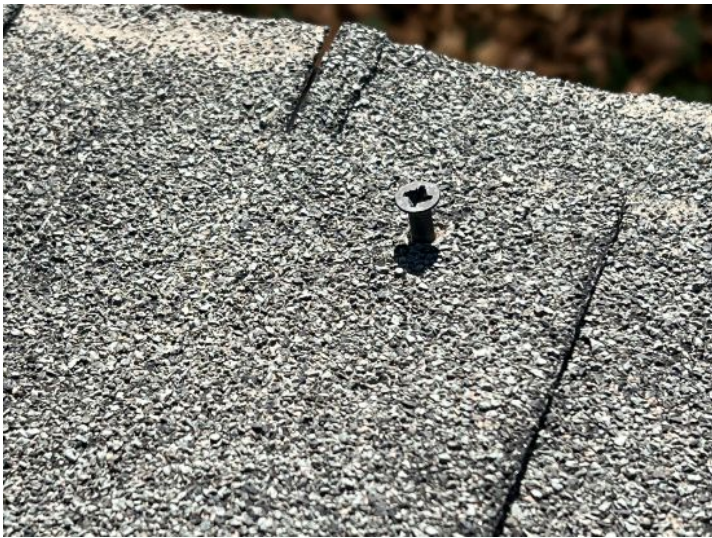
There are areas of displaced, damaged, and deteriorated shingles.

There are screw heads exposed on the roof surface. Not only will this allow them to rust, but it is a potential leak hazard. This is generally considered a poor and unreliable installation method.

The composition shingles are older, deteriorating, and losing their surface granules. It may be nearing the time to replace this roof covering.

Exposed screw heads

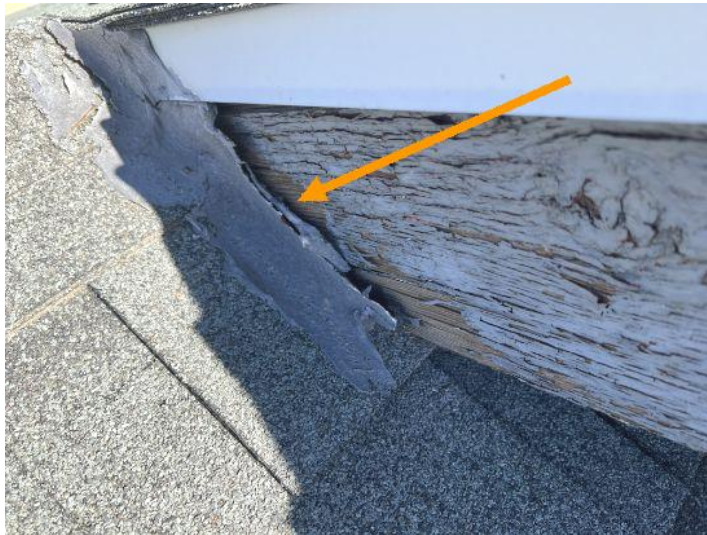
The flashings have been covered over with mastic, this usually means these have potentially leaked in the past. Mastic over time dries out and begins to crack which means the seal has been broken. This is a temporary solution and will require regular ongoing maintenance to help ensure moisture doesn't enter the roof / attic system at this point.

The chimney flashing is deteriorated in areas.

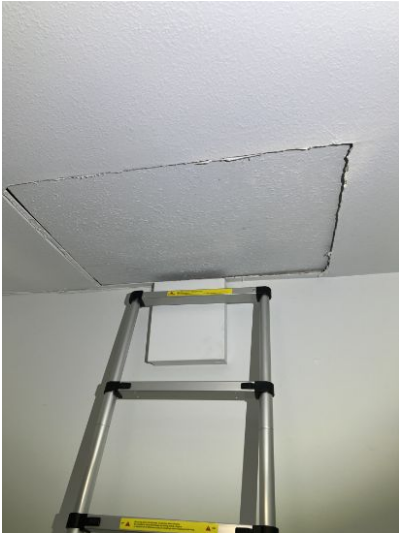
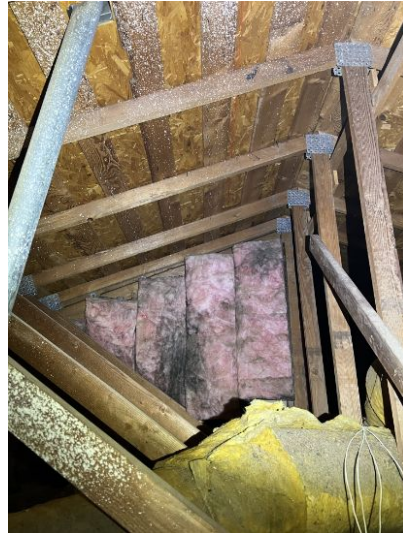
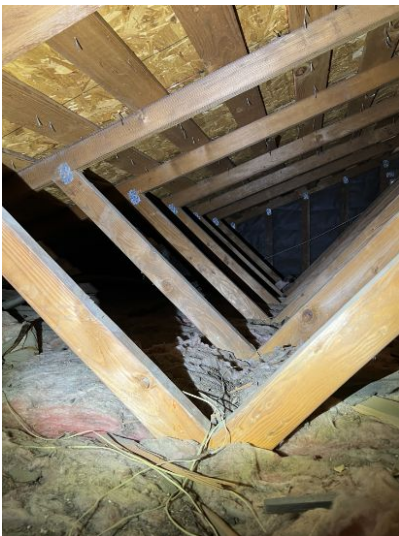
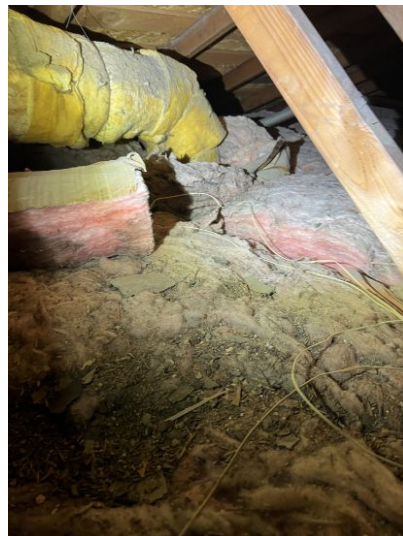
The attic has wood shingle debris in it. This occurred when the old wood roof was removed and pieces of it fell in the attic and were not cleaned up. Ideally this should be removed as this can extra food for "termites".

Debris

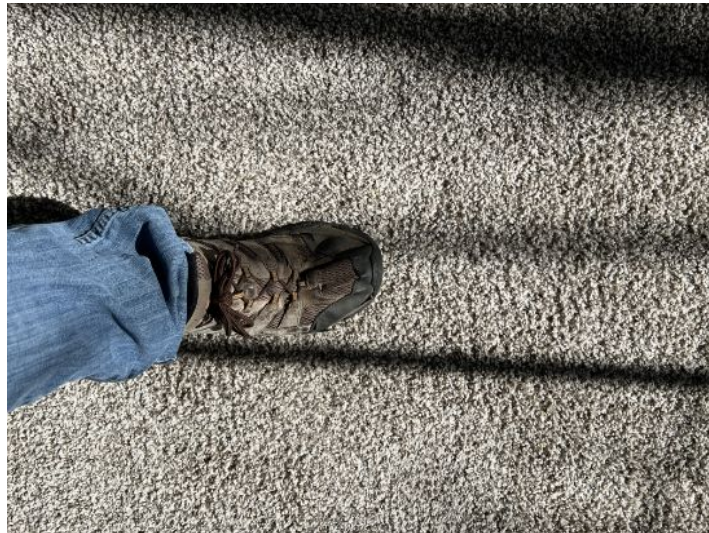
**There are areas where a damaged or cracked slab can be felt through the finished floor. This needs to be checked out with the finish flooring removed - living room.**

Crack felt in floor - living room

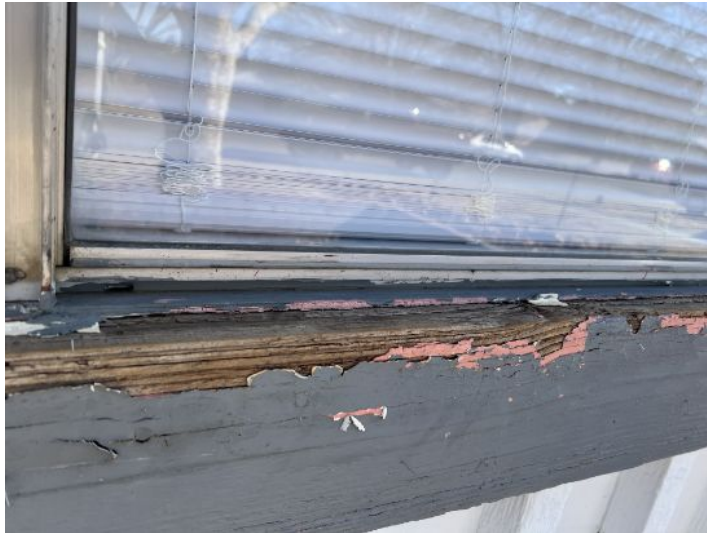
The exterior trim has areas of peeling and weathered paint.

The exterior trim is deteriorated in areas.

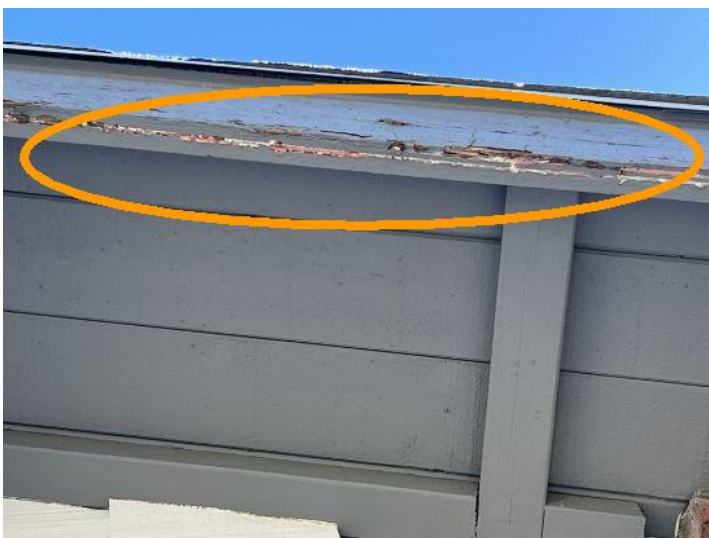
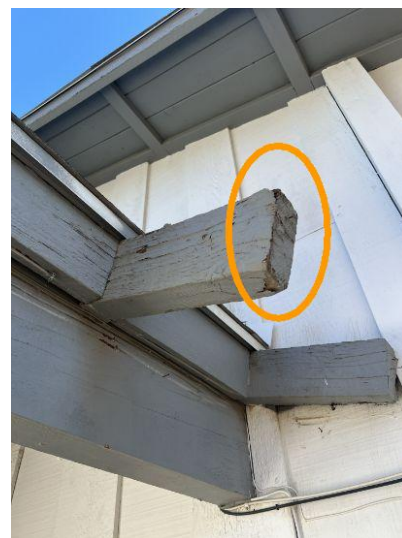
The rafter tails are deteriorated in areas.

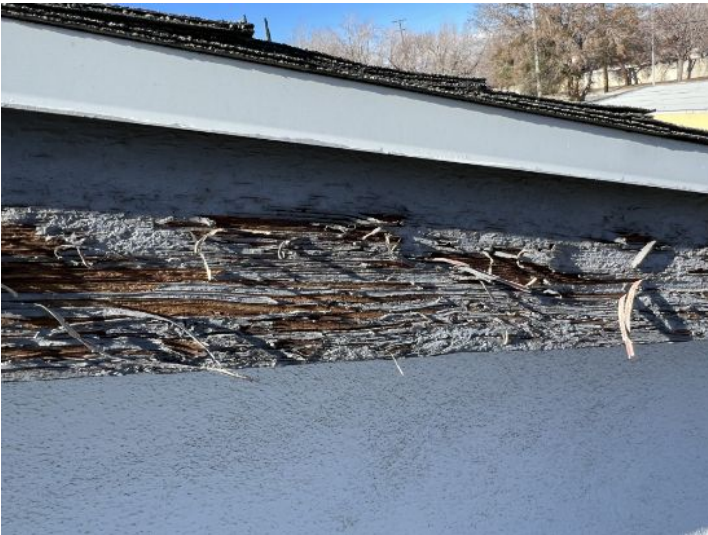
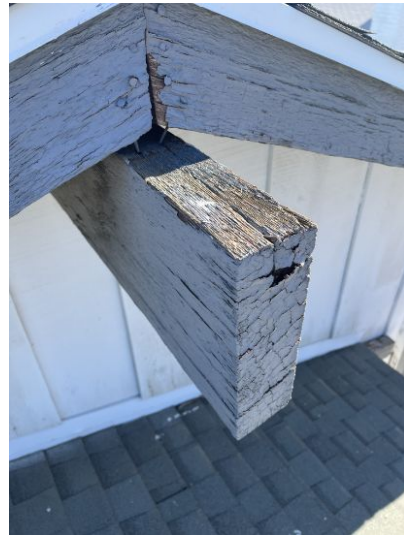
The rafter tails are deteriorated in areas.

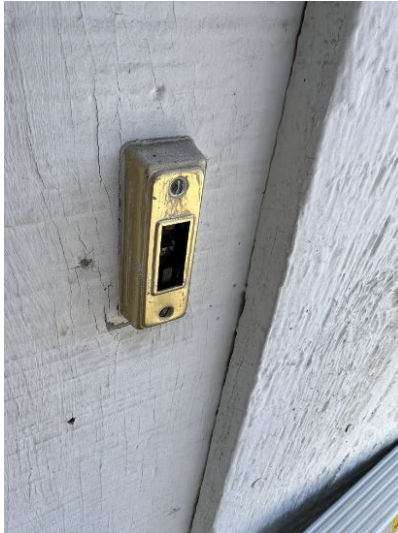
The doorbell ringer is missing some parts.

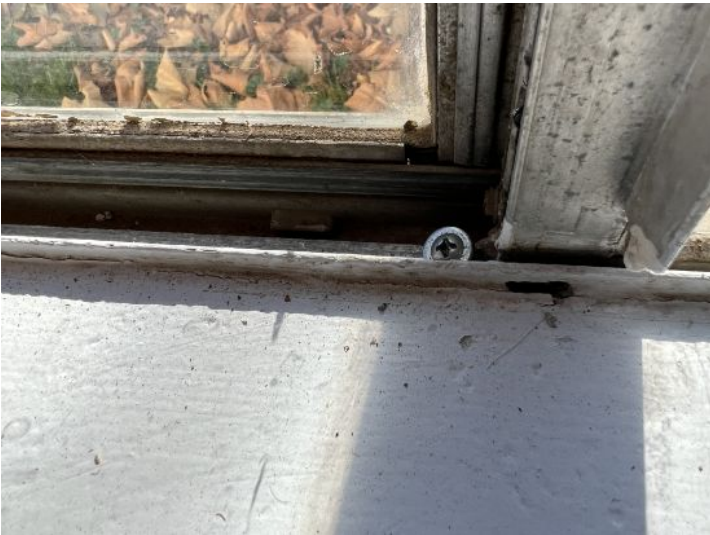
Some windows do not have locking mechanisms. They are locked in place with screws.

Screws being used as lock

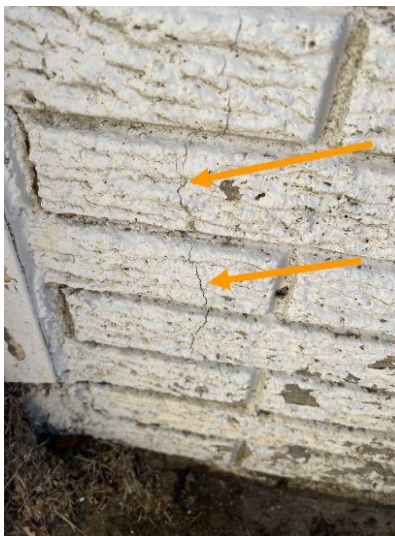
The chimney has areas of minor cracking noted. When pushed, the chimney does not move. These do not appear to be significant at the time, but these will need to be checked often to ensure these cracks don't worsen and lead to bigger problems. A chimney specialist could be consulted for a full evaluation.

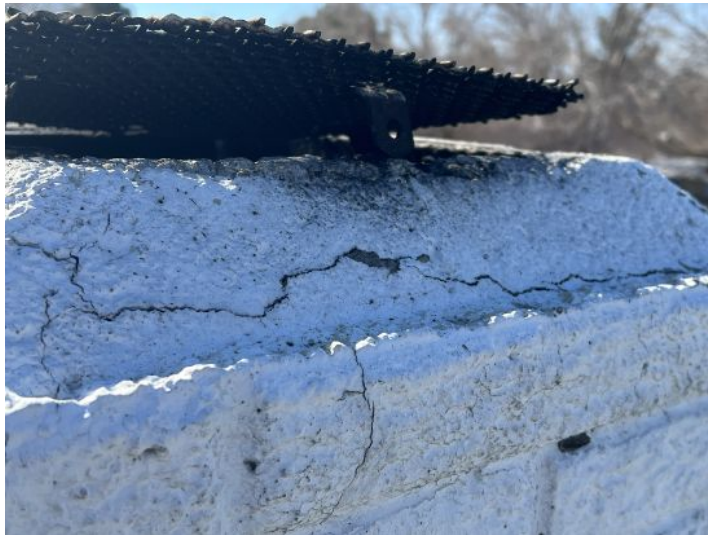
There are cracks in the concrete chimney crown that will need repair.

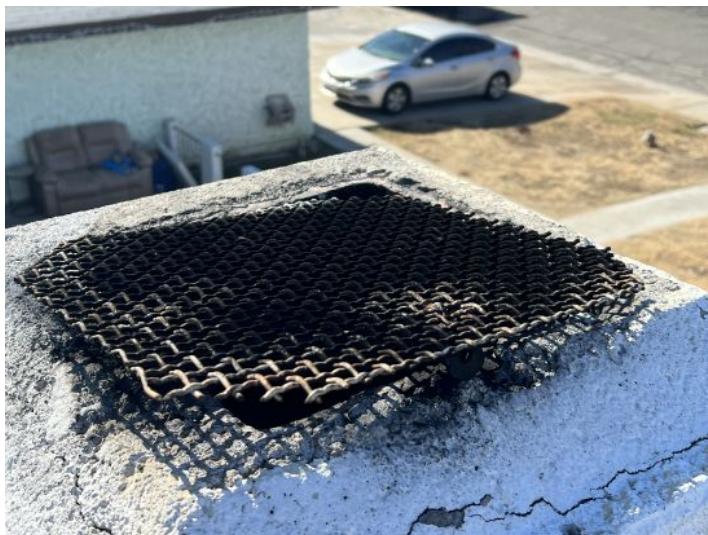
The chimney has screen on it as a spark arrestor. This is non-standard as the screens do not prevent water intrusion, and they may clog. There needs to be a proper weather proof spark arrestor installed as per current standards.

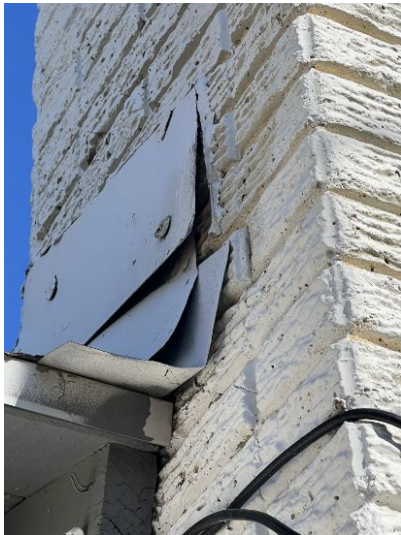
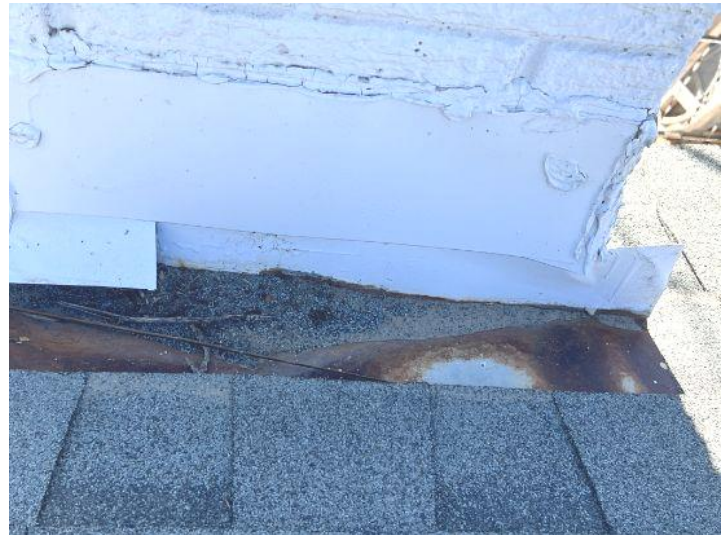
The chimney flashing is deteriorated and rusty in areas.

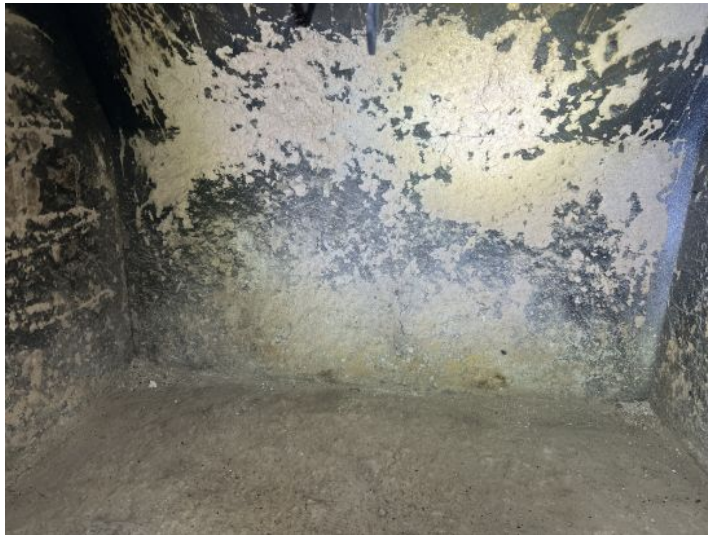
There is some deterioration to the firebox back wall area, this does not appear to be a fire safety concern at this time. Some re grouting and filling of cracks with a fire rated grout is advised to ensure future fire safety.

There is a crack at the side wall of the firebox that needs minor maintenance.

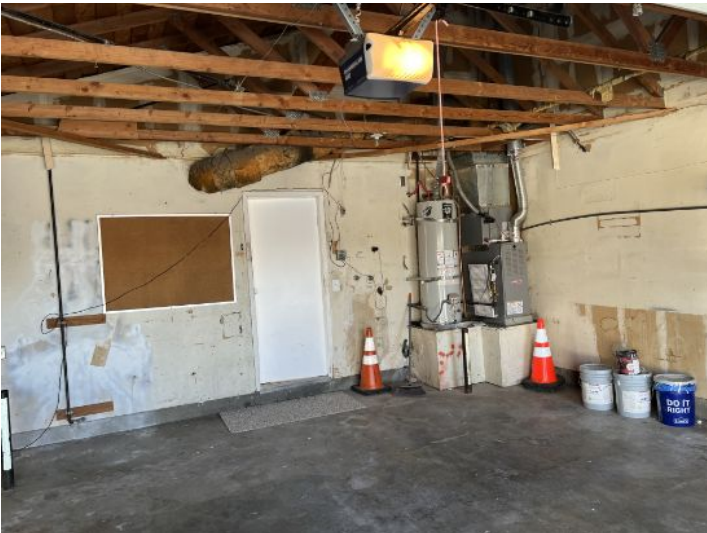
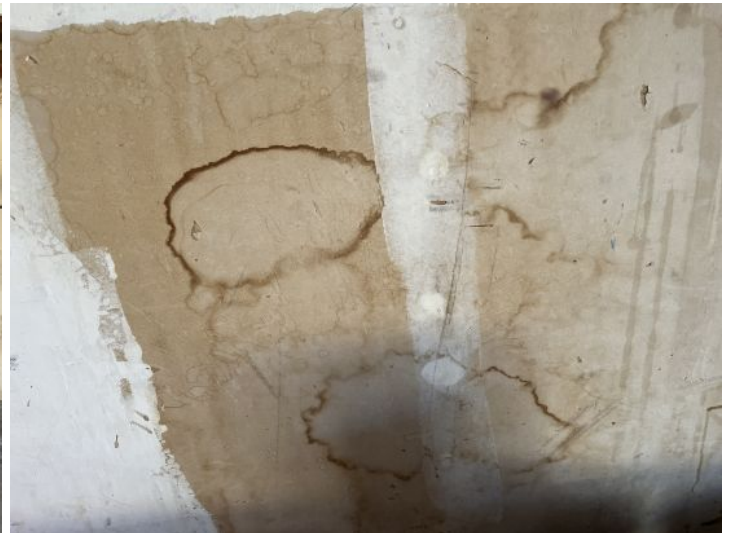
The garage interior has areas of moisture stains on the walls.

Stains

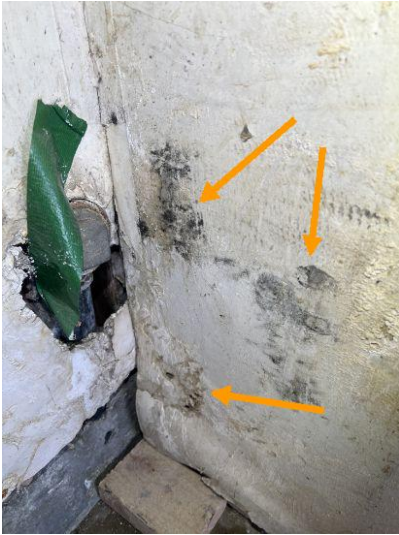
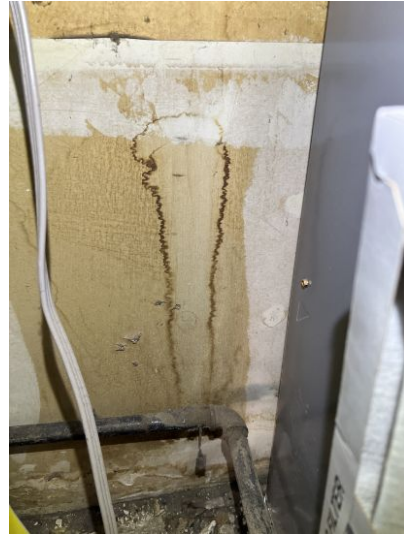
There are areas of possible mold and mildew observed on the water heater stand. This can be cleaned locally or replaced.

Stains

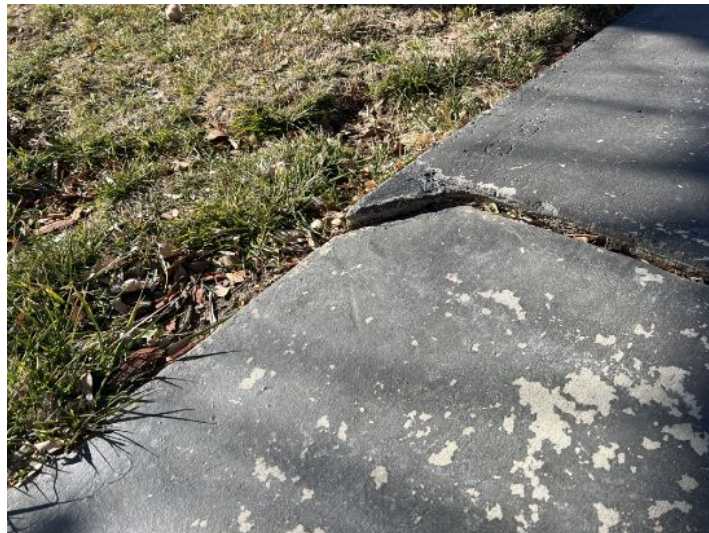
There are tree root systems causing shifting and cracking of the walkways in areas.

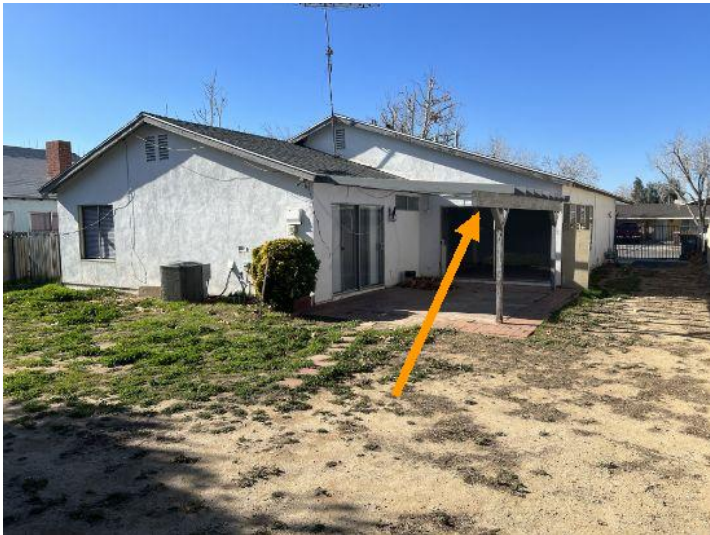
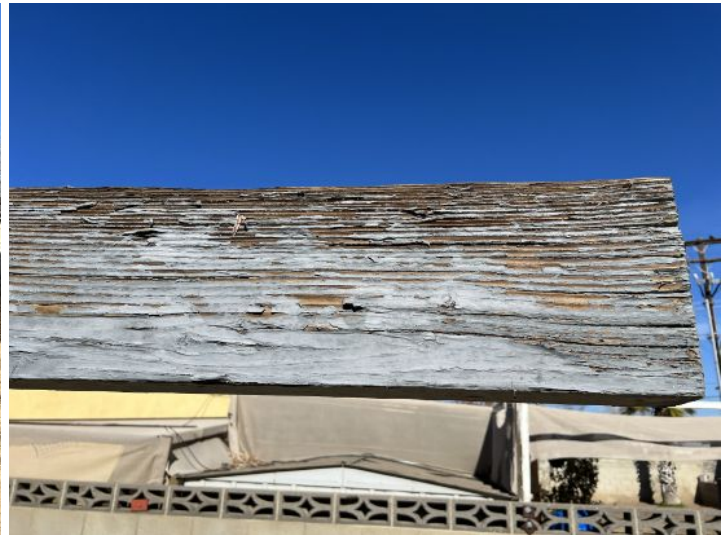
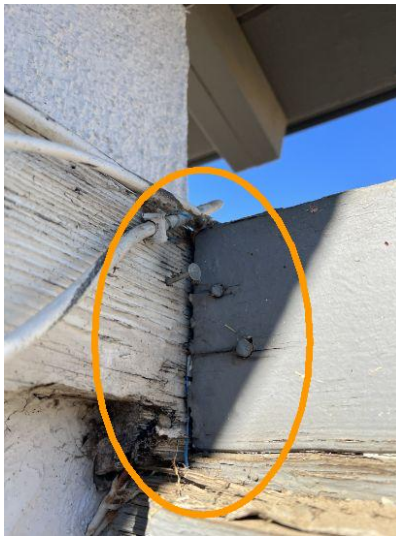
There are areas of deterioration on the trellis cover.

**The back framing has been attached to the roof with nails. This is not a reliable method to attach the pergola to the house. A different method of attaching to the pergola to the house should be explored.**

The back framing has been attached to the roof with nails. These penetrations may allow for water intrusion. A different method of attaching to the pergola to the house should be explored.

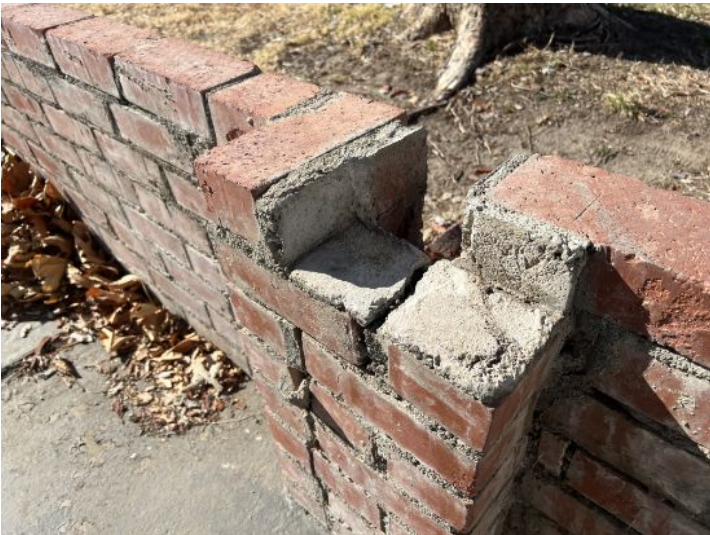
There are garden brick walls that are leaning, missing bricks and/or have step cracking in them.

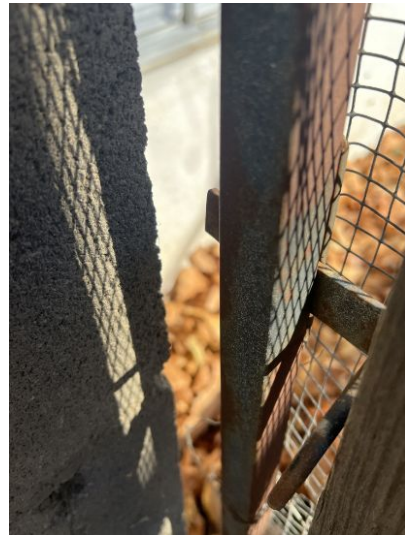
Right side gate - missing locking mechanism

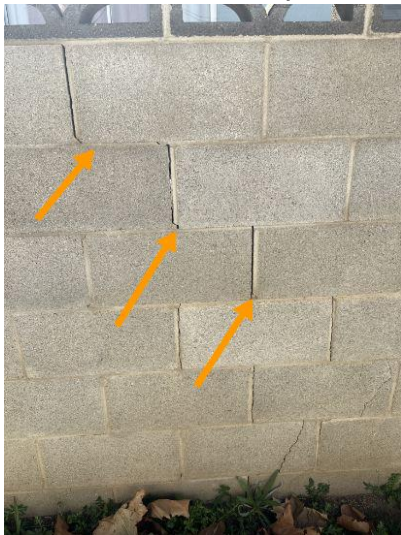
There are areas of step cracking noted on the block fencing. Step cracking will usually point to an area of movement in the wall. This is can be indicative of uneven, moisture-related settling.

Step cracking

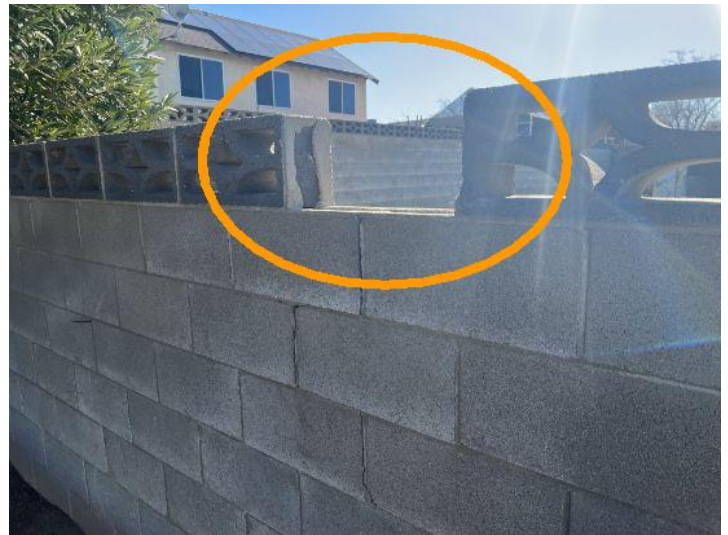
Damaged block wall

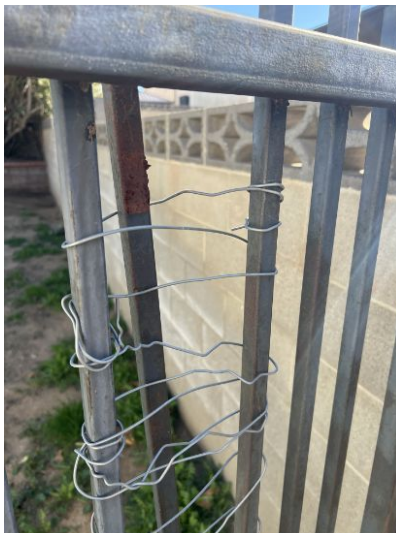
Damaged gate - right side

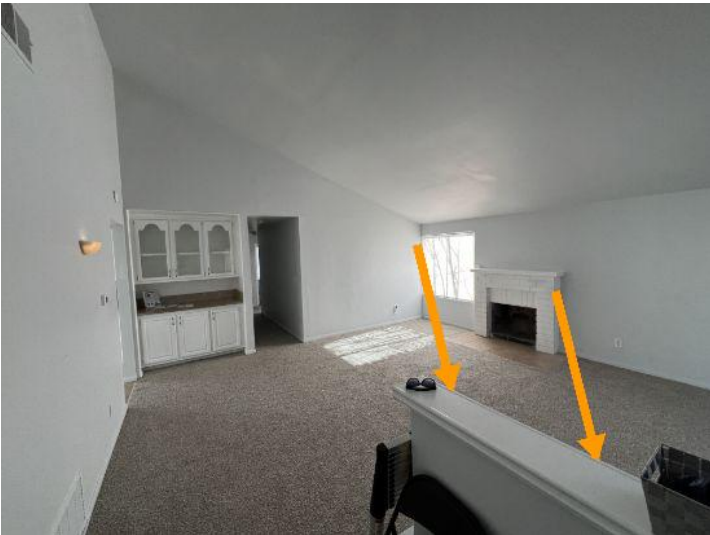
**The decorative pony-wall at the entry is not secured properly and is loose.**

The decorative pony-wall at the entry is not secured properly and is loose.

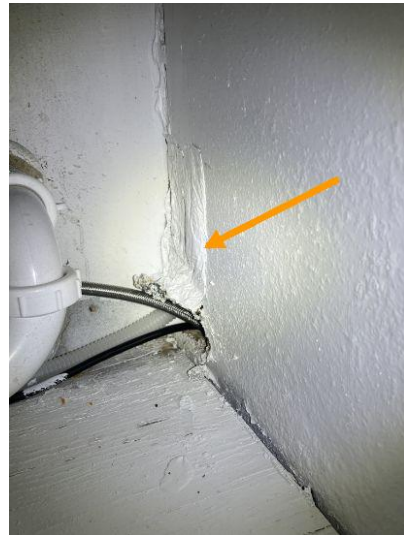
There are some areas where there have been temporary "fixes" for things. It appears that non-standard repair practices were used when these fixes were made. - Under kitchen sink.

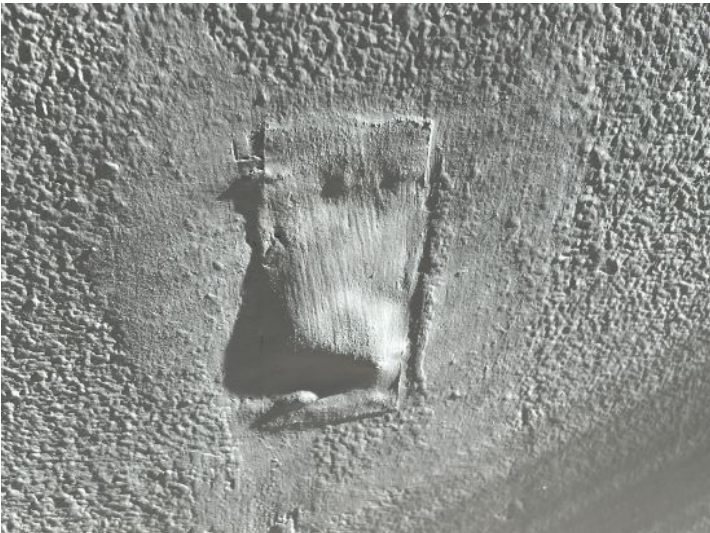
Patching

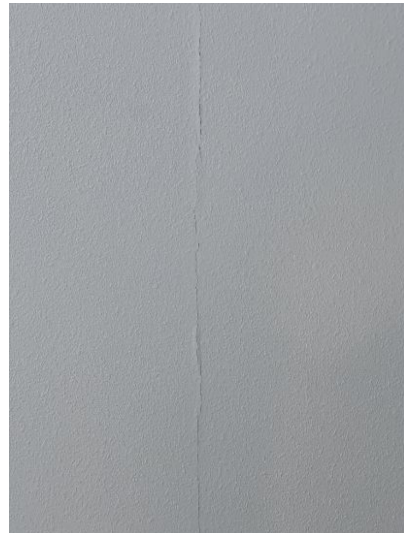
Stress crack - living room

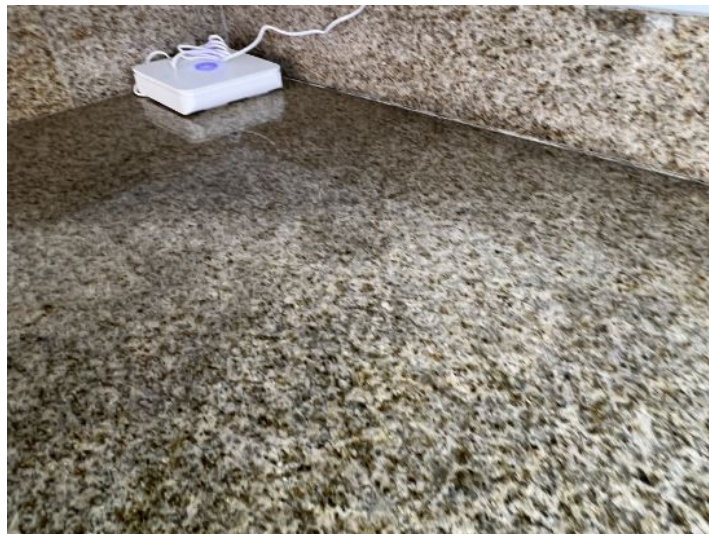
The counter has stains in areas.

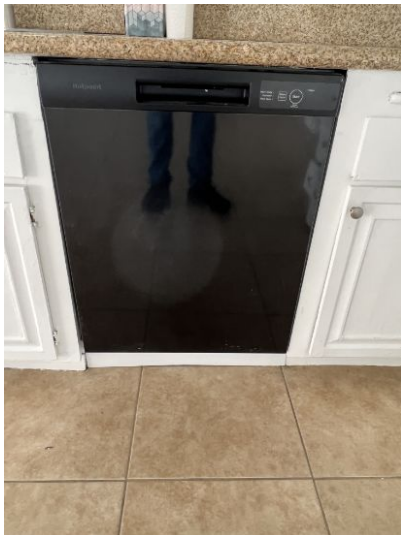
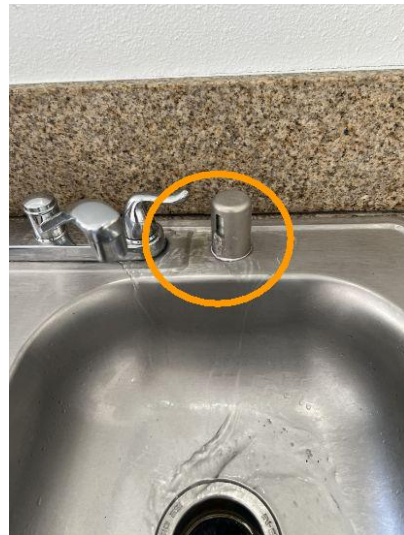
The water from the dishwasher is coming out of the **air gap** during the drain cycle. This is many times a blocked drain pipe from the dishwasher to the waste line and may need the rubber drain hose replaced. It is near the end of its expected useful life.

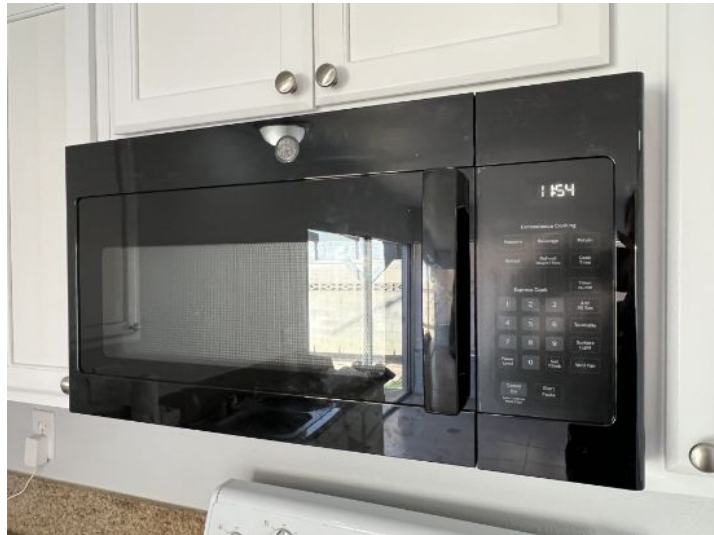
The microwave is loose and needs to be secured properly.

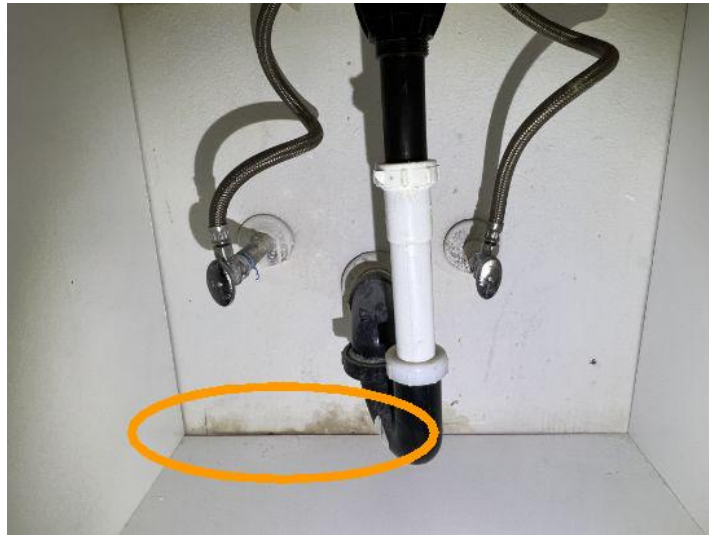
The cabinet area below the sink has damage/deterioration which appears to have been caused by moisture.

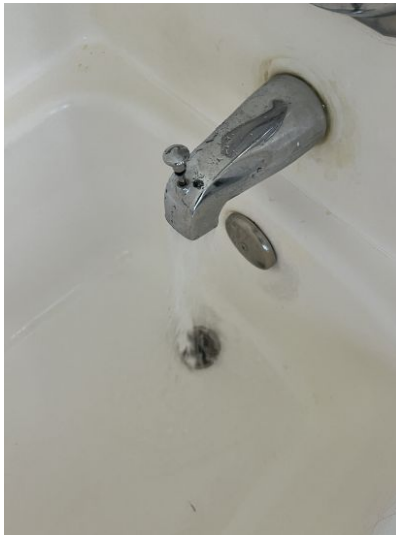
The shower diverter does not divert all the water from the tub to the shower when in operation and much of it is still going to the tub.
