First Shield Home Inspections

3300 Somewhere Lane, Los Angeles, CA,

Prepared For: Mr and Mrs Buyer

Date of Inspection: 1/1/2024

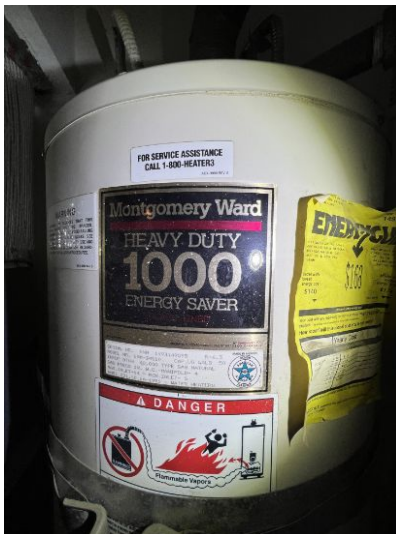
Data Label

Manufactured 1993 / 50 gallon

The water heater is very old. It may need to be replaced soon.

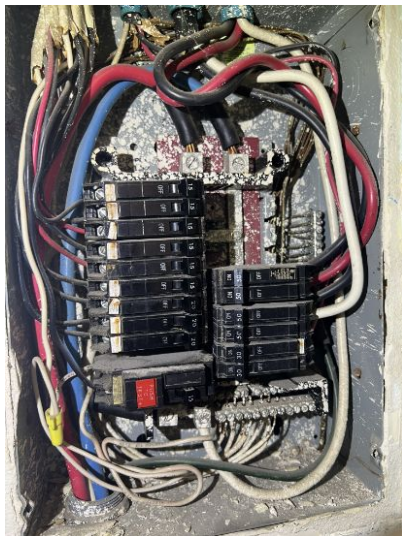
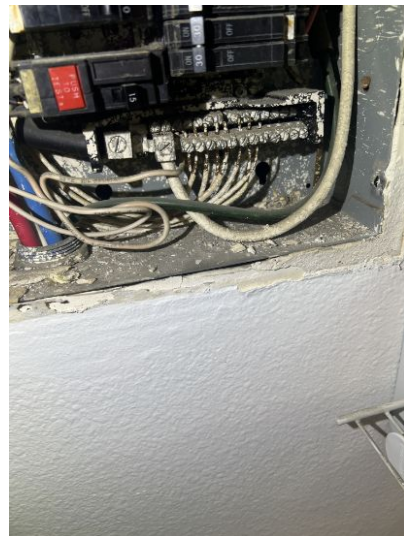
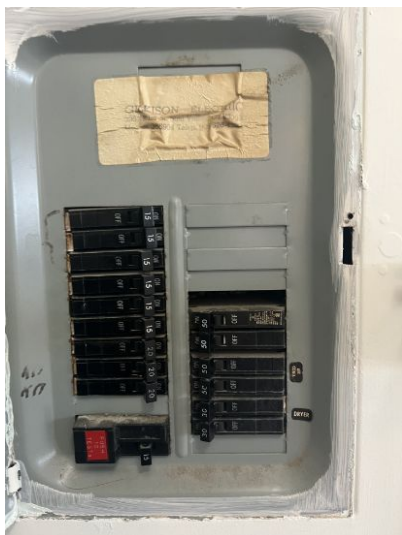
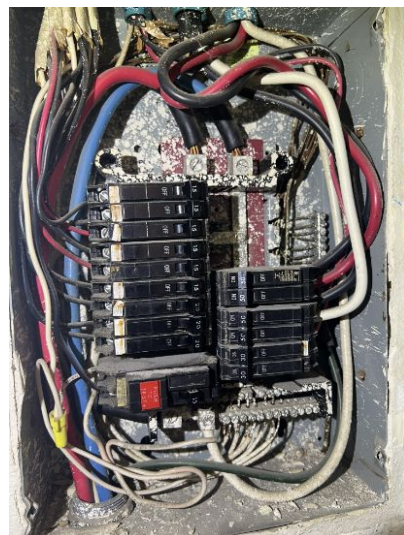
The circuit breakers in the sub panel are not labeled. It is not known which circuit goes with which breaker. This could pose a problem in case there is an emergency reason comes up to shut off power to a specific area of the home.

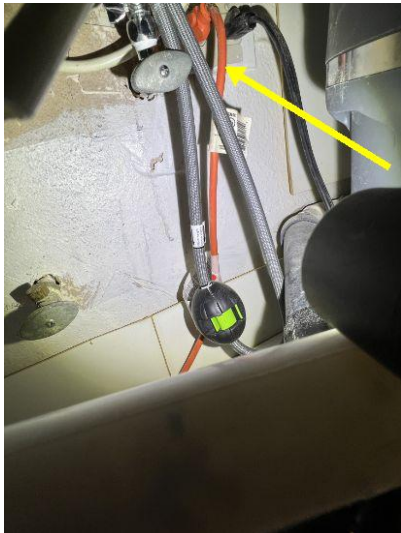
An extension cord is being used to provide power. It needs to have proper wiring installed as the extension cord is not rated to supply permanent power - kitchen (under sink).

Extension cord

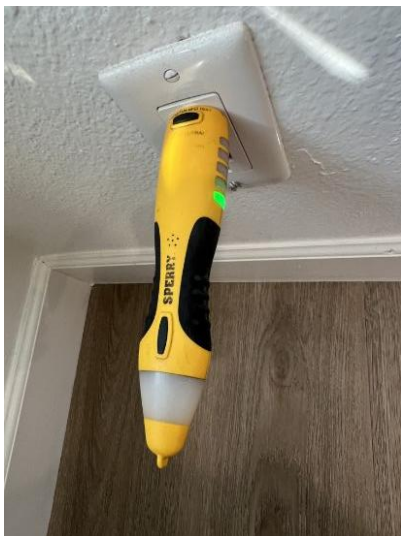
Living room

There is one or more outlets that have 3 prongs, but there was no ground in them. Repair to the existing wires or upgrade to new wiring may be needed.

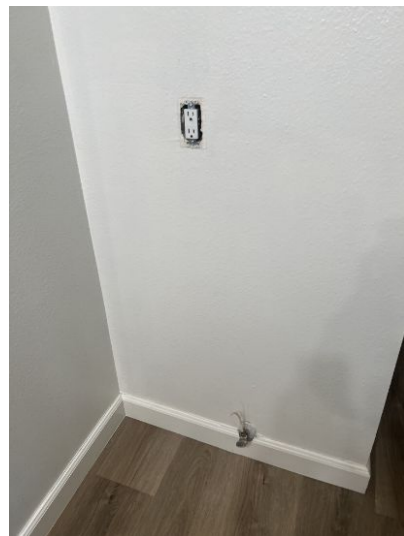
There is one or more missing cover plates in areas of the home.

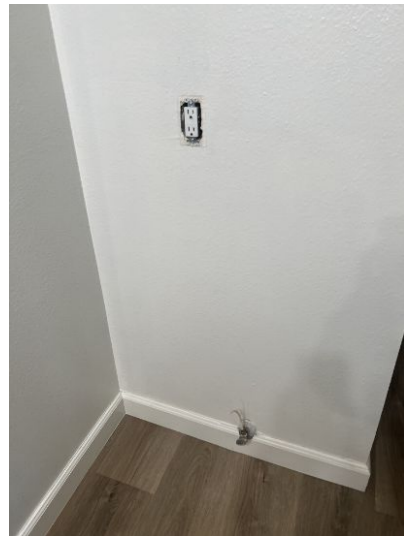
There is one or more missing cover plates in areas of the home.

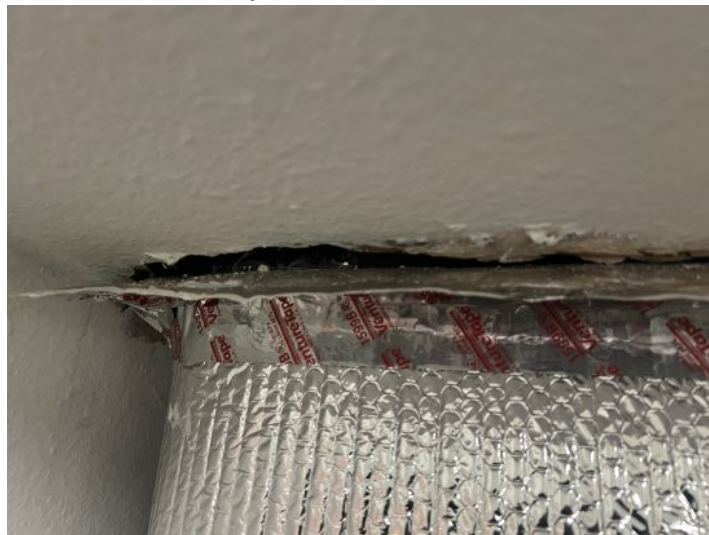
Air is leaking at the duct connections in areas. These should be checked and sealed for energy conservation.

Not sealed properly

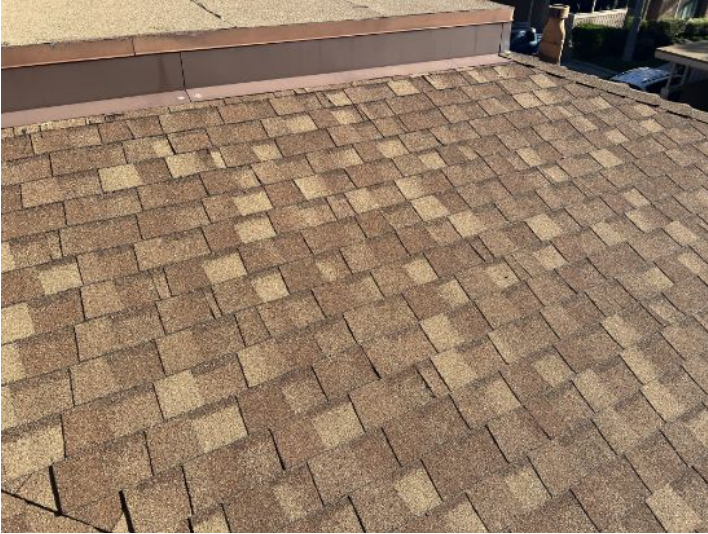
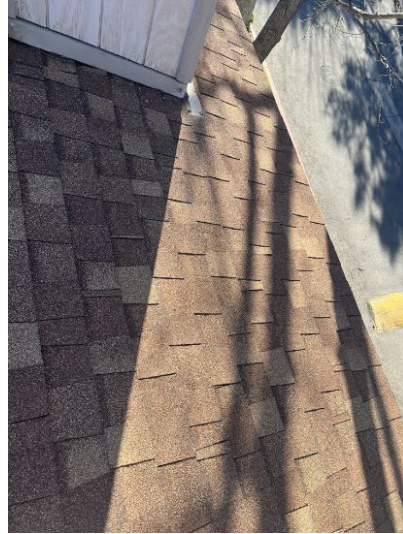
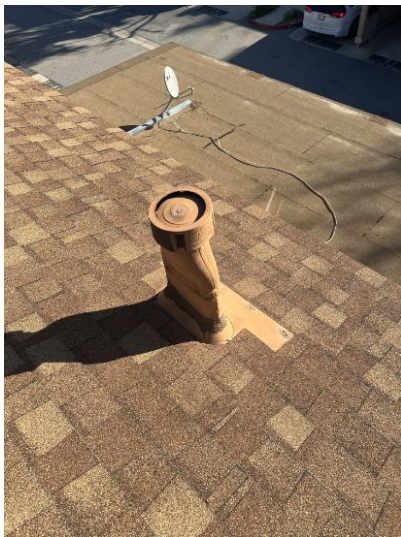
There are patches on the roof, these are a possible indication that there have been problems with the roof at some point in time. The seller could be consulted on the past of this area.

Small patch

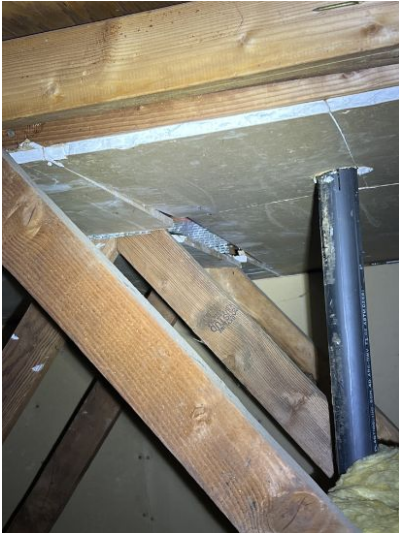
There are areas of moisture stains on the framing lumber. These are common in attics and may indicate past leaks.

Stains

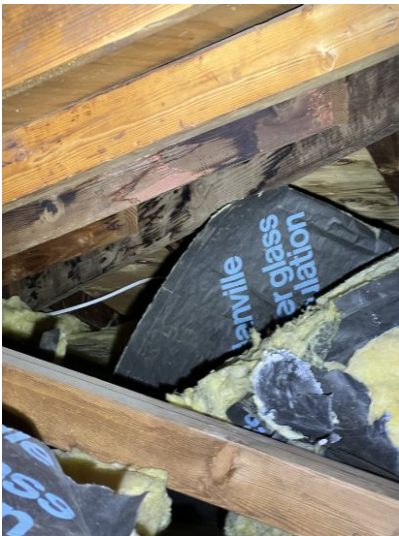
Stains

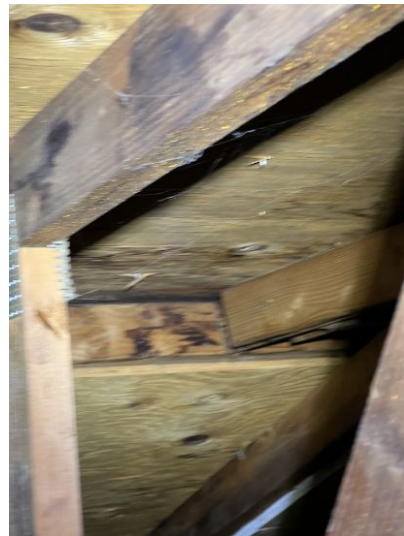
Stains

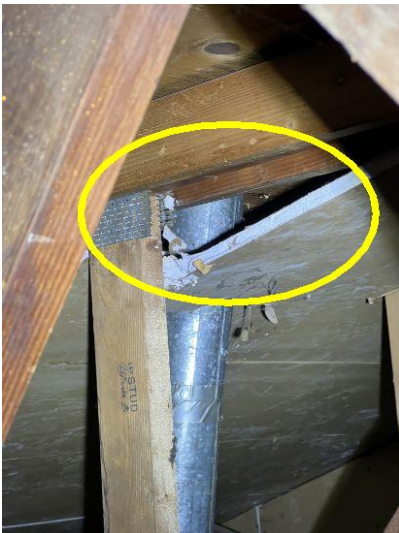
The firewall is damaged. The sheetrock has come loose and should be re-attached to the framing in order to reduce any risk of fire.

Firewall damage

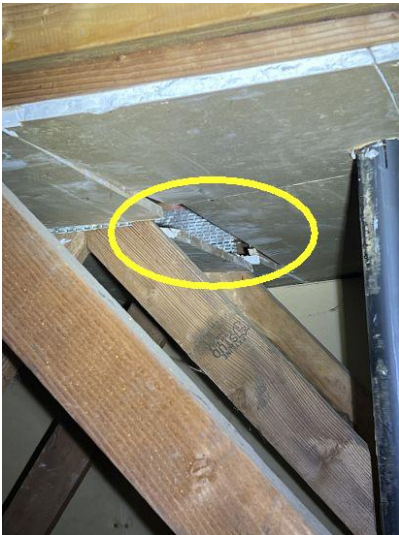
Firewall damage

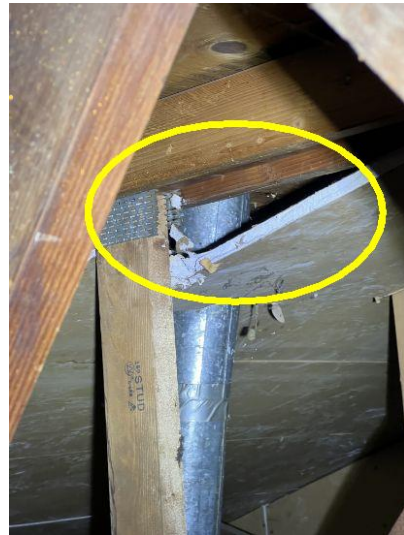
Firewall damage

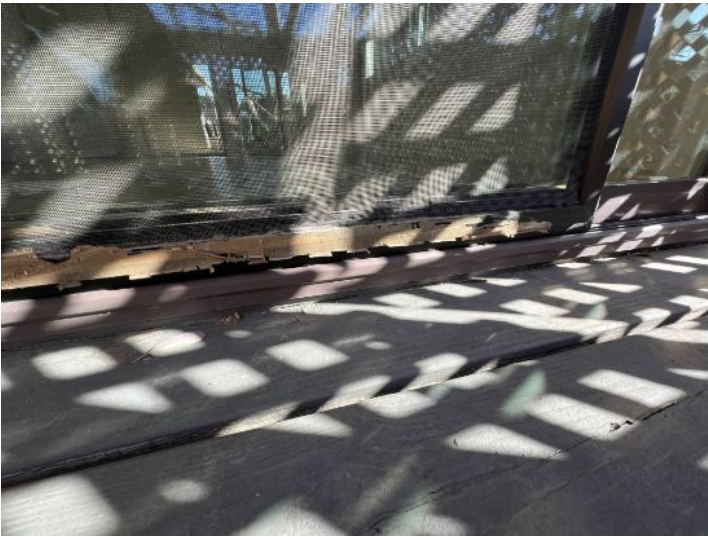
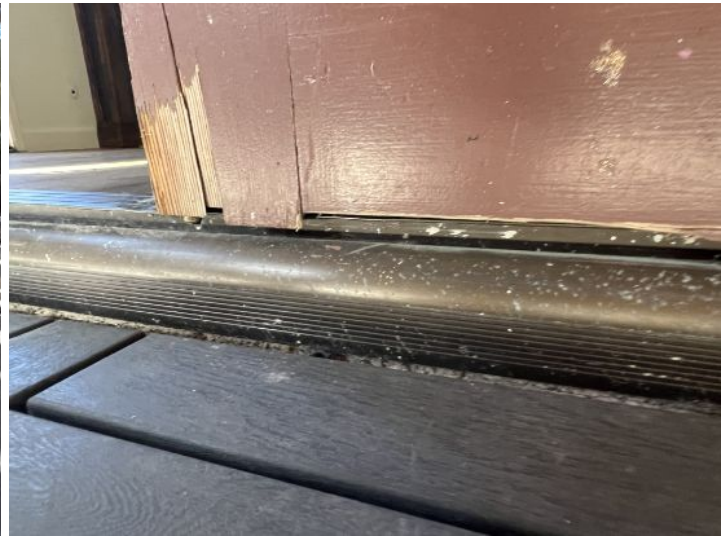
There are exterior doors that have some deterioration.

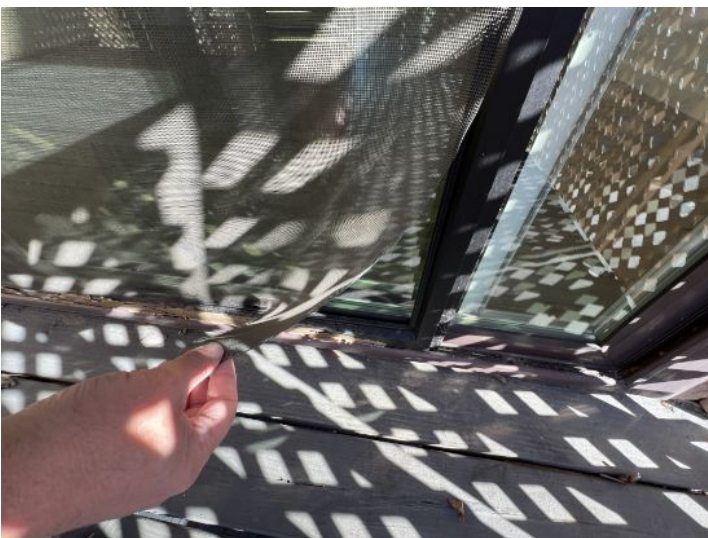
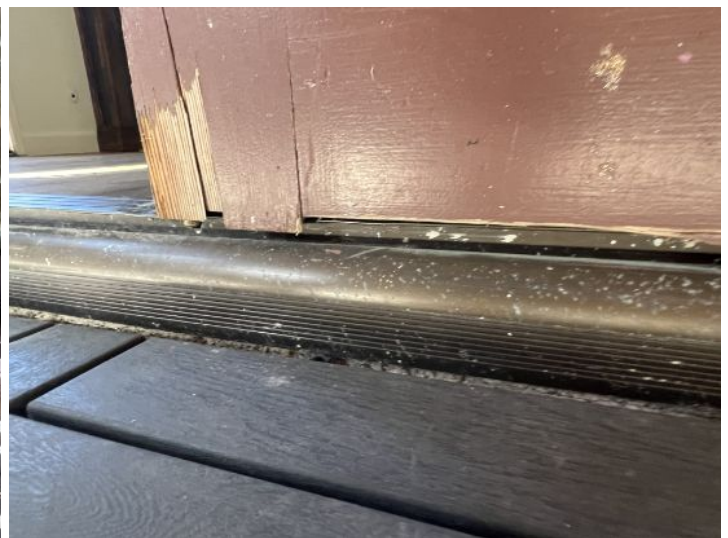
There are exterior doors that have some deterioration.

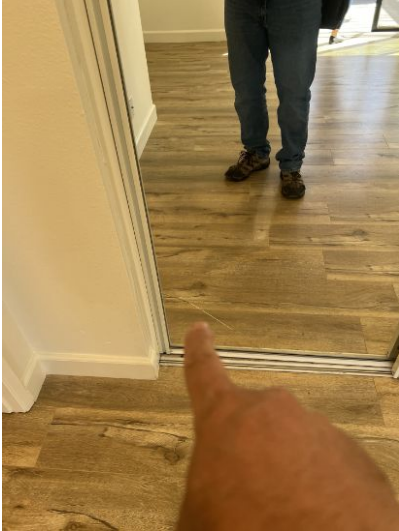
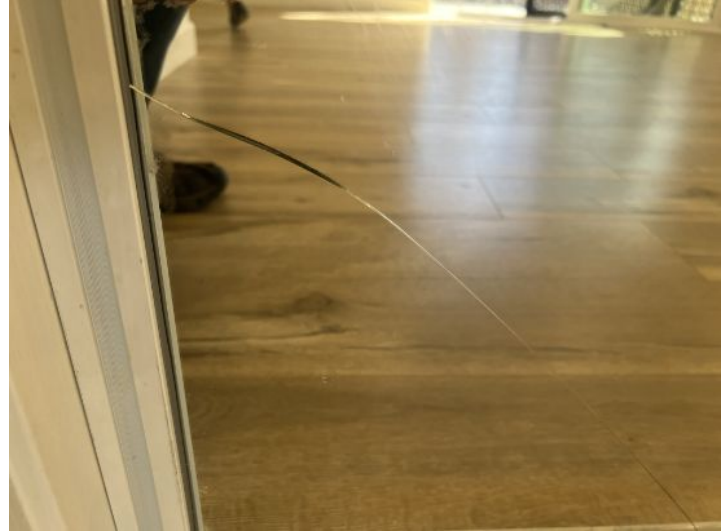
There are broken mirrors on the sliding closet doors - master bedroom.

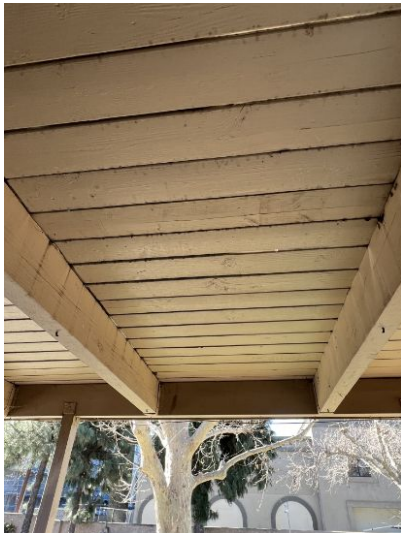
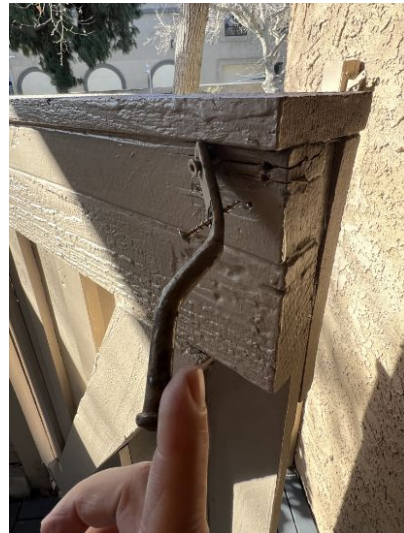
The gate handle and or hardware is not working properly. This will need repair or replacement to work properly.

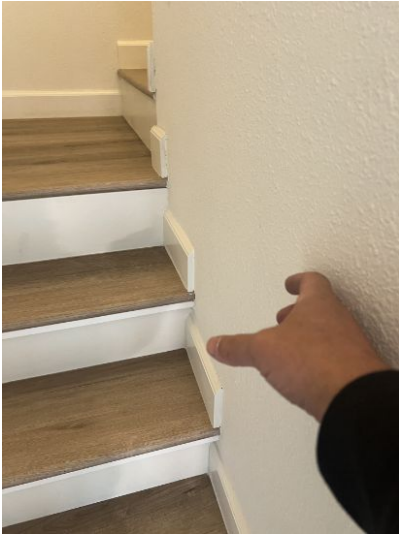
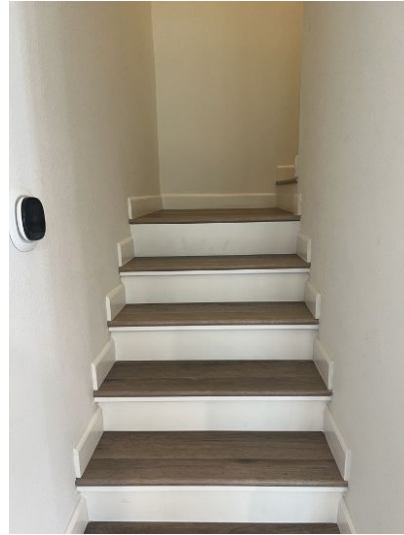
The handrail is missing.

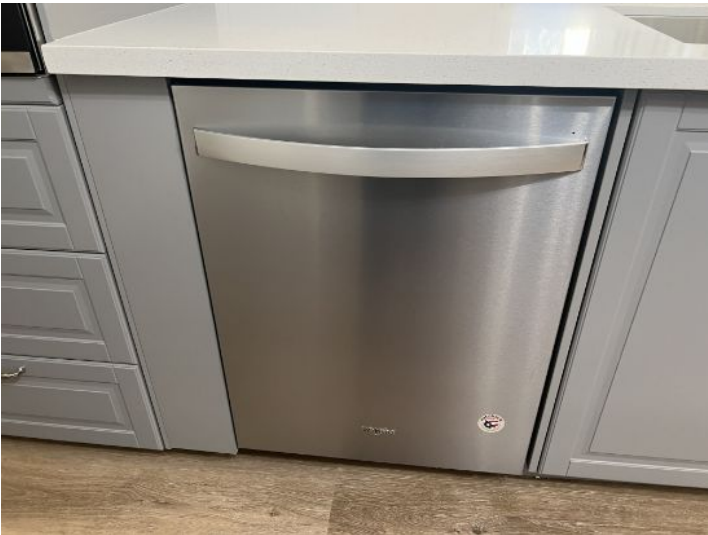
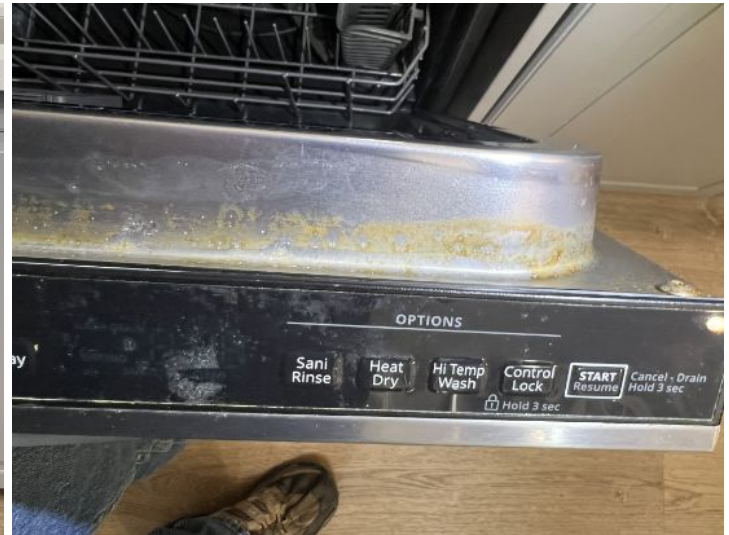
There is some corrosion at the top of the door.

The handle is loose.

Corrosion at the top

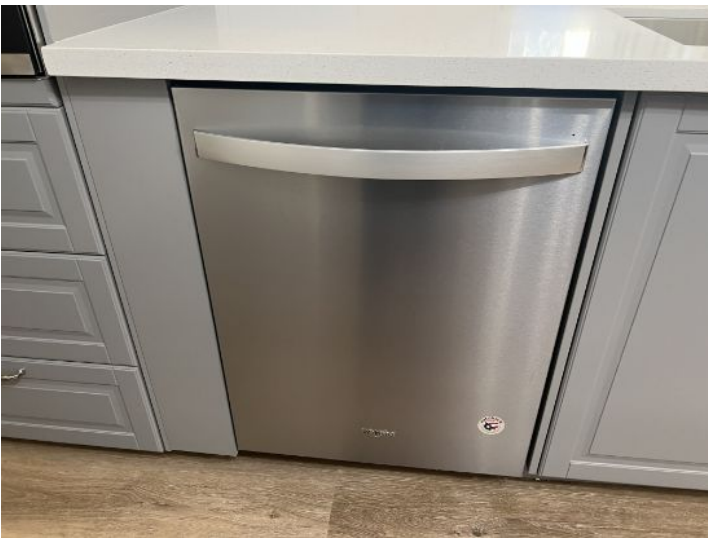
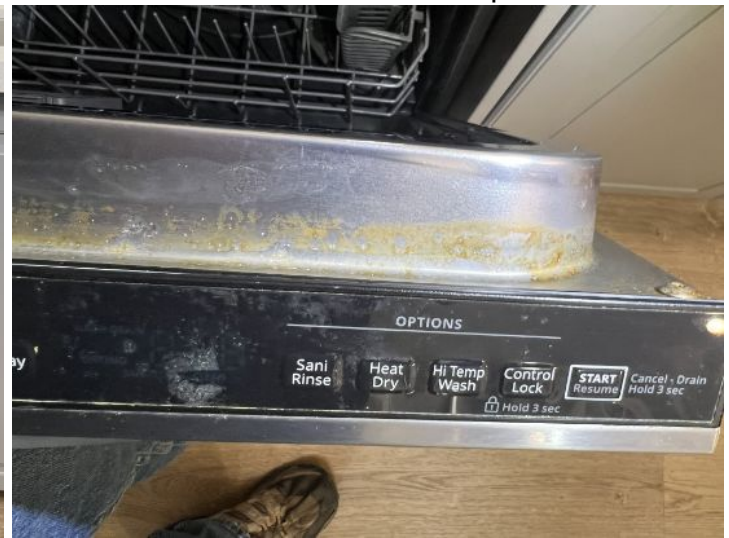
Corrosion at the top

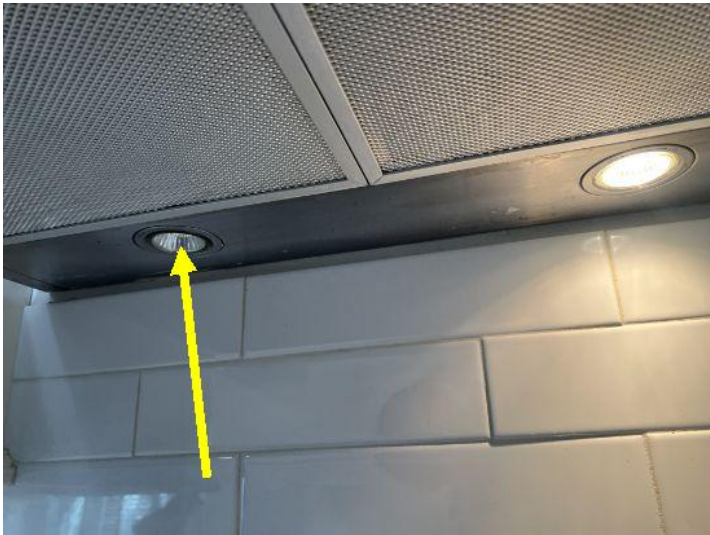
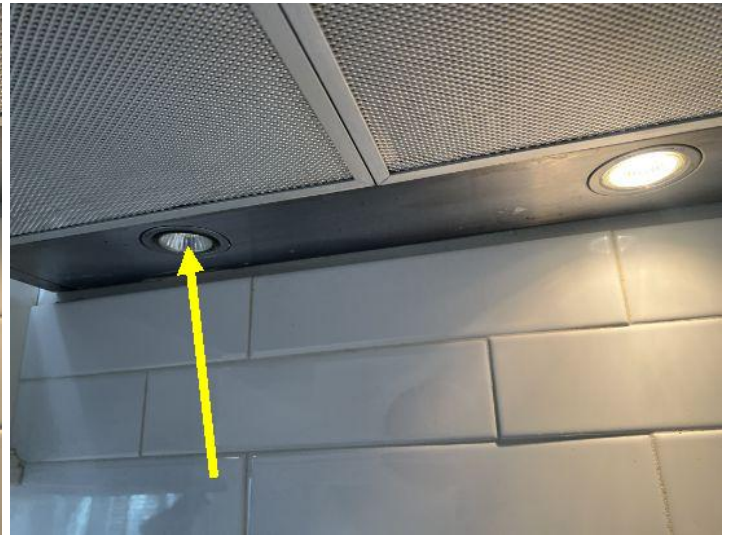
The light in the ventilation fan is not working.

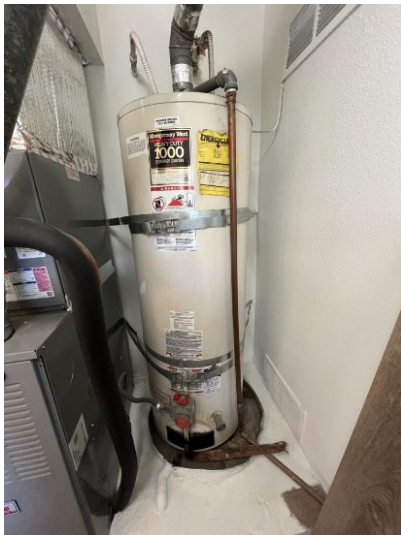
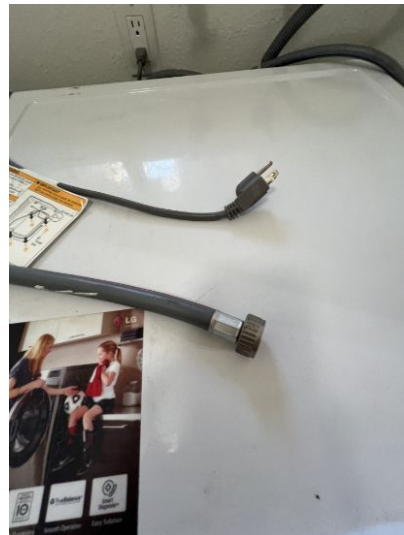
The washing machine water line was not hooked up, nor was it plugged in. Please make sure that this works before closing.

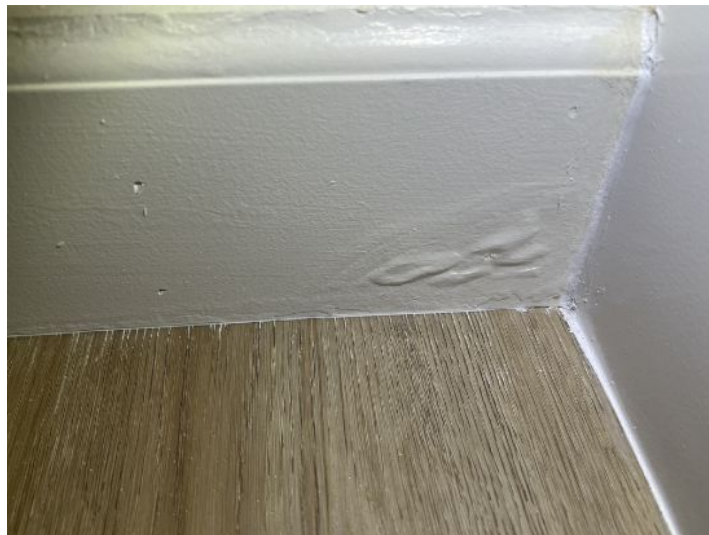
There are areas of moisture deterioration at the wall surfaces.

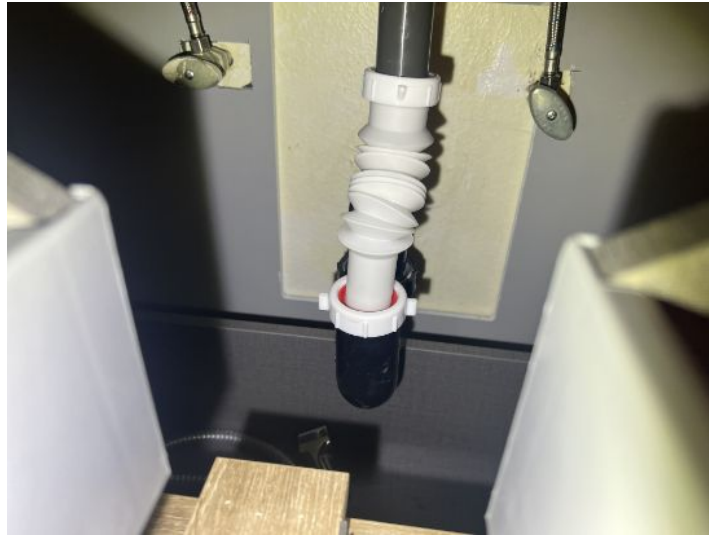
Improper flexible piping materials are being used as part of the drain line below the sink. This corrugated material is non-standard and it should be a smooth wall type of piping.

Flex duct

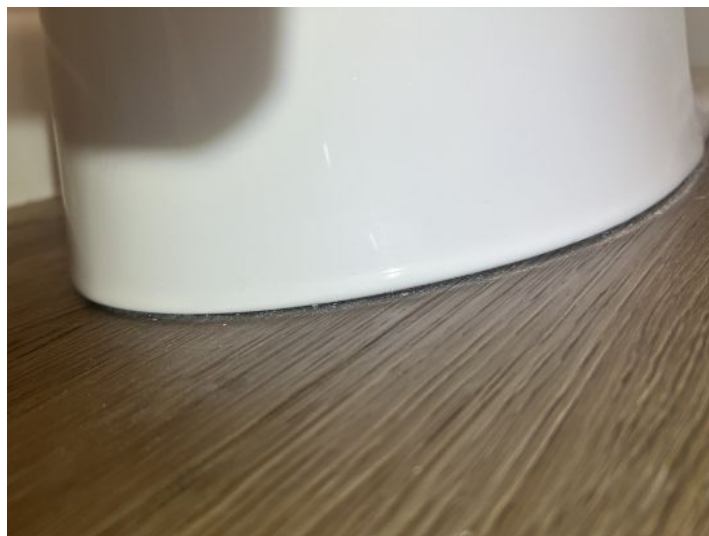
The toilet is loose and not properly attached to the floor. It needs to be properly bolted down.

There is no visible caulk seal between the base of the toilet and the floor.

No seal

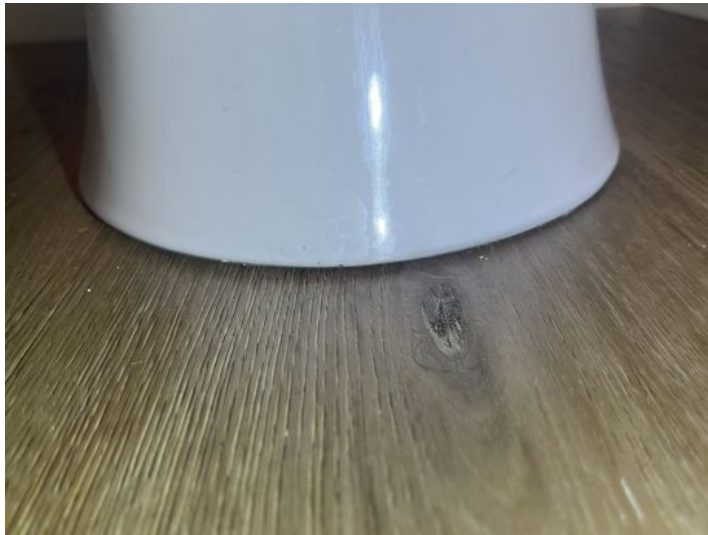
The toilet is loose and not properly attached to the floor. It needs to be properly bolted down.

There is no visible caulk seal between the base of the toilet and the floor.
