First Shield Home Inspections

123 Near Here, Los Angeles, CA,

Prepared For: George Washington

Date of Inspection: 1/1/2024

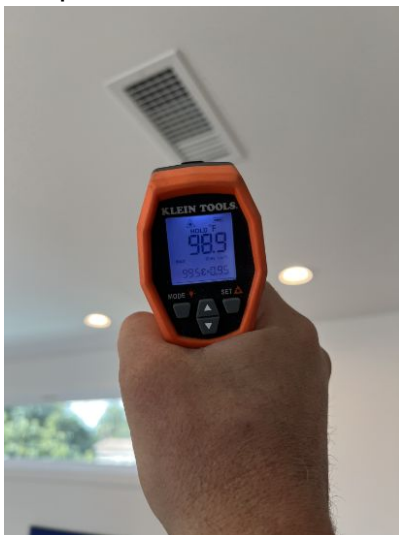
Upstairs - 98 deg F

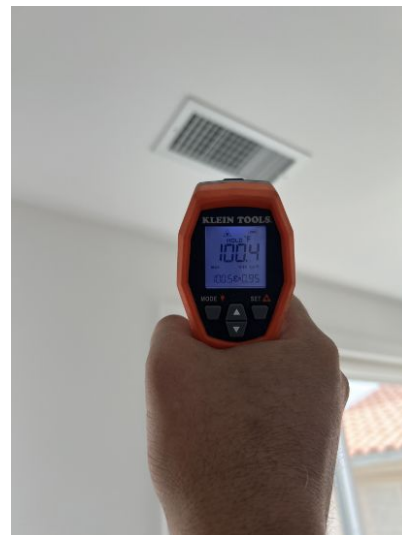
Upstairs - 100 deg F

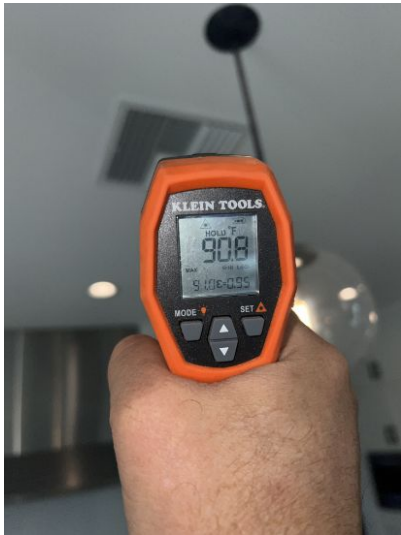
Downstairs - 90 deg F

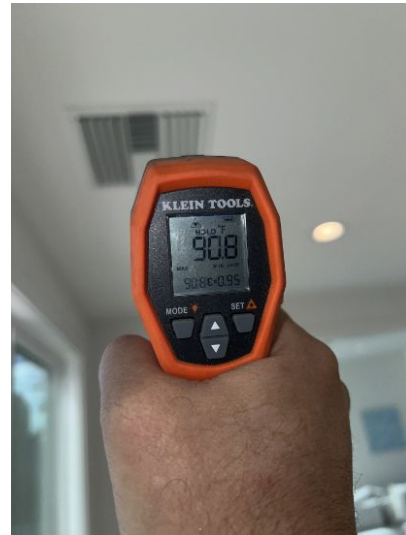
Downstairs - 90 deg F

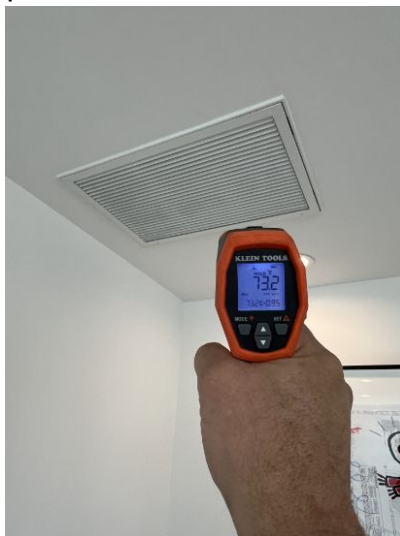
Upstairs - 73 deg F - return air

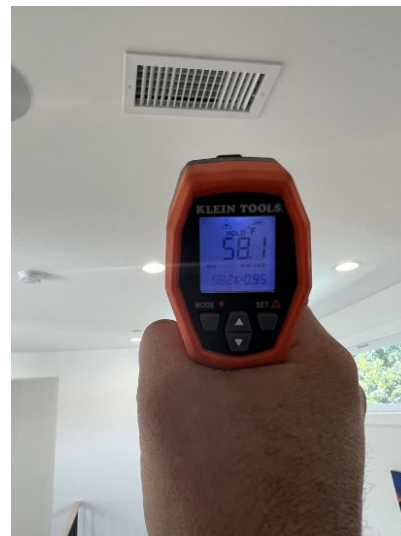
Upstairs - 58 deg F

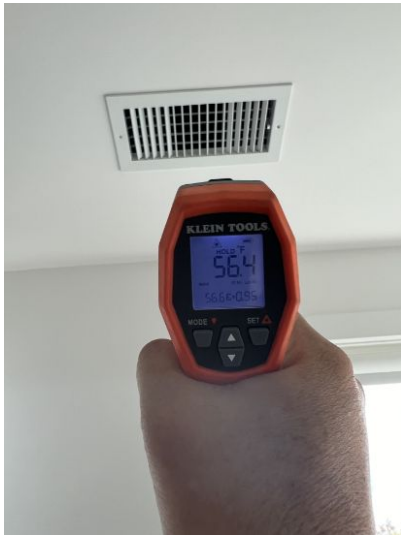
Upstairs - 56 deg F

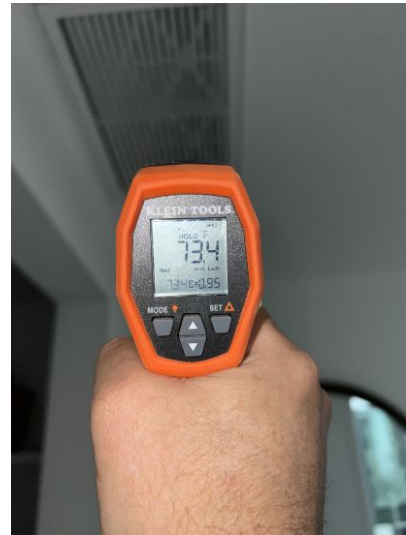
Downstairs - 73 deg F return air

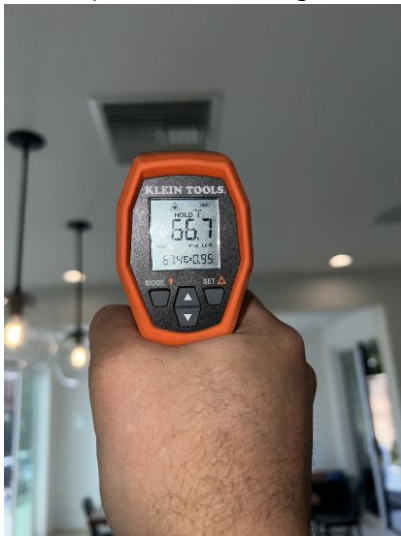
Downstairs - 66 deg F

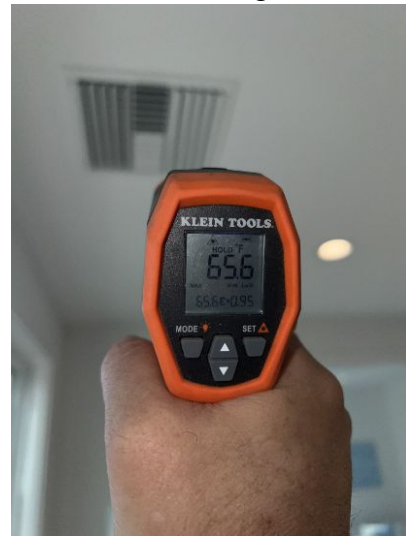
Downstairs - 65 deg F

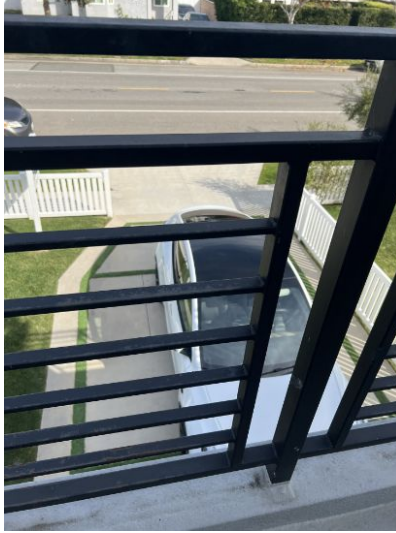
Guardrail

The guardrails are made out of metal.

The guardrail design can act as a ladder to small children. Adding some type of barrier would improve child safety.

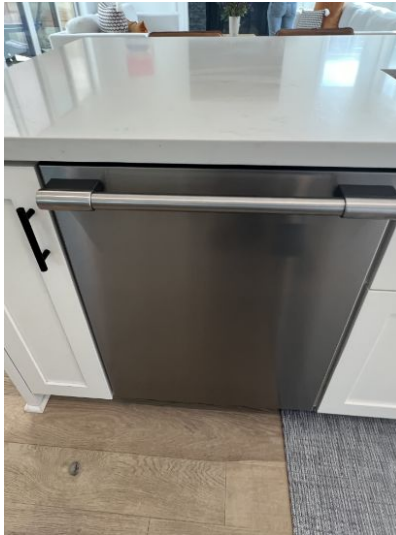
Dishwasher

A proper **air gap** is not installed in the dishwasher drain line. This is a newer dishwasher and it may not be required. Please refer to the installation manual.
