First Shield Home Inspections

789 Place, Los Angeles, CA,

Prepared For: Mr and Mrs Purchaser

Date of Inspection: 1/1/2024

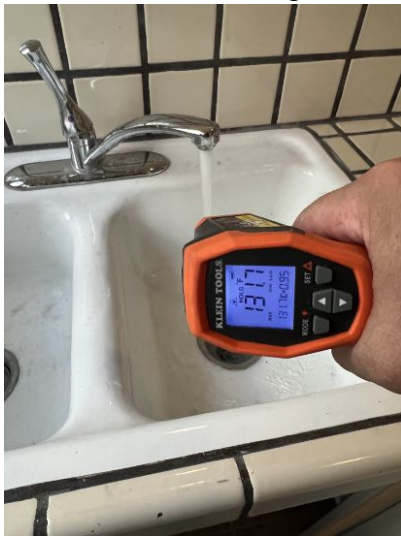
The hot water in all of the units is too hot. Water temperature should be no higher than 120 deg F.

Unit 2 - Kitchen 131 deg F

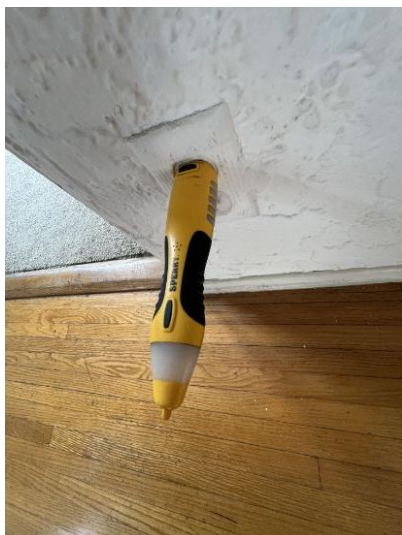
Unit 4: There are outlets that are dead and not working - Unit 4

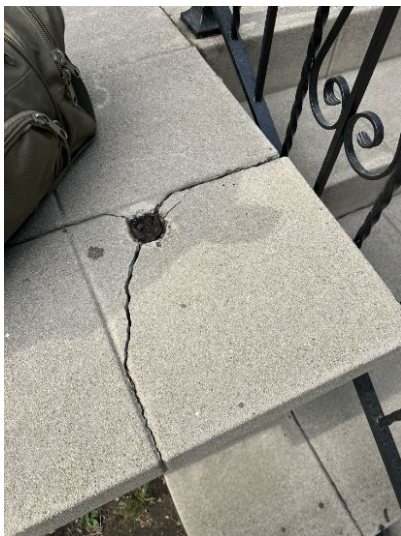
Cracked cement tile near the front stairs.

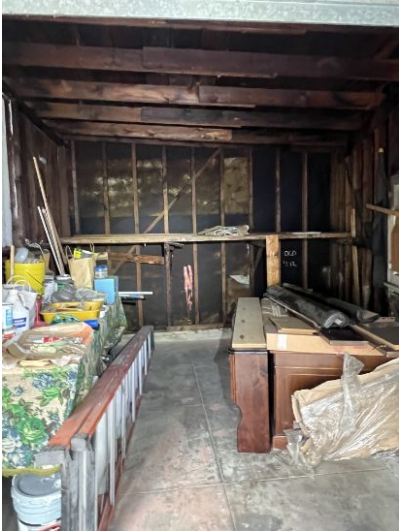
Some garages have windows that are missing the glass. They are boarded up.

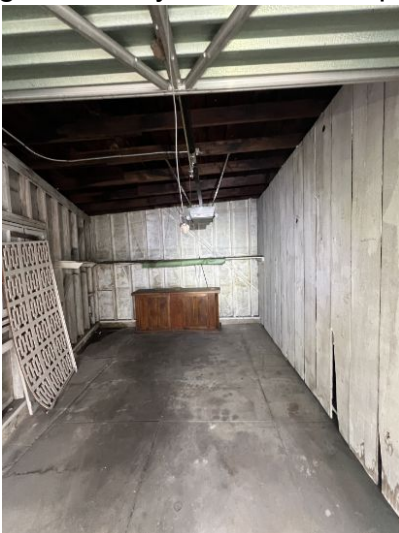
Unit 3 - Staining along wall

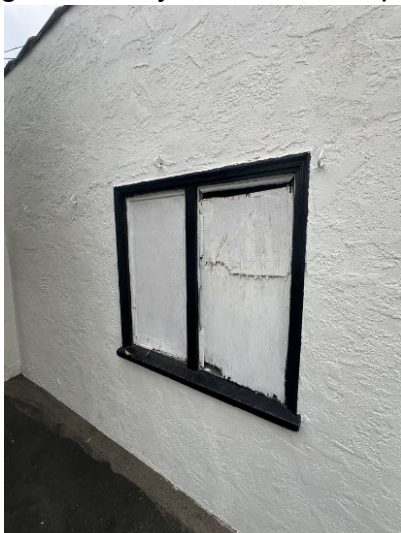
Some garages have windows that are missing the glass. They are boarded up.

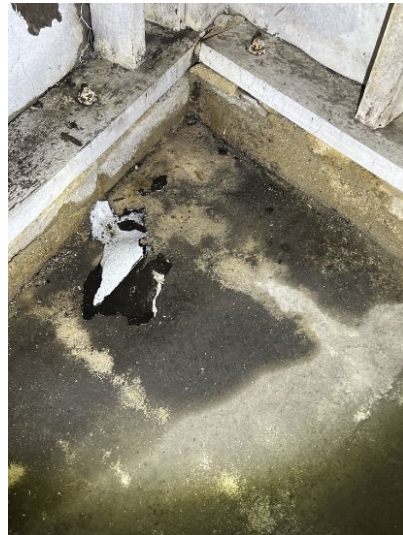
Moisture on the floor.

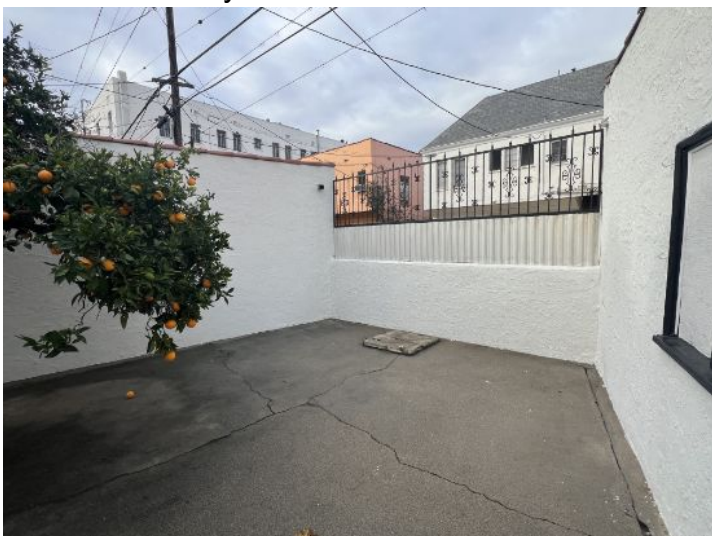
There is debris visible in the below grade drains. These need to be cleaned and tested, so they function as they should.

This area drain is full and overflowing.

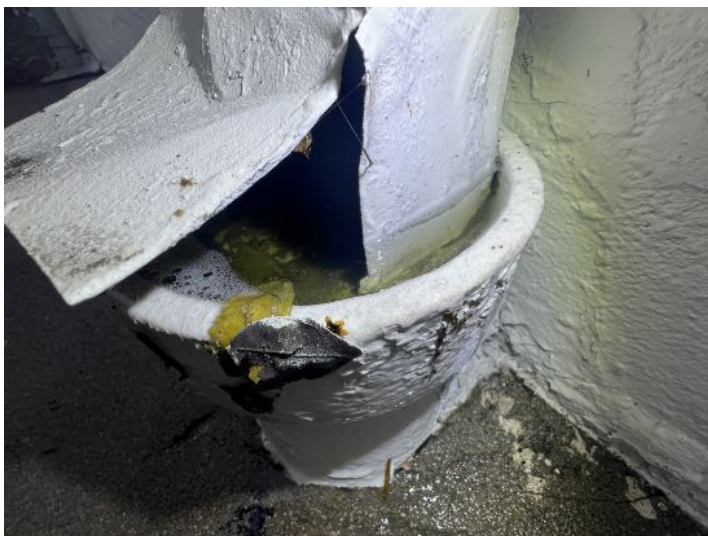
This area drain is full and overflowing.

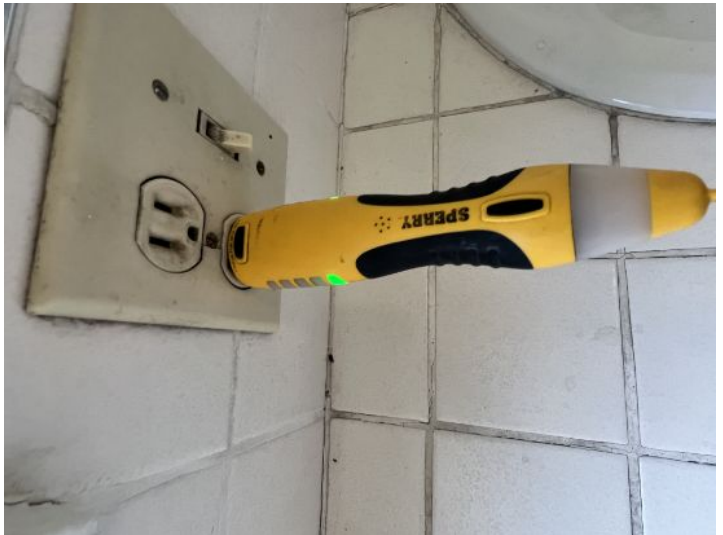
Bathroom - NO GFCI

The outlets are the 2 prong type. These are the older ungrounded type. In many cases they could be upgraded to the 3 prong type with a ground in them but it is not a requirement

There are no GFCI outlets in areas that require them, such as the kitchen, bathrooms or any area exposed to a water source.
