# First Shield Home Inspections

**12345 Anyplace, Lancaster, CA,**

**Date of Inspection: 1/10/2024**

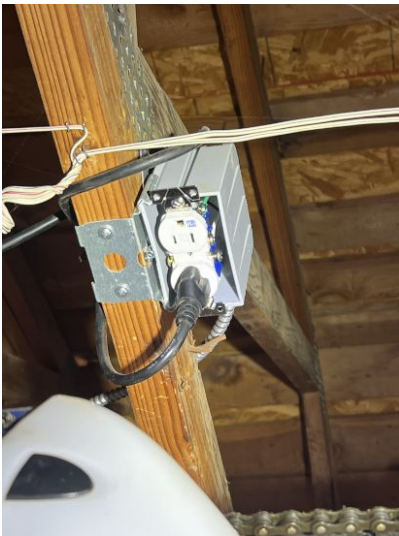
No coverplate - in garage.

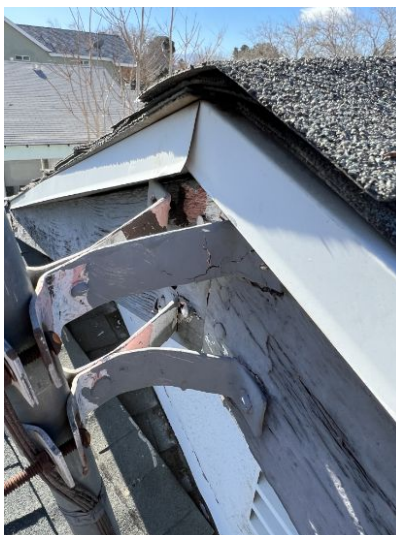
Roof antenna is pulling away from bolting / fascia.

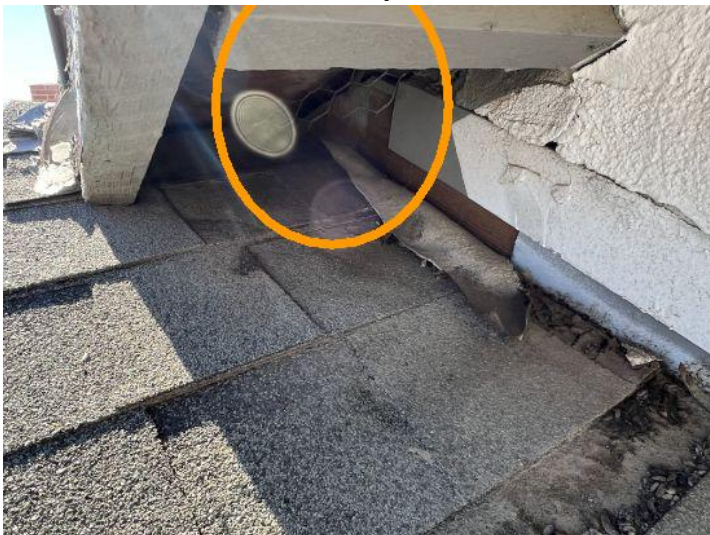
There are small areas (where the roof joins a side wall) that are open to the outside, but have no screens on them. This may allow animals or insects to enter.

Area is open to the attic.

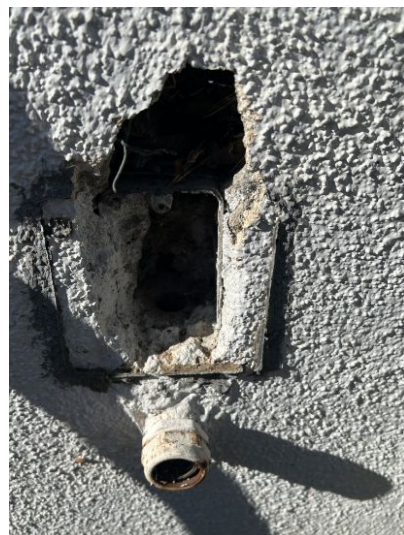
Hole in exterior
