First Shield Home Inspections

3300 Somewhere Lane, Los Angeles, CA,

Prepared For: Mr and Mrs Buyer

Date of Inspection: 1/1/2024

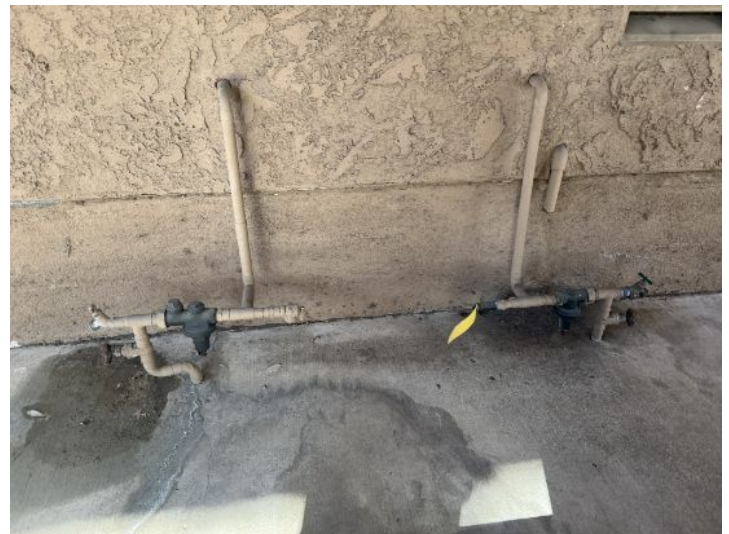
Because they are not marked, it is unclear which one belongs to Unit A

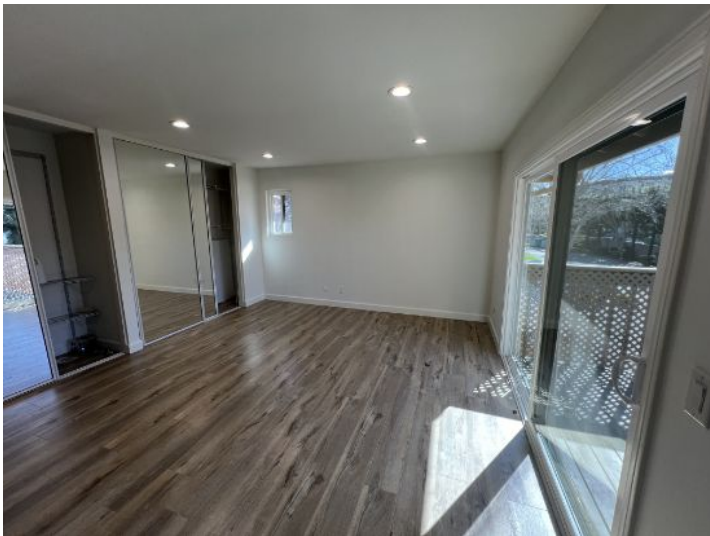
There is one or more outlets that have 3 prongs, but there was no ground in them. Repair to the existing wires or upgrade to new wiring may be needed.

Bedroom 2 - NOT GROUNDED PROPERLY

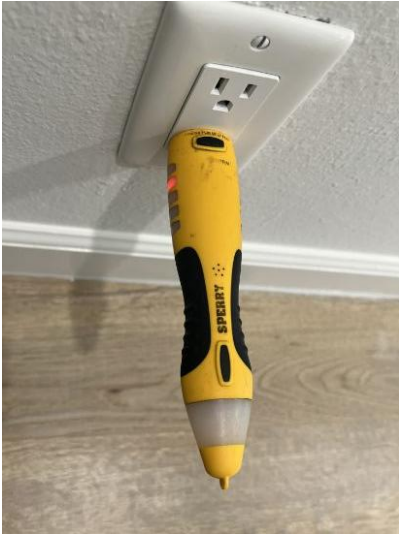
Bedroom 2 - NOT GROUNDED PROPERLY

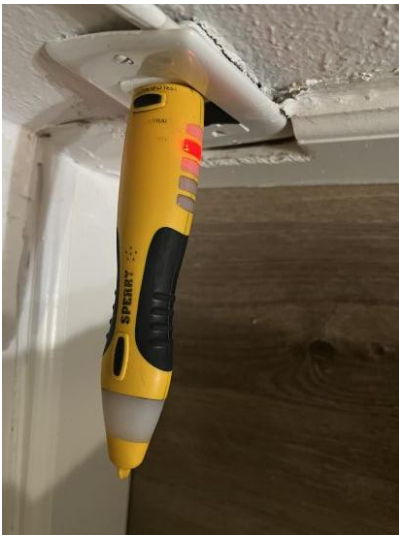
Under stairs - NOT GROUNDED PROPERLY

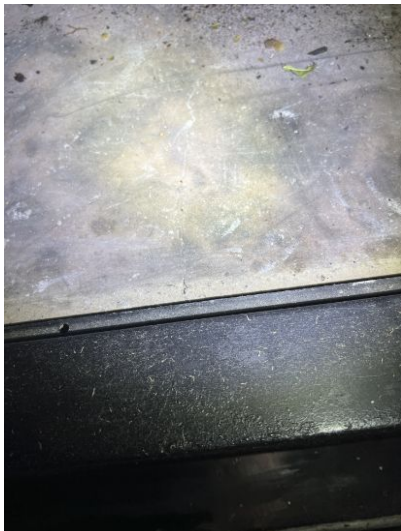
There is a gas line in the firebox that is capped off so the gas could not be tested.

Gas line is capped
