First Shield Home Inspections

567 Here Ave, Los Angeles, CA,

Prepared For: J Smith

Date of Inspection: 1/1/2024

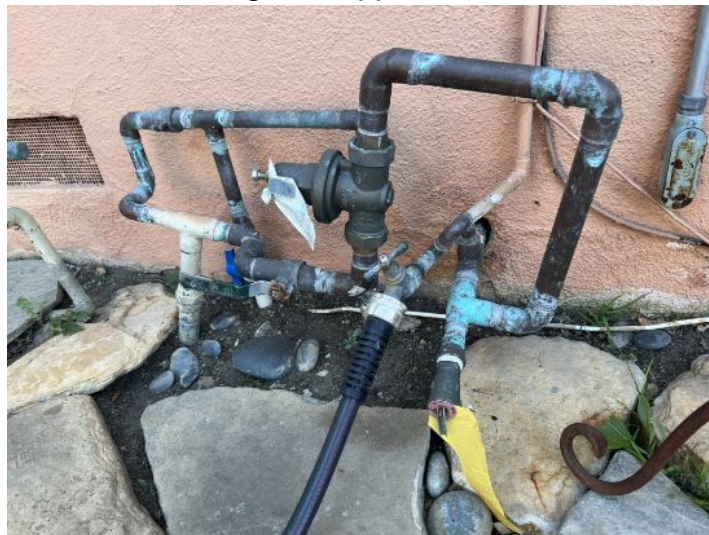
The main water shutoff is at the left side of the building, in the patio area of Unit 3302.

Copper piping is viewed coming out of the ground by the building and as the main line runs underground from the street to the building, this appears to be the main water line.

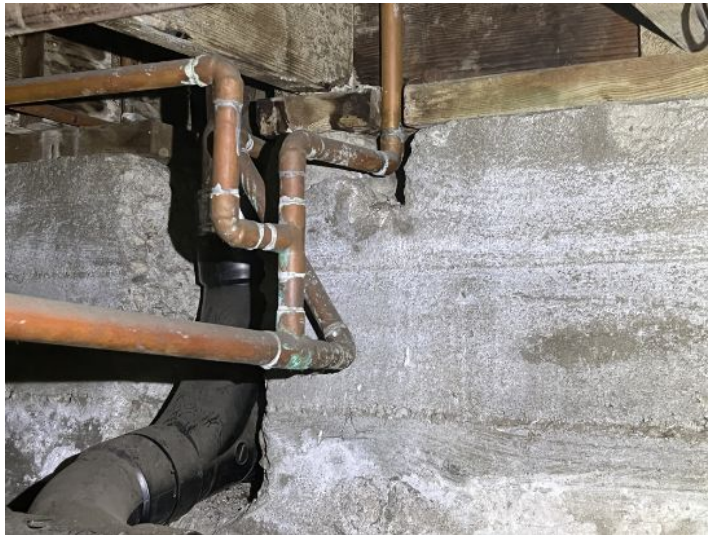
Interior Water Line Material

The interior piping that supplies the water throughout the building is made of copper where visible.

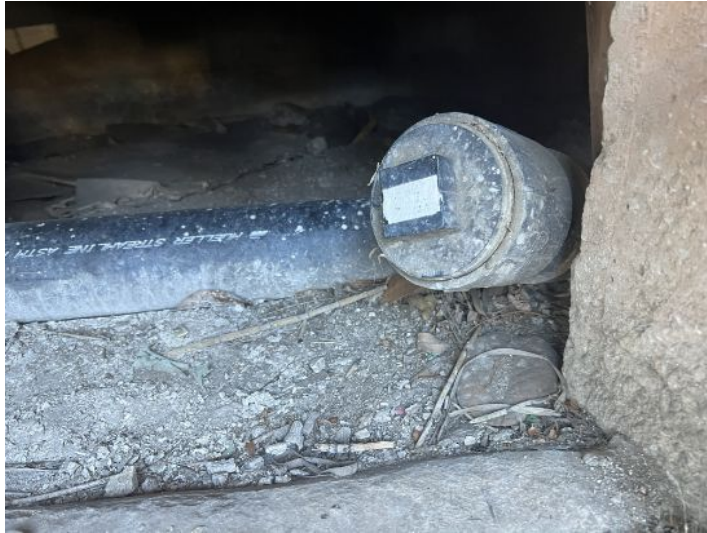
SEWER LINE ACCESS LOCATION

The sewer line access was located just inside of the crawlspace, near unit 3306.

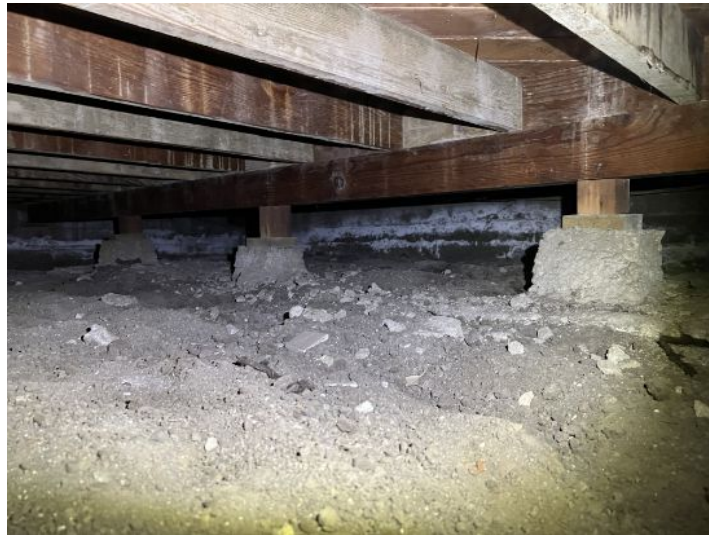
Expansive soils have been known to be present in this area. This soil expands when wet and contracts as it dries out. Movement of the structure should be expected during excessively wet or dry periods of weather. A Geologist would have more information about this subject if required.

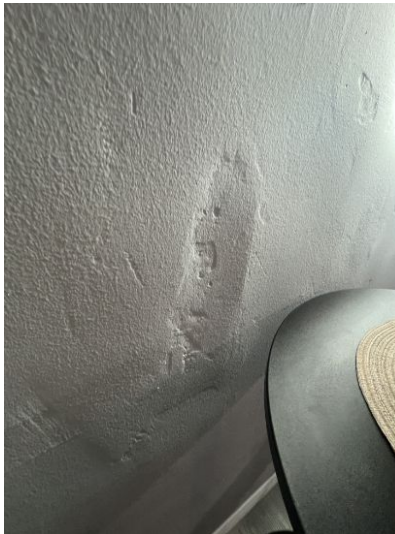
There are areas of past patching and painting. The seller could be consulted.

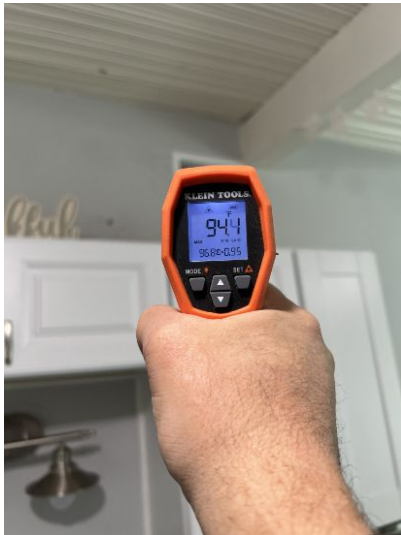
94 deg F

There is ducting that is crushed

Air is leaking at the duct connections. These should be checked and sealed for energy conservation.

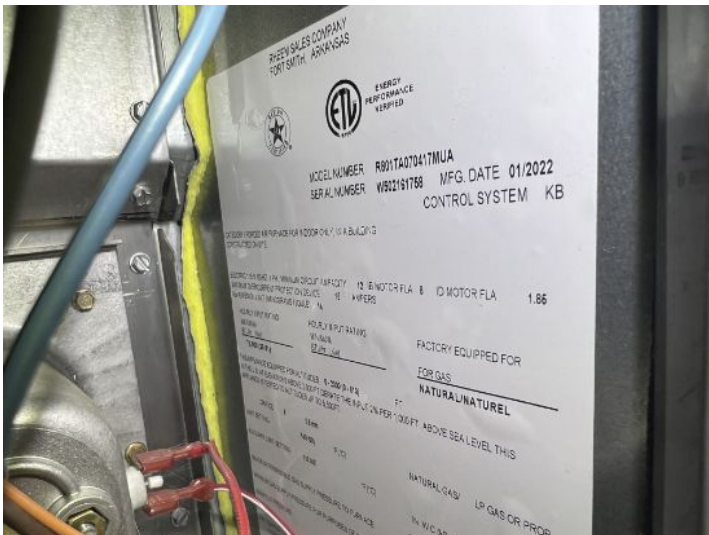
Manufactured 2022

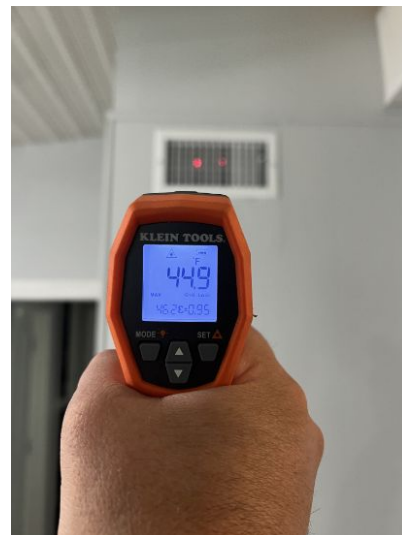
Return Air - 61 deg F

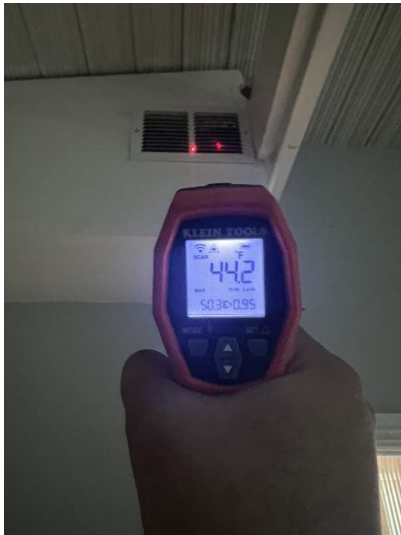
44 deg F

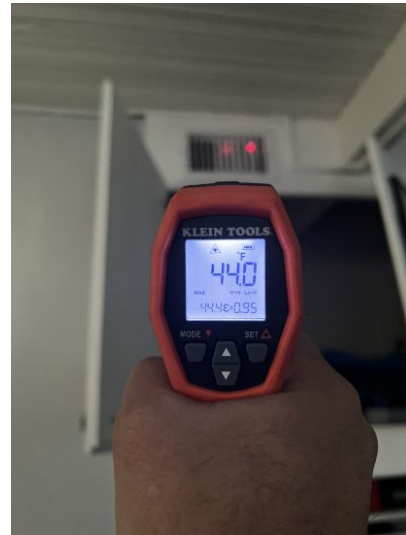
44 deg F

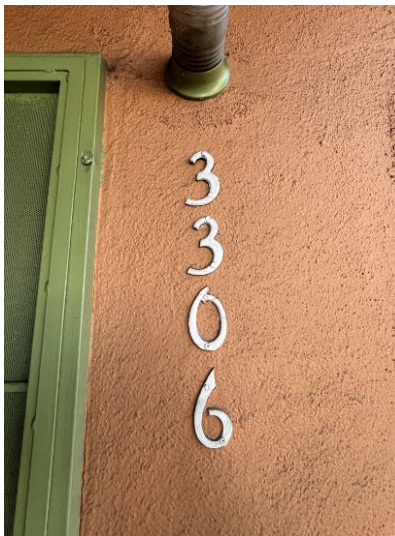
This unit is identified as 3306.

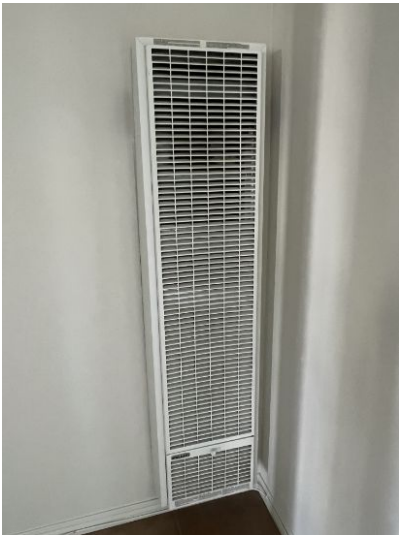
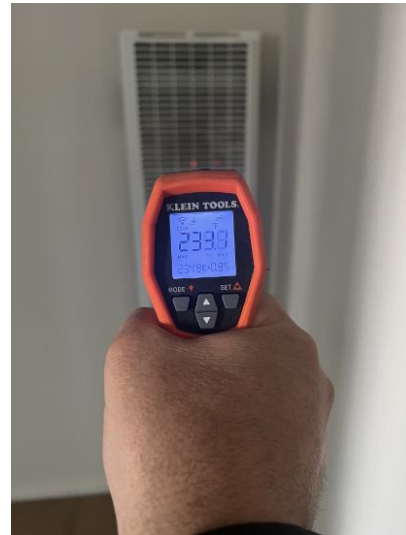
This is a gas wall heater

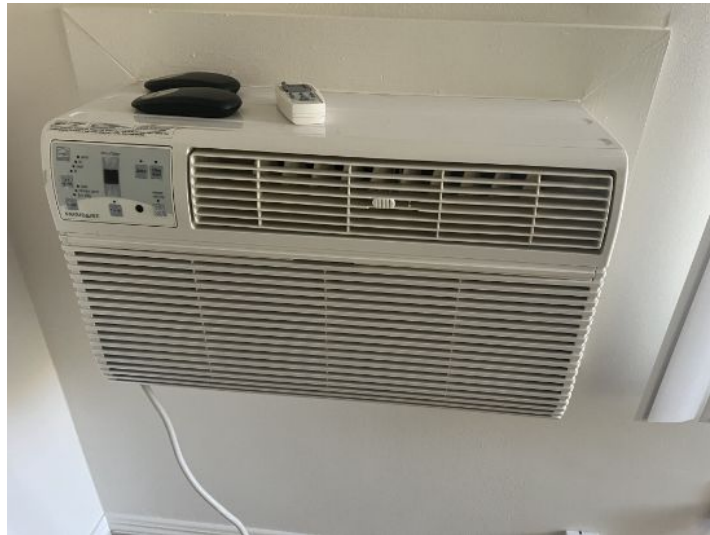
The air conditioning is handled through wall/window appliances. This was not tested.

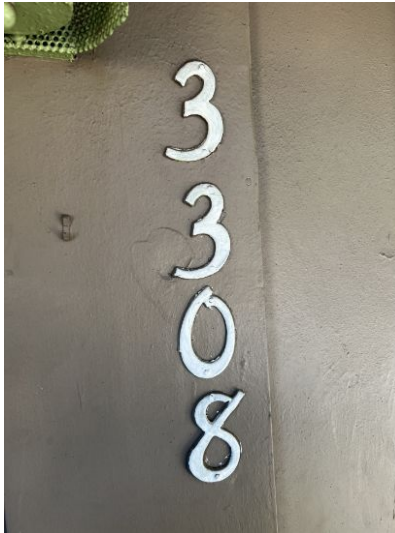
This unit is identified as 3308.

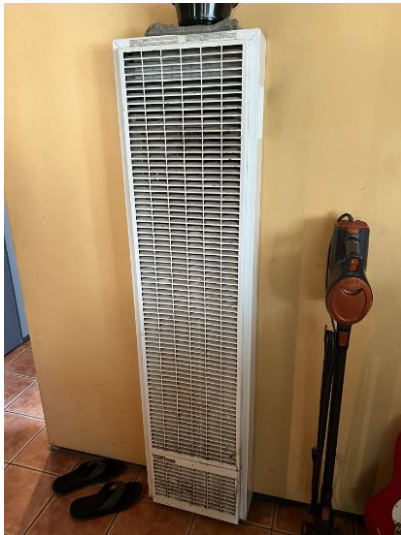
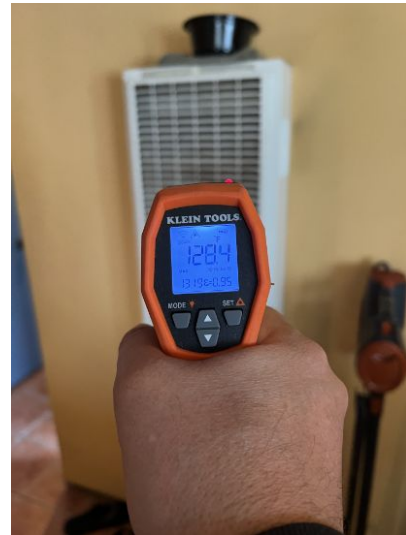
This is a gas wall heater

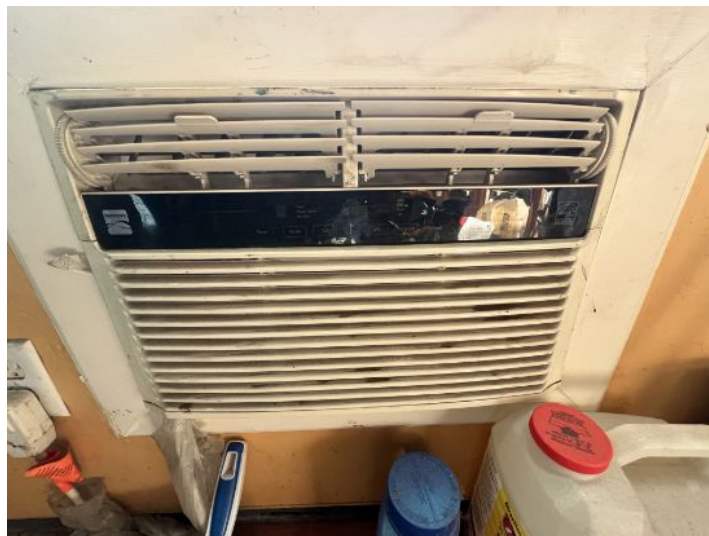
The air conditioning is handled through wall/window appliances. These are tested briefly for power only.
