First Shield Home Inspections

789 Place, Los Angeles, CA,

Prepared For: Mr and Mrs Purchaser

Date of Inspection: 1/1/2024

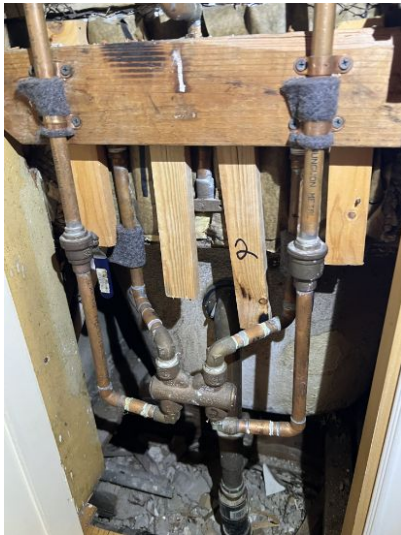
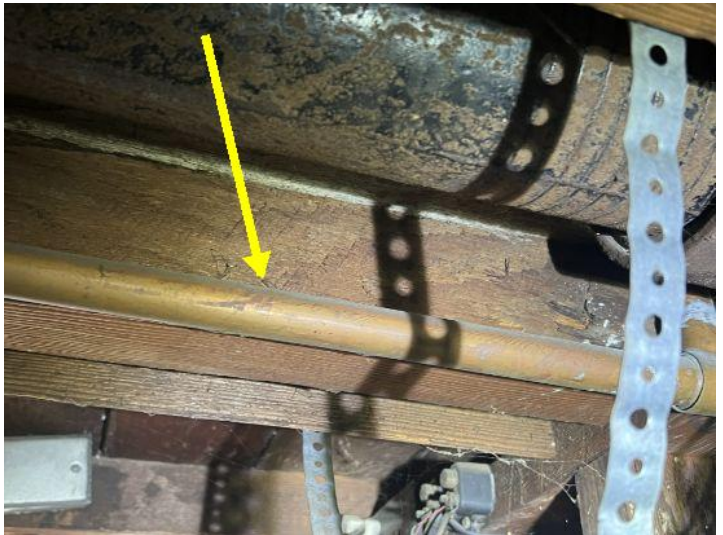
The water lines are a combination of copper and galvanized steel piping. The original galvanized steel piping that is left in the system has rust and is showing deterioration. The horizontal pipes under the house have mostly been replaced with copper piping, which is why there is a lot of copper in the system. The remaining vertical galvanized steel pipes that are in the walls may need to be replaced in the future as they continue to wear out. There was brown water that came out of the tub in UNIT 4.

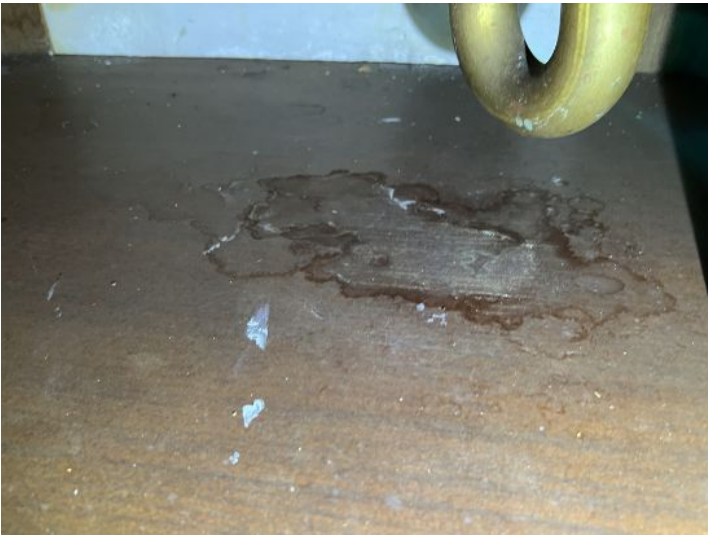
The hot water in all of the units is too hot. Water temperature should be no higher than 120 deg F.

Unit 1 - 126 deg F

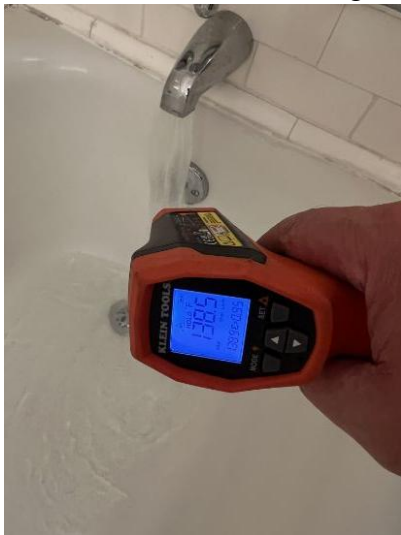
Unit 2 - bathtub - 138 deg F

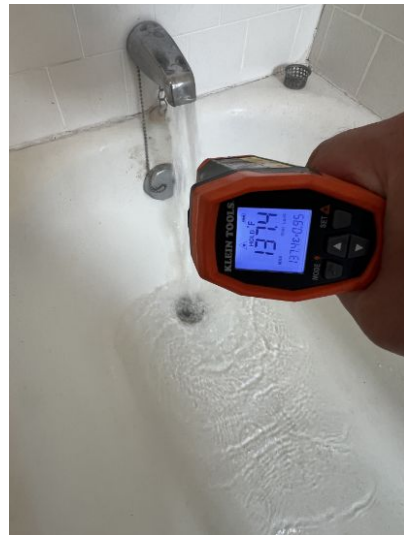
Unit 3 - bathtub 137 deg F

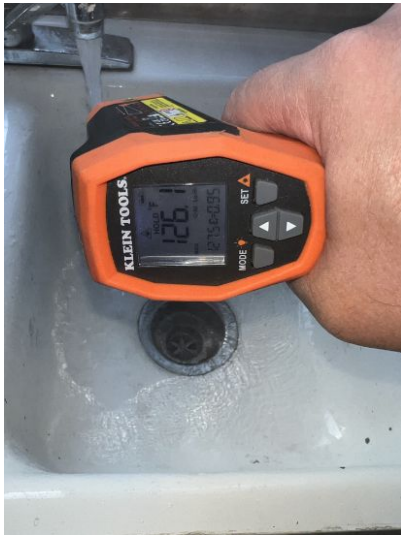
Unit 1 - 126 deg F

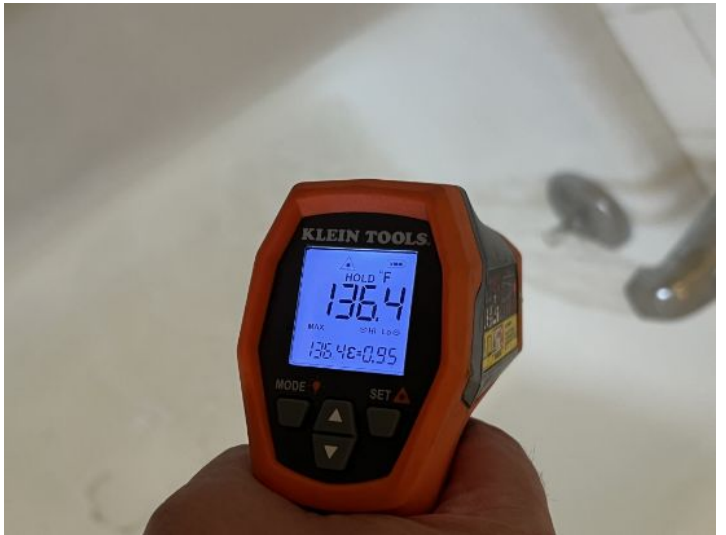
Unit 1 - bathtub - 136 deg F

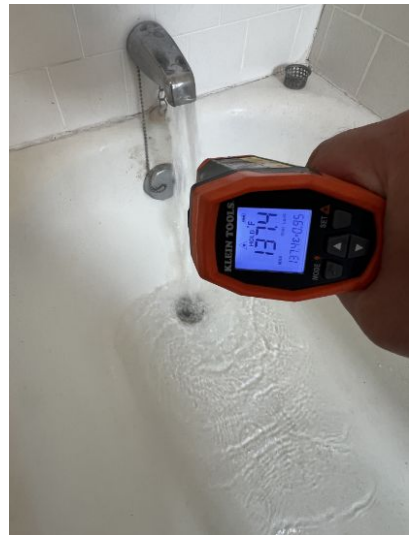
Unit 3 - bathtub 137 deg F

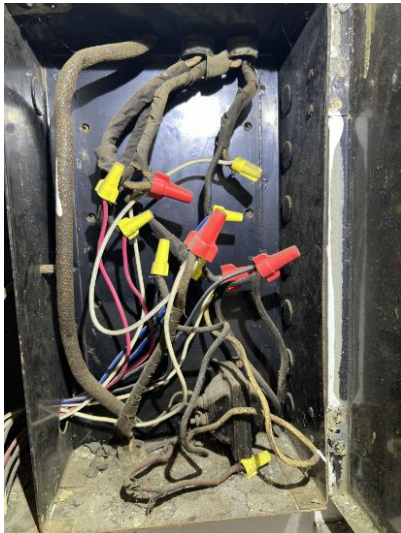
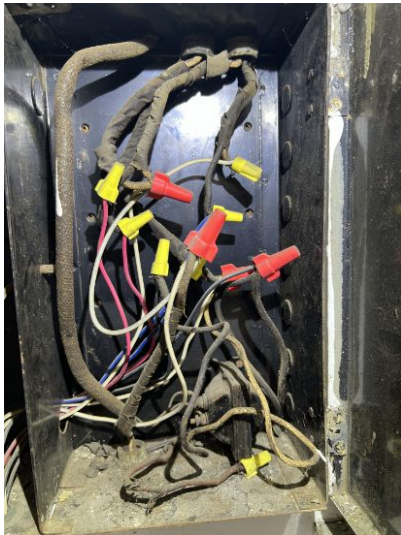
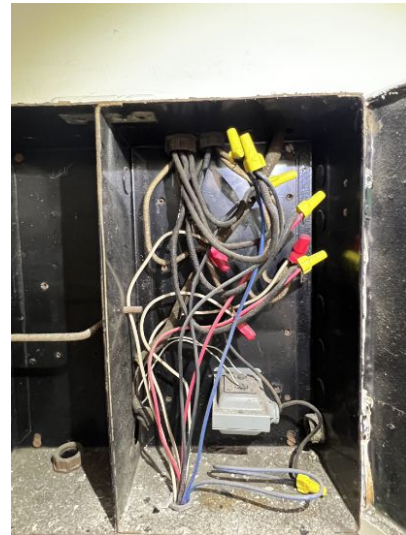
The wiring is a combination of the original cloth covered wiring and the newer plastic coated wiring. The cloth covered wiring is older but will continue to generally function unless it is disturbed or overloaded. The cloth covering will continue to wear out and have to be replaced at some time in the future when it can no longer serve its purpose of insulating the wires

It is advisable to have an electrician examine the system and make all needed repairs to ensure a properly installed and correctly operating electrical system.

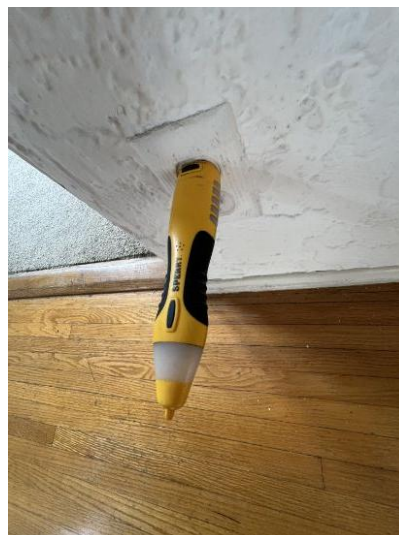
Unit 4: There are outlets that are dead and not working - Unit 4

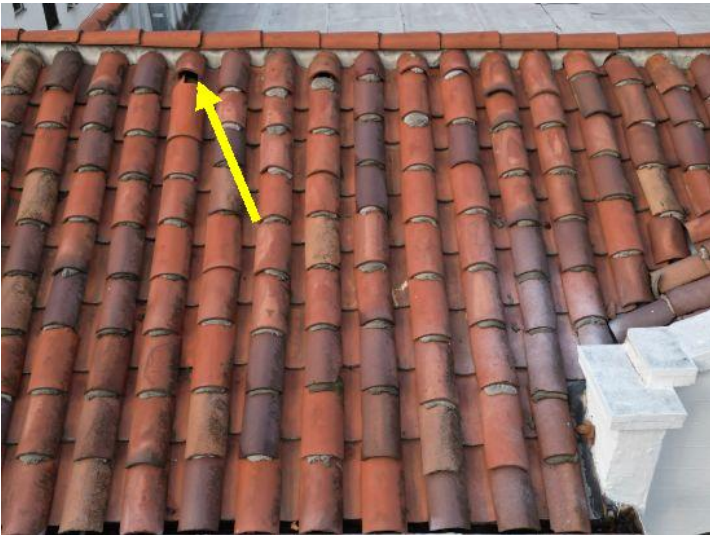
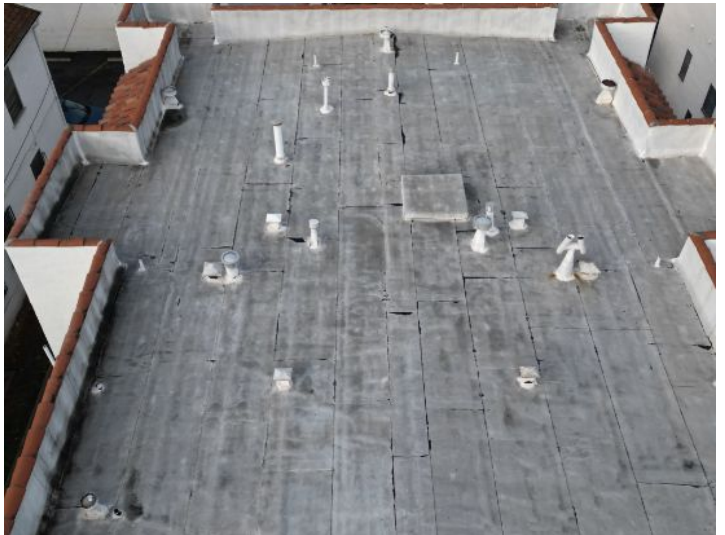
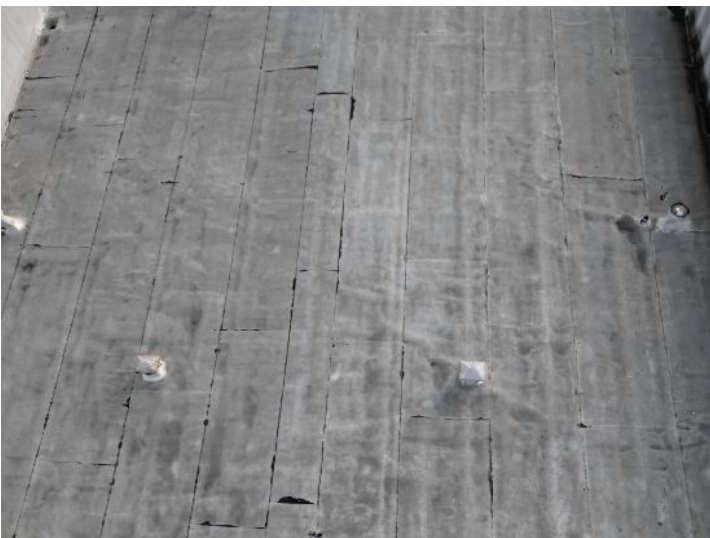
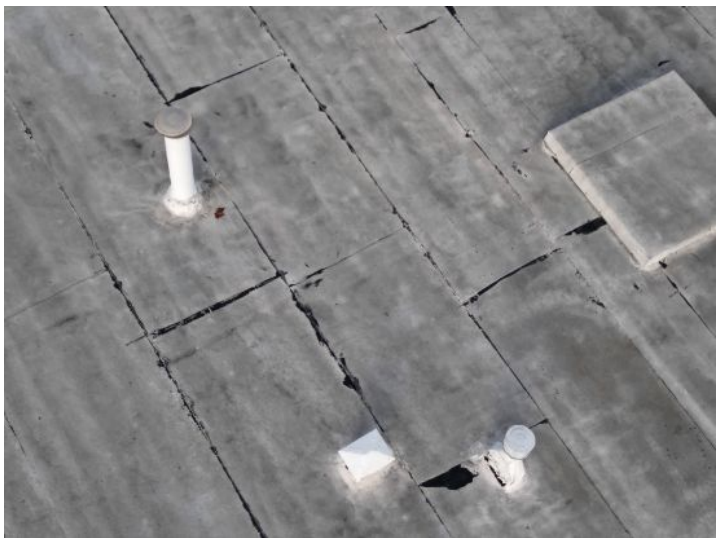
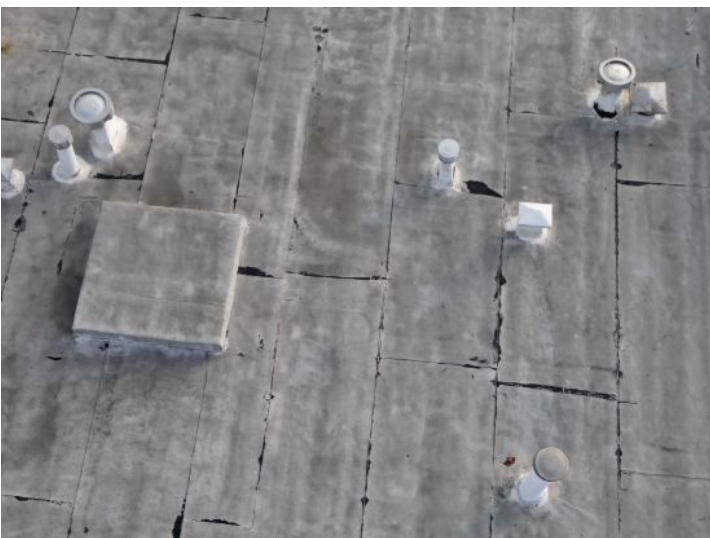
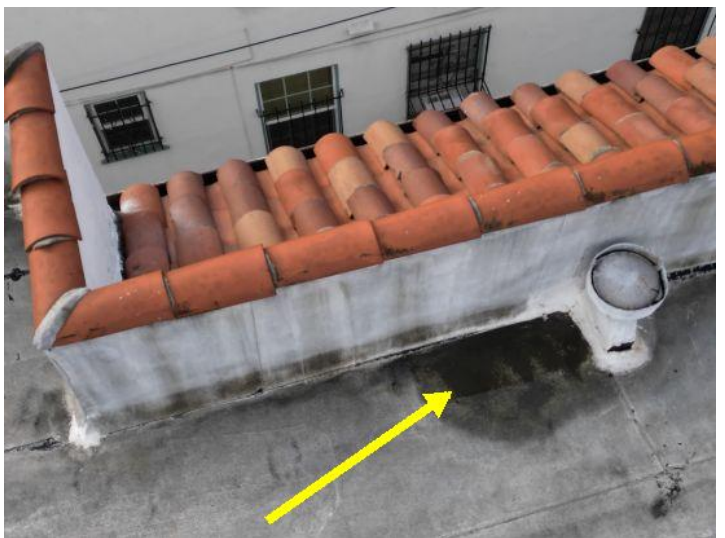
Pooling water

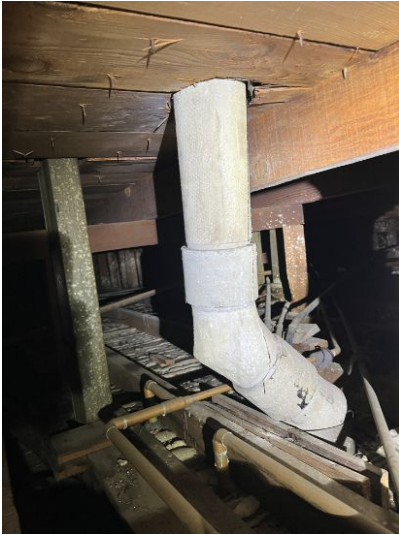
Possible asbestos

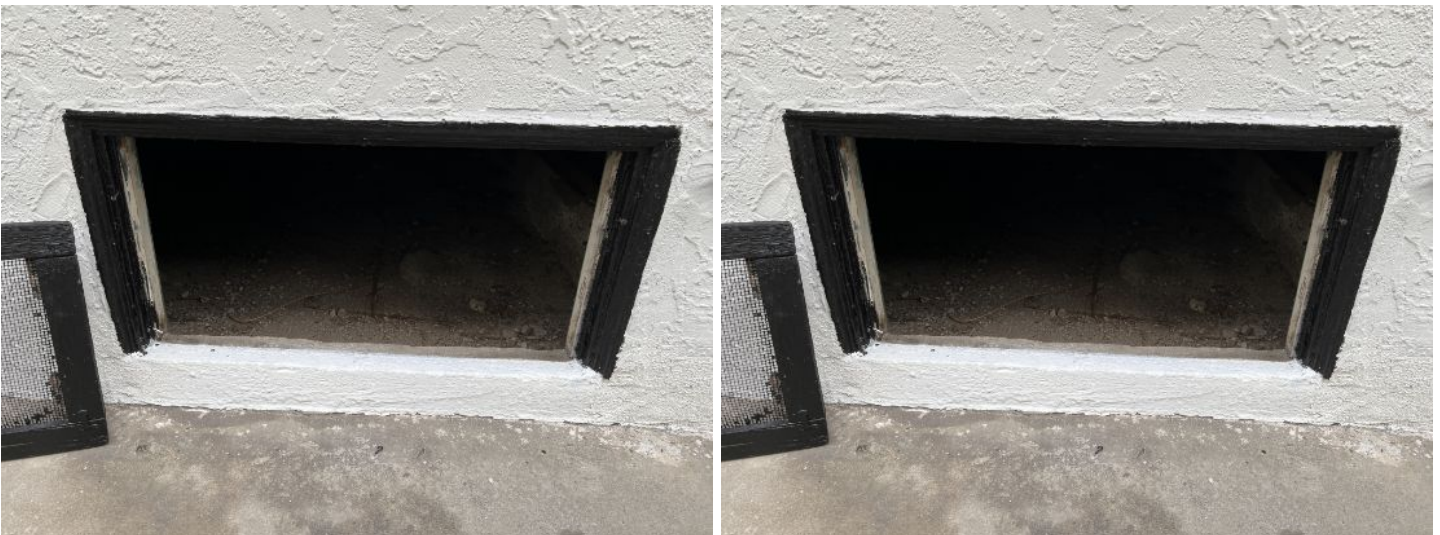
Crawlspace Access Location

The crawlspace has debris in it, it is advisable to have it removed and the area cleaned up. Wood especially should be removed to help prevent future infestations

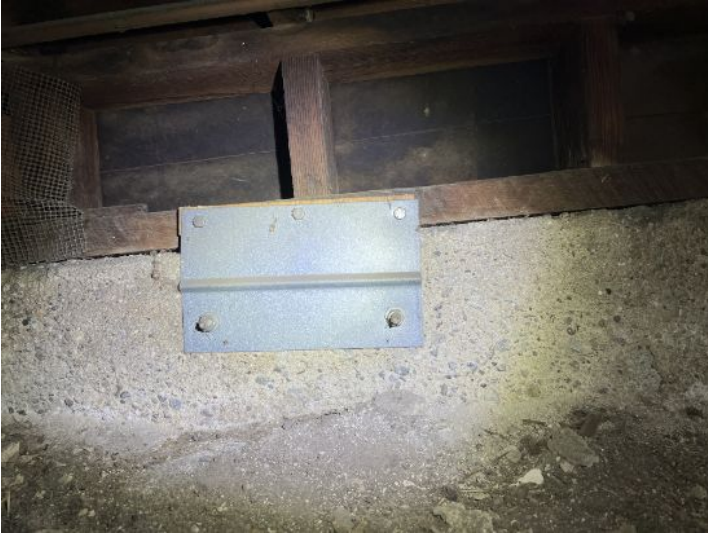
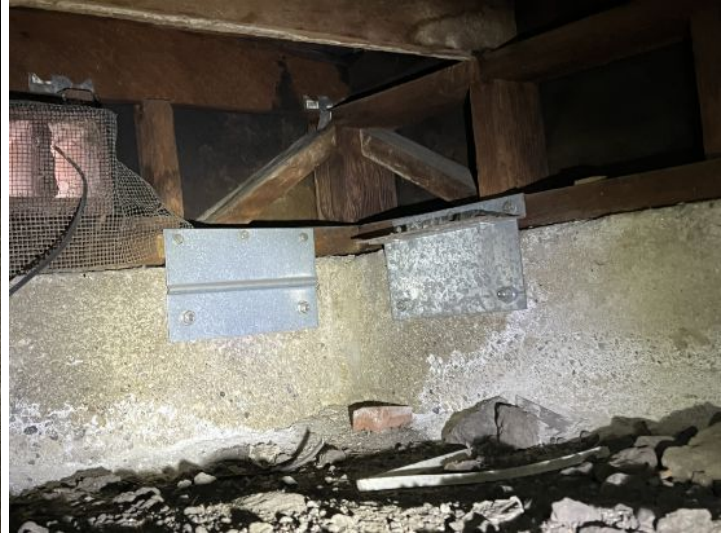
Foundation Bolting

The foundation has been seismically retrofitted with anchor bolts at a later date than the original construction. This is an upgrade.

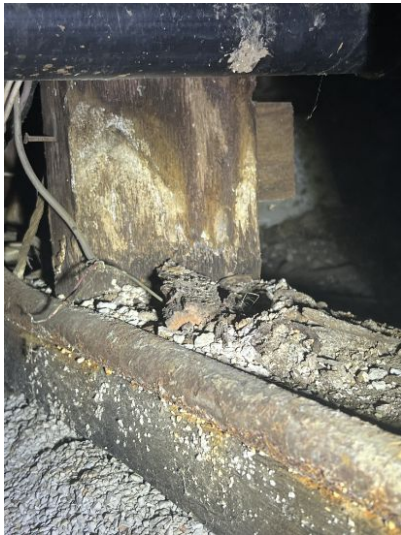
There are damaged and deteriorated areas of floor framing.

Deteriorated

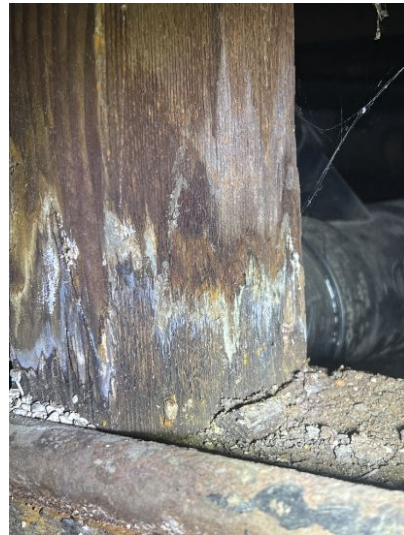
There are stained areas of floor framing - it is advisable to consult the structural pest control operator report for more information on this situation

Staining

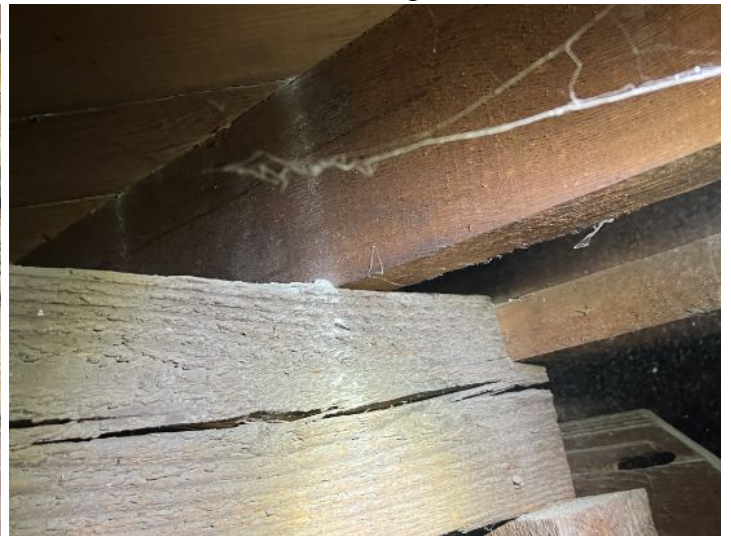
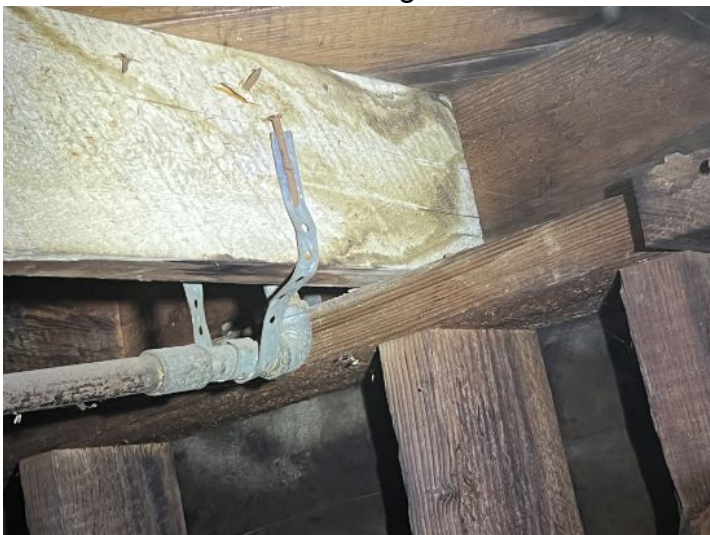
Staining

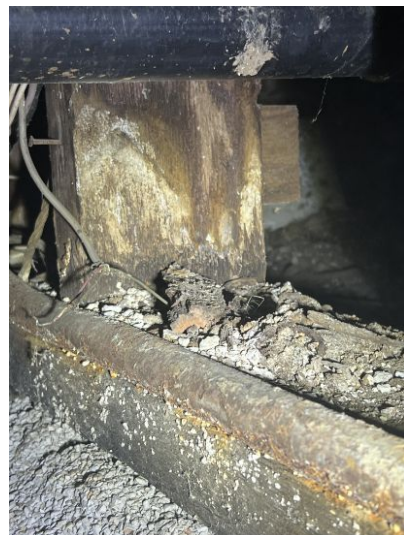
Deteriorated

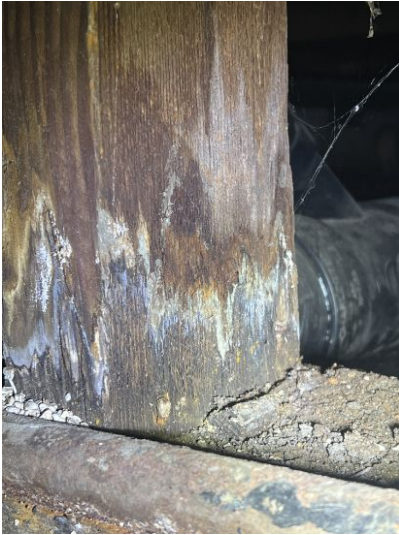
Staining

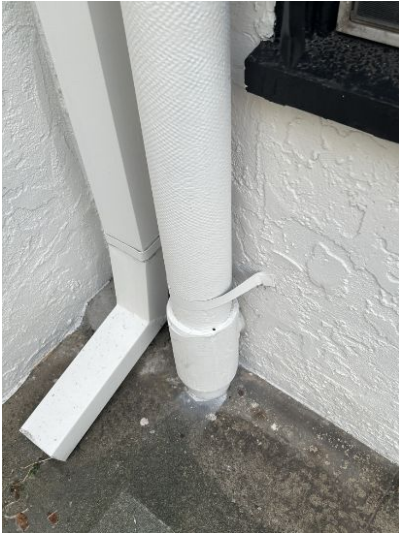
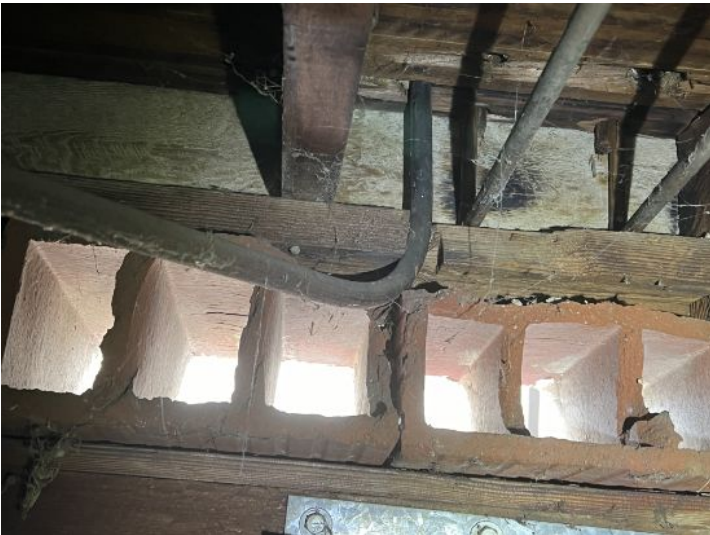
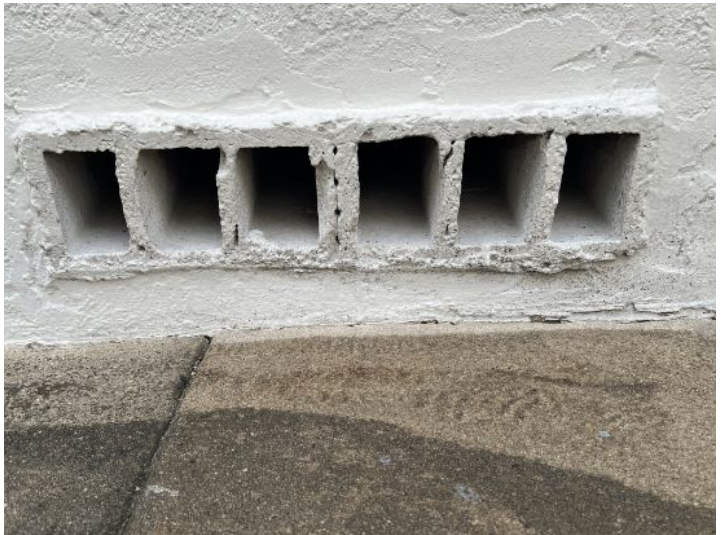
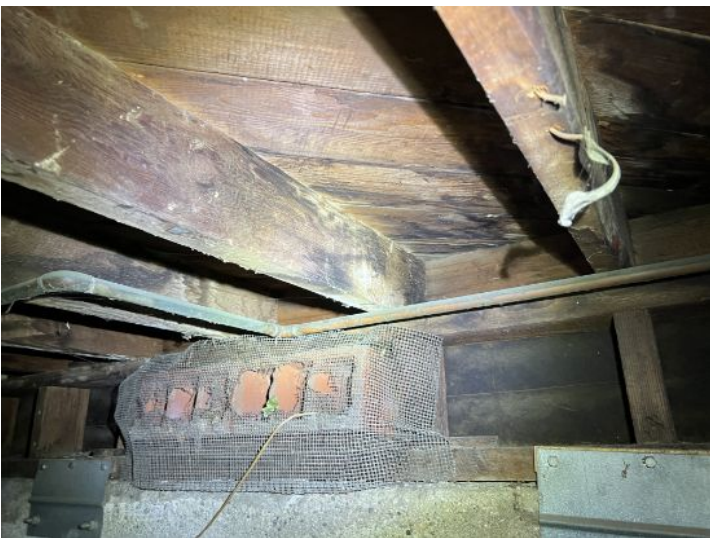
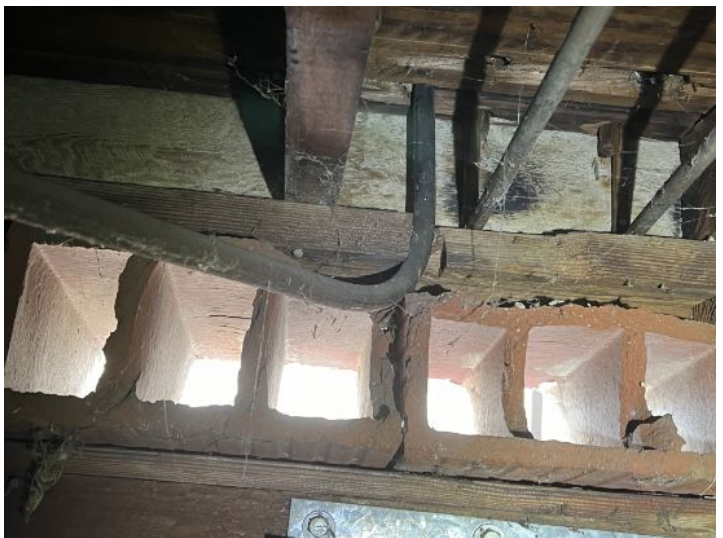
There are missing fresh air vent screens. These will allow animals and insects to enter

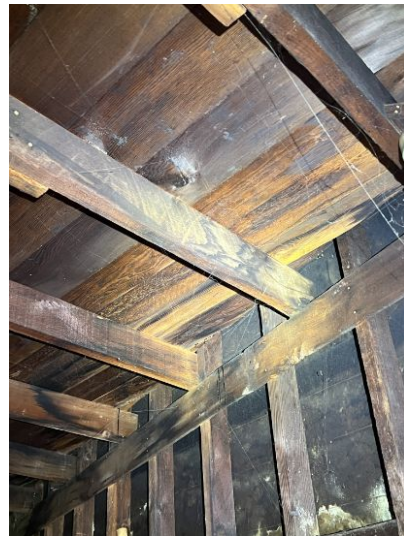
Staining

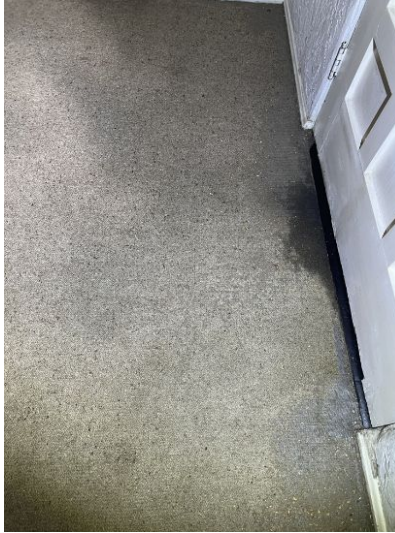
The carpet is worn/stained in areas.

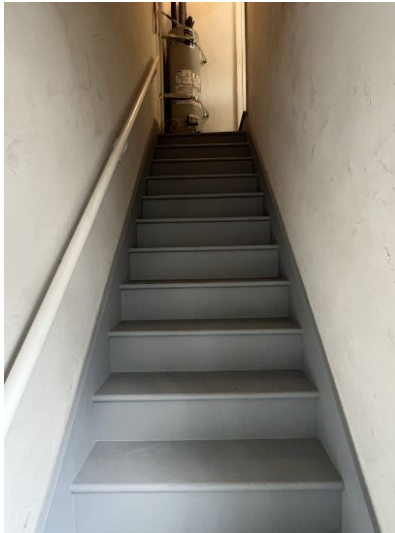
The stairs have narrow tread depths which is a trip hazard.

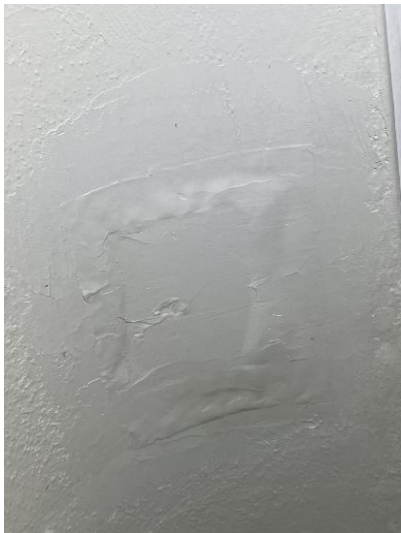
Patching

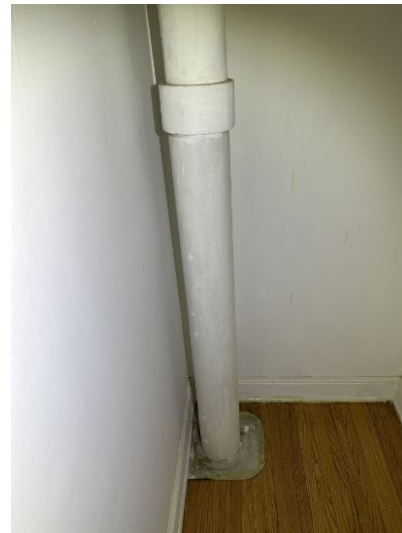
Possible asbestos materials were in the closet. These would have to be tested by an independent lab to confirm the presence of asbestos.

Possible asbestos

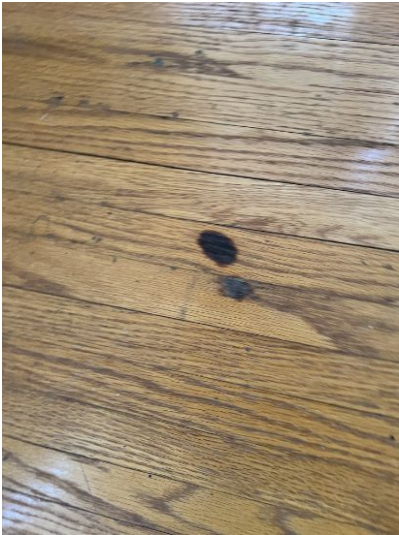
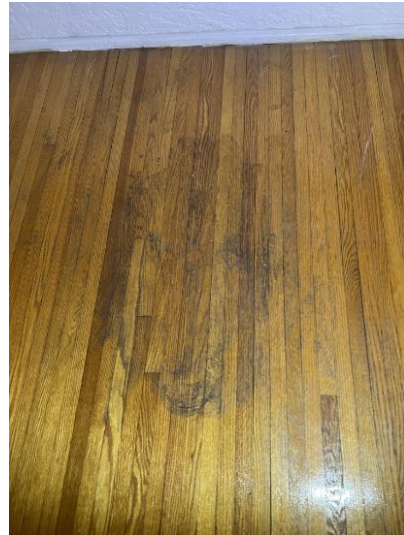
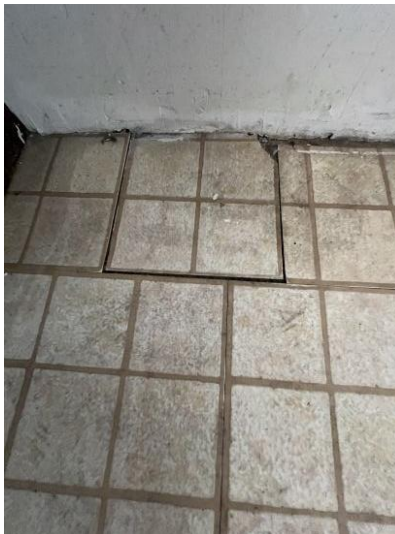
The carpet is worn/stained in areas.

There are stains on areas of the hardwood flooring that may be due to moisture of some kind. This type of staining is often saturated into the wood such that no amount of sanding will remove it. This condition should be further examined by a wood flooring specialist to determine the extent of repair needed to bring it to a condition that will be satisfactory

The vinyl flooring is damaged in areas.

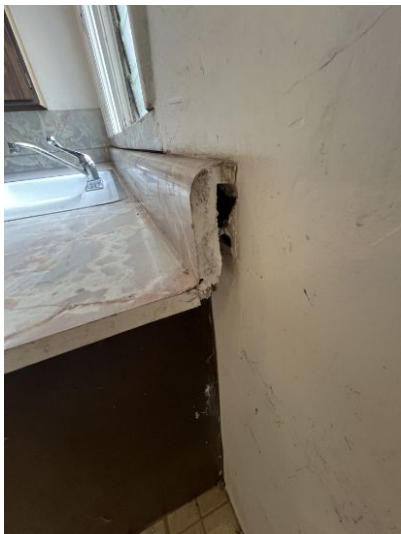
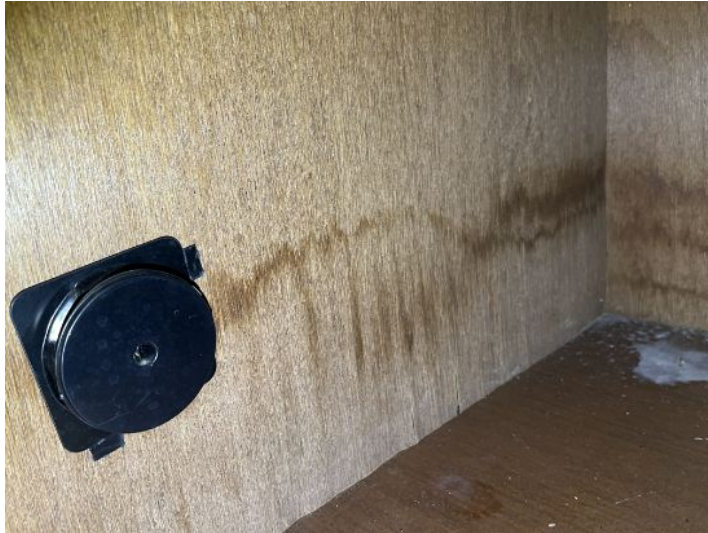
There are areas of wear to the counter.

There are areas of wear to the cabinets.

The seam at the rear and side where the counter and backsplash meet is open and needs to be resealed to prevent moisture intrusion to the area behind.

The cabinet area below the sink has damage/deterioration which appears to have been caused by moisture.

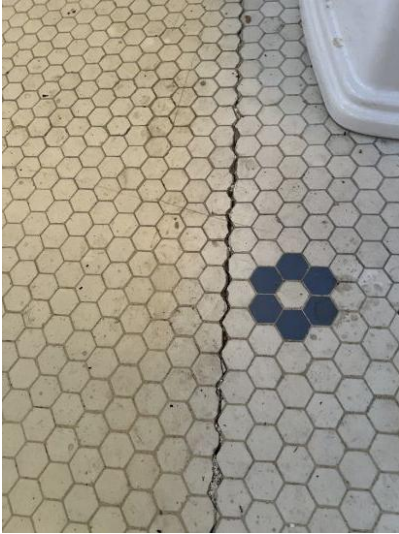
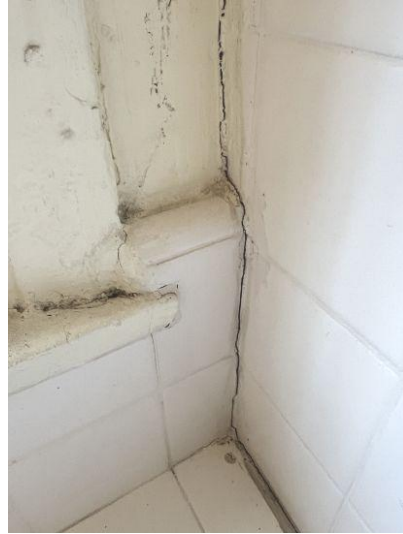
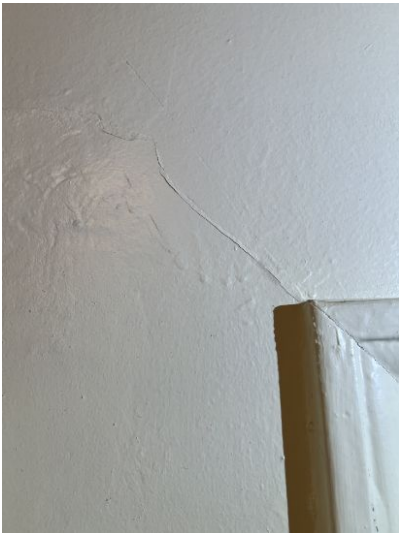
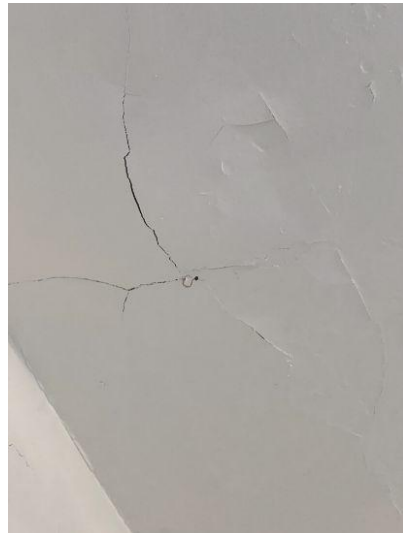
There are areas of patching and apparent repairs on the wall surfaces.

The bathroom floor tile is cracked in areas

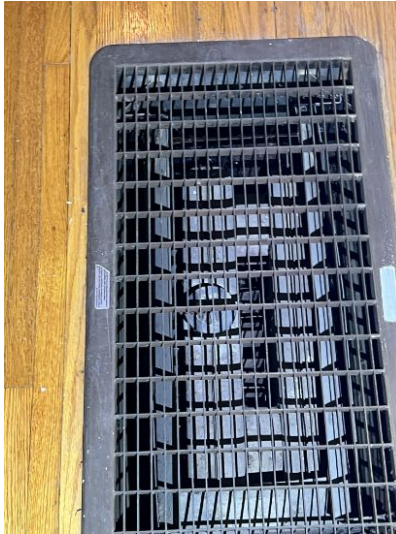
Fixture does not operate

The system did not respond and is not working at this time so the thermostat could not be tested

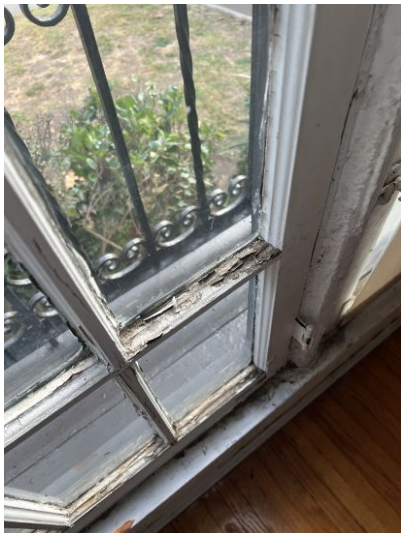
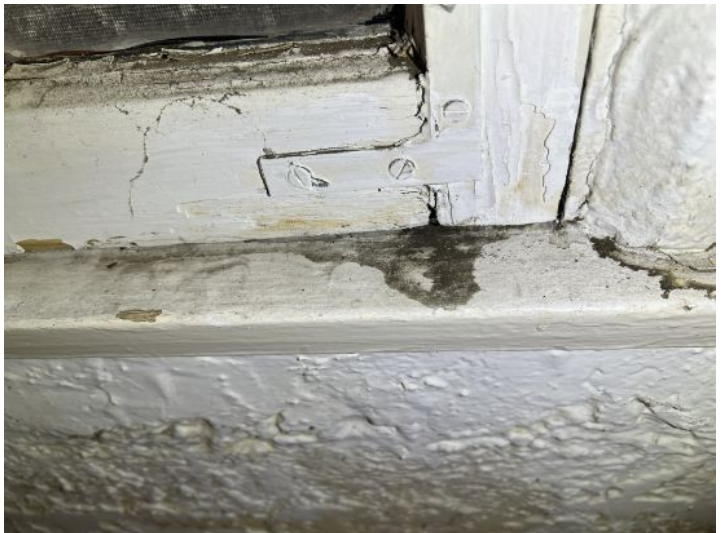
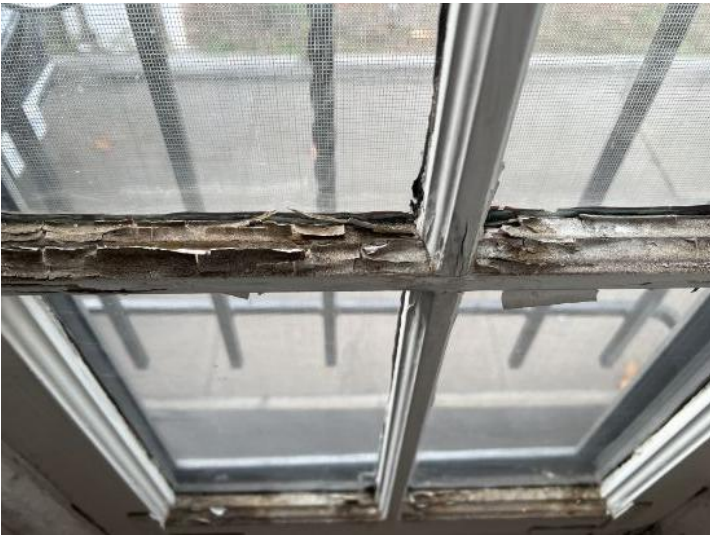
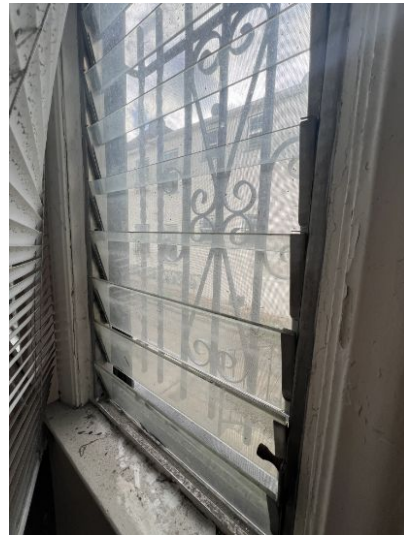
There are areas of weather beaten wood and peeling paint

Some of the older windows are sticking and difficult to open. This appears to be due in part to paint buildup and past building movement

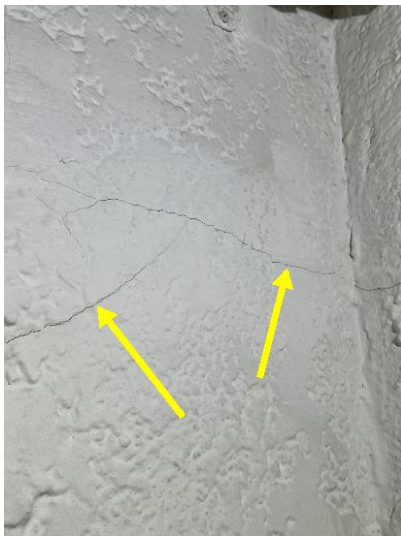
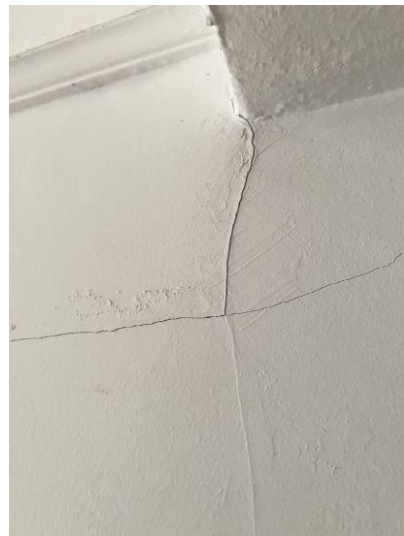
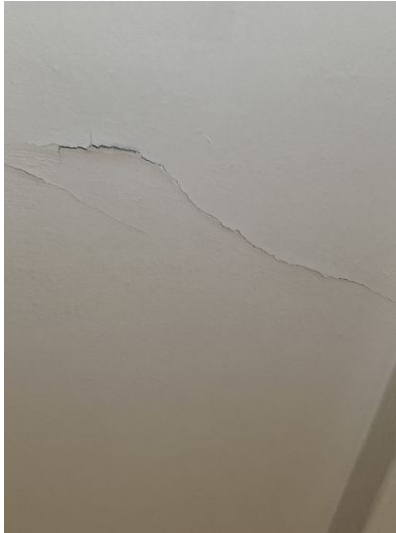
There are areas of stress cracks in the walls and ceiling

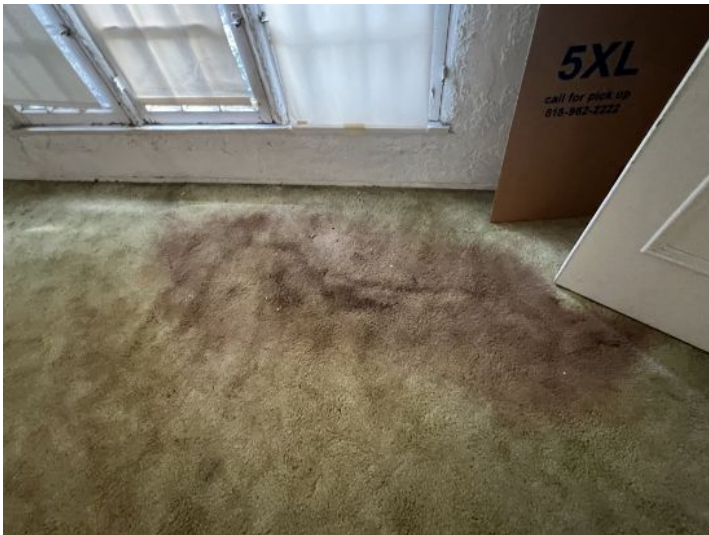
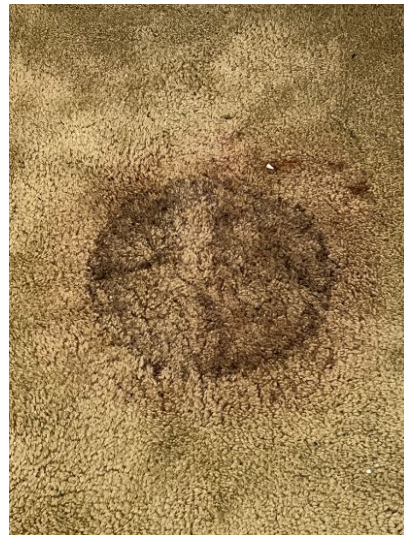
The carpet is damaged in areas.

The hardwood flooring is damaged in areas that may need repair.

The vinyl flooring is damaged in areas.

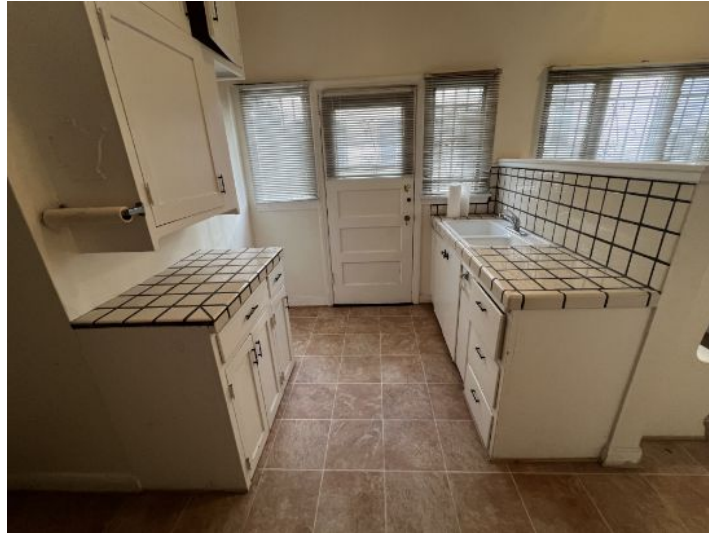
Kitchen Photo

There are areas of wear to the counter.

The sink is worn in areas.

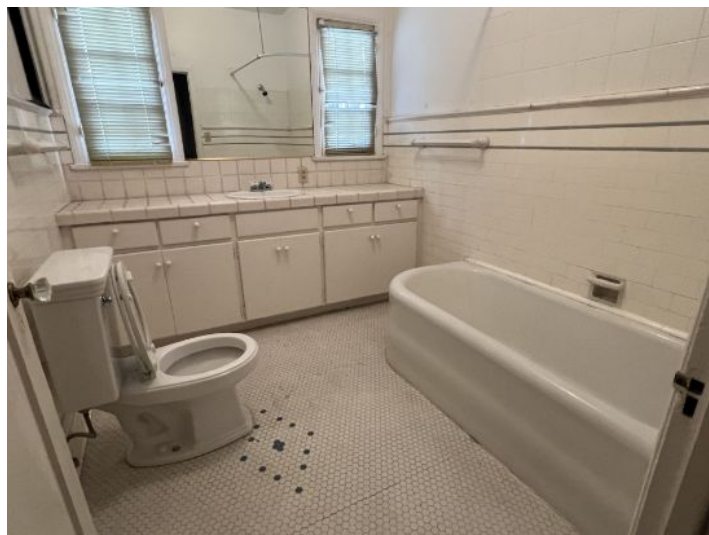
Bathroom Photo

There are areas of moisture deterioration at the wall surfaces.

The bathroom floor tile is cracked in areas

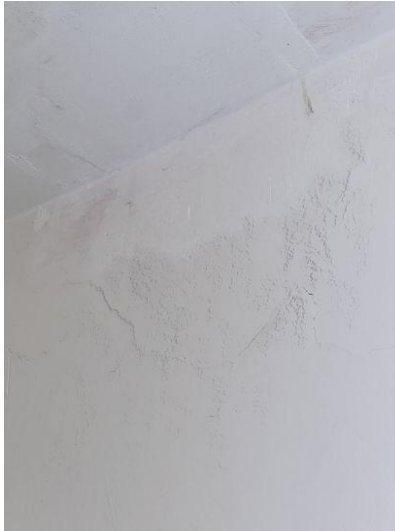
There are areas of moisture deterioration at the wall surfaces.

The bathroom floor tile is cracked in areas

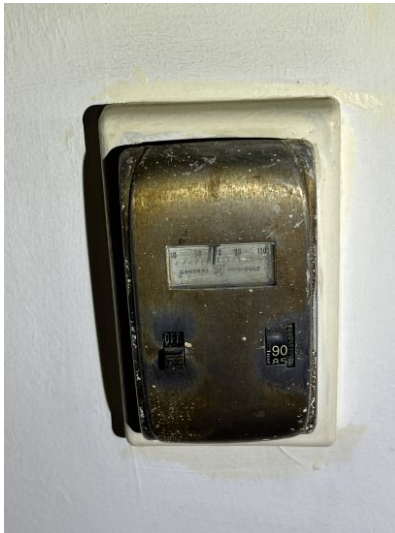
The furnace is very old and aged.

The heating system was not working at the time of the inspection and will need further evaluation.

Old thermostat

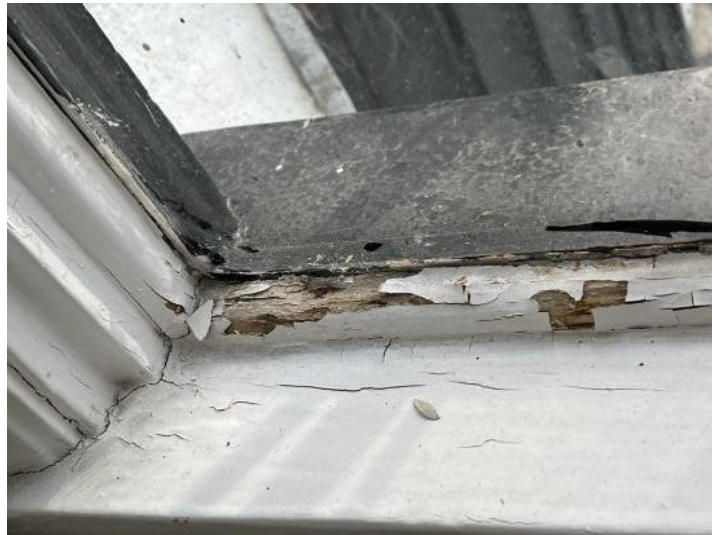
There are areas of deterioration to the exterior of the windows

Some of the older windows are sticking and difficult to open. This appears to be due in part to paint buildup and past building movement

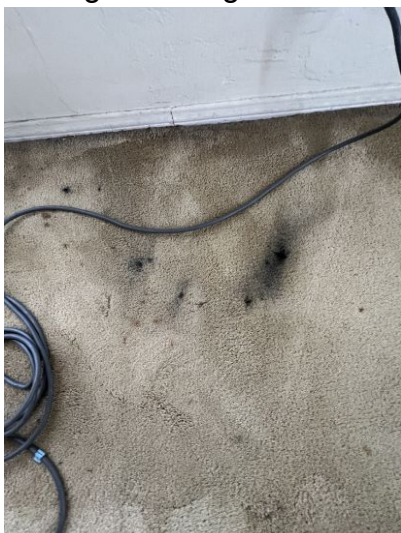
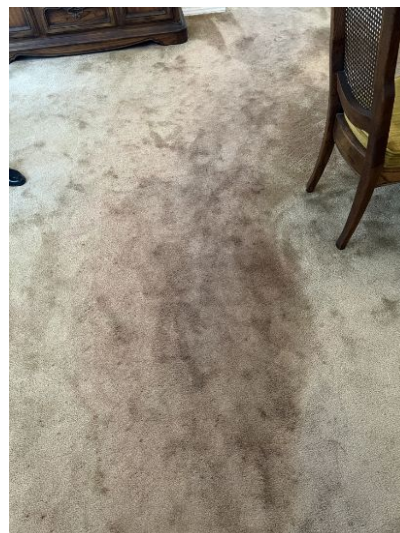
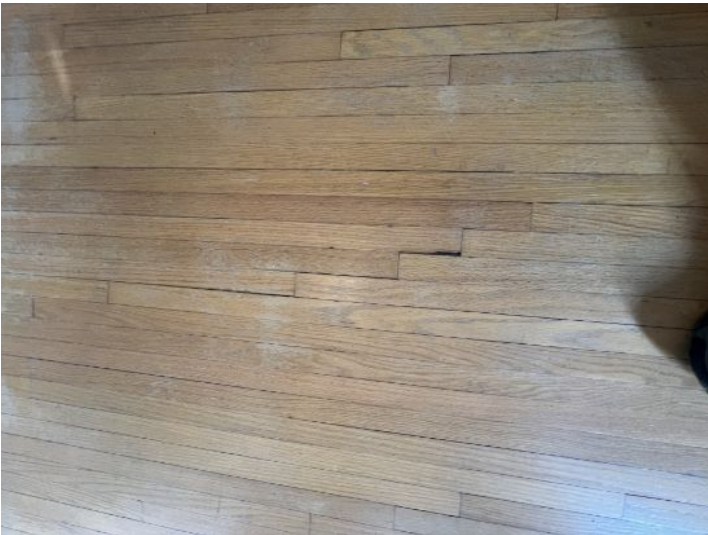
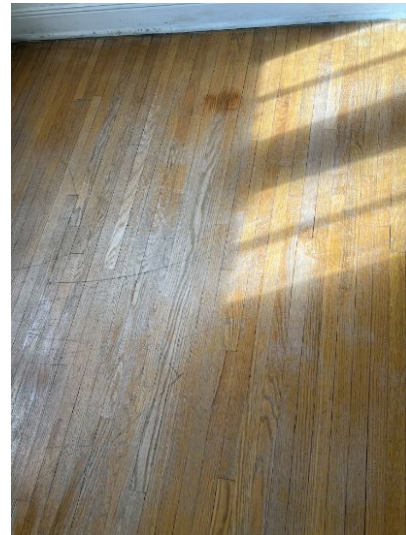
There are areas of stress cracks in the walls and ceiling.

The carpet is worn/stained in areas.

There are stains on areas of the hardwood flooring that may be due to moisture of some kind. This type of staining is often saturated into the wood such that no amount of sanding will remove it. This condition should be further examined by a wood flooring specialist to determine the extent of repair needed to bring it to a condition that will be satisfactory

The hardwood flooring is cupped in areas, this is usually due to moisture.

The vinyl flooring is damaged in areas.

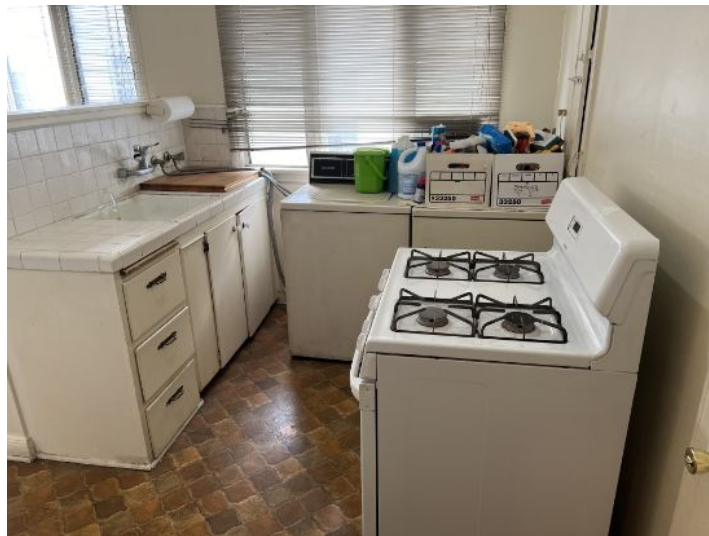
Kitchen Photo

There are areas of wear to the counter.

There are areas of wear to the cabinets.

The sink is worn in areas.

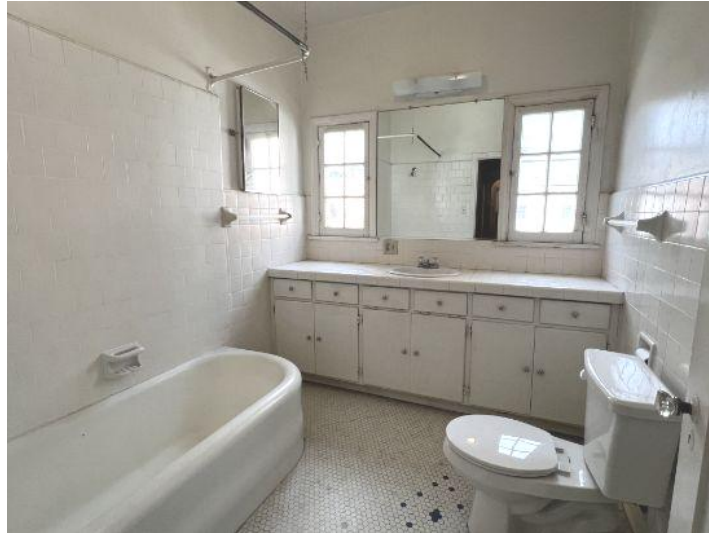
Bathroom Photo

There are areas of moisture deterioration at the wall and ceiling surfaces.

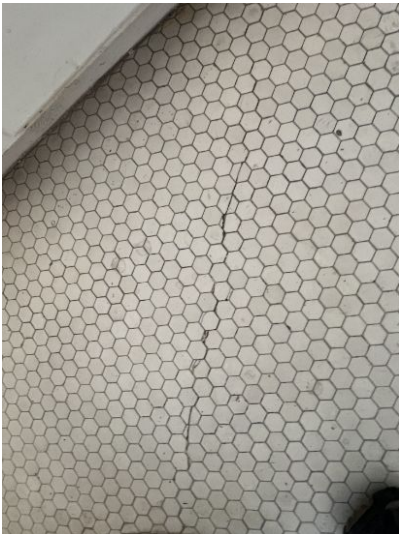
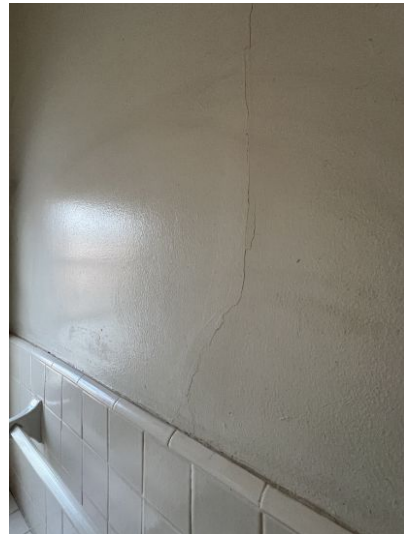
There are areas of moisture deterioration at the wall and ceiling surfaces.

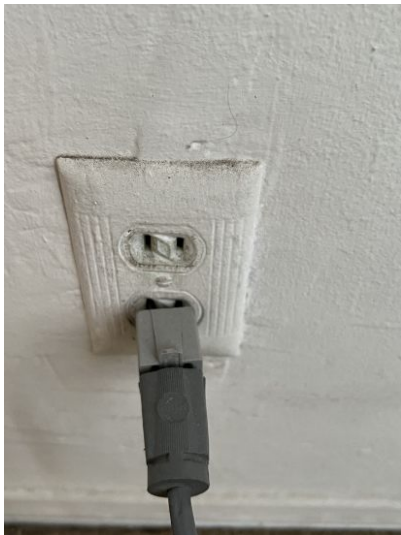
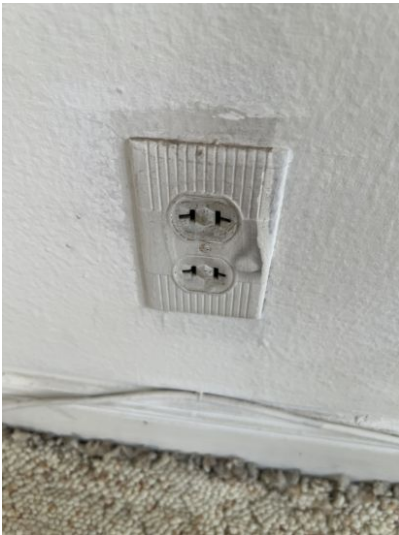
Bathroom - NO GFCI

The outlets are the 2 prong type. These are the older ungrounded type. In many cases they could be upgraded to the 3 prong type with a ground in them but it is not a requirement

There are no GFCI outlets in areas that require them, such as the kitchen, bathrooms or any area exposed to a water source.

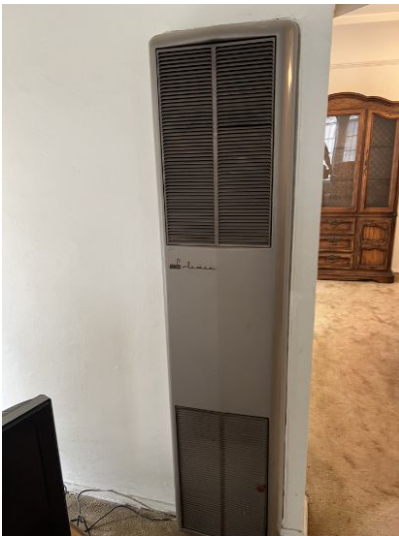
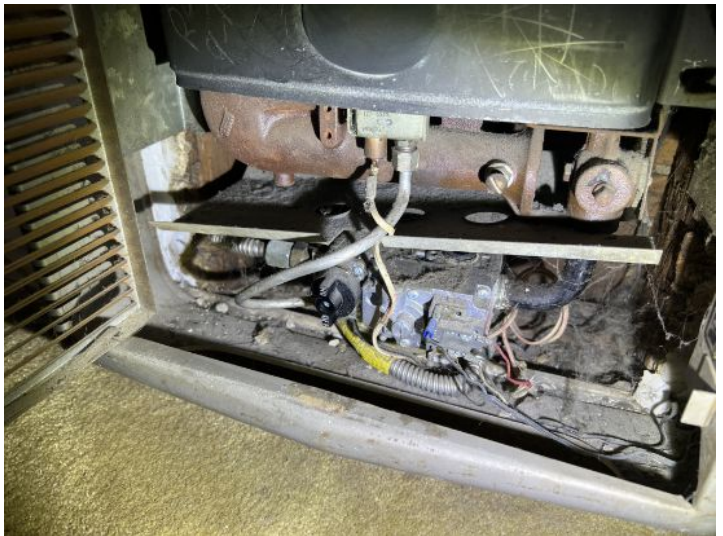
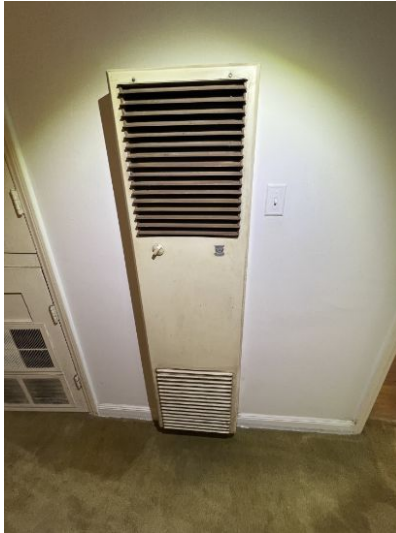
The furnace is very old and aged.

The heating system was not working at the time of the inspection and will need further evaluation.

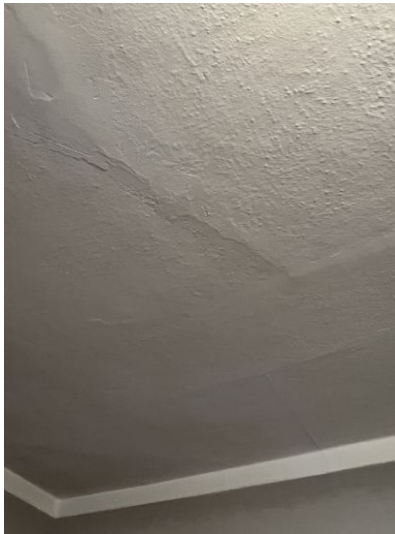
There are areas of stress cracks in the walls and ceiling.
