First Shield Home Inspections

789 Place, Los Angeles, CA,

Prepared For: Mr and Mrs Purchaser

Date of Inspection: 1/1/2024

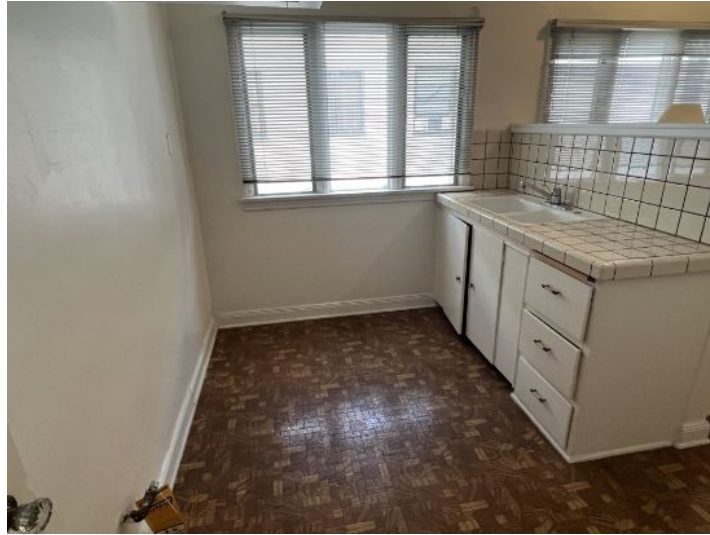
Kitchen Photo

There are areas of wear to the counter.

The sink is worn in areas.

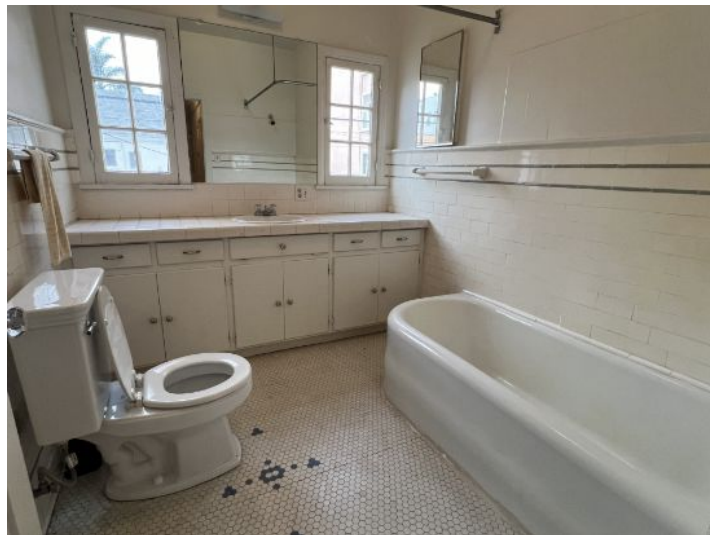
Bathroom Photo

There are areas of moisture deterioration at the walls and ceiling.

There are cracked tiles in areas.

The bathroom floor tile is cracked in areas

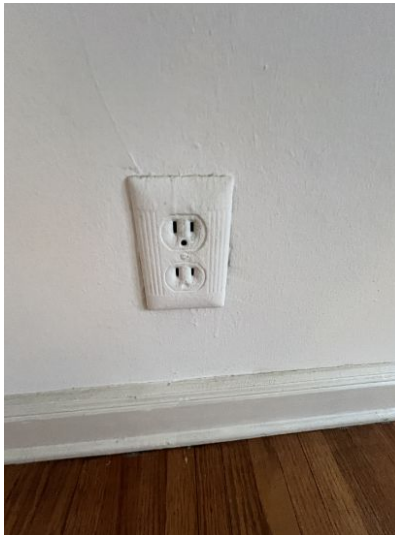
The outlets are the 2 prong type. These are the older ungrounded type. In many cases they could be upgraded to the 3 prong type with a ground in them but it is not a requirement

There are no GFCI outlets in areas that require them, such as the kitchen, bathrooms or any area exposed to a water source.

Painted over

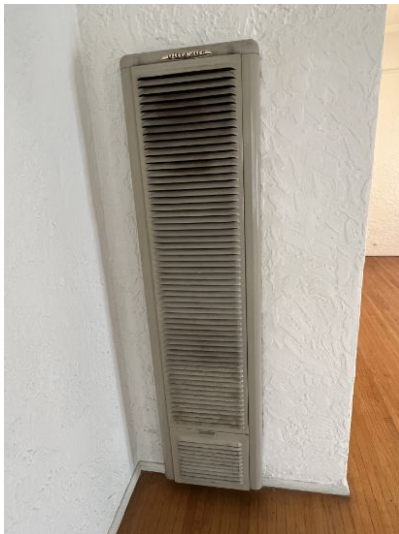
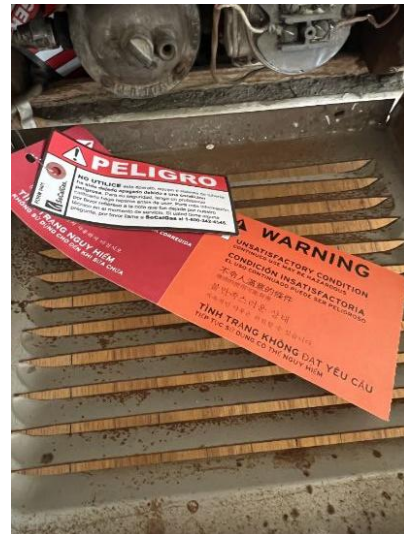
The furnace is very old and aged.

The living room furnace has been red-tagged by the Gas company as "unsafe".

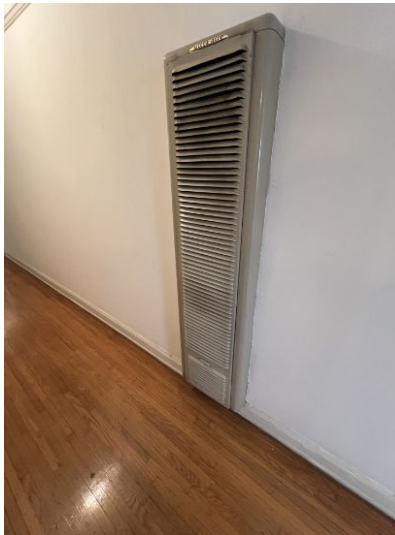
The living room furnace has been red-tagged by the Gas company as "unsafe".

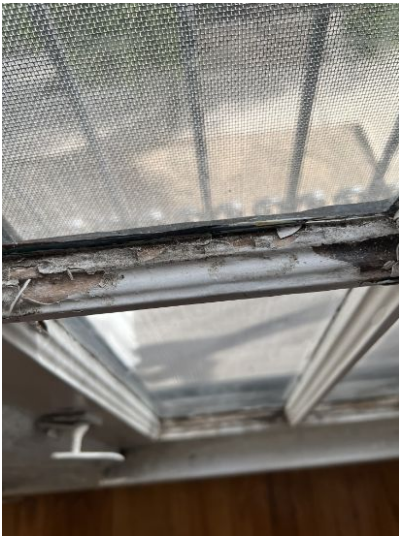
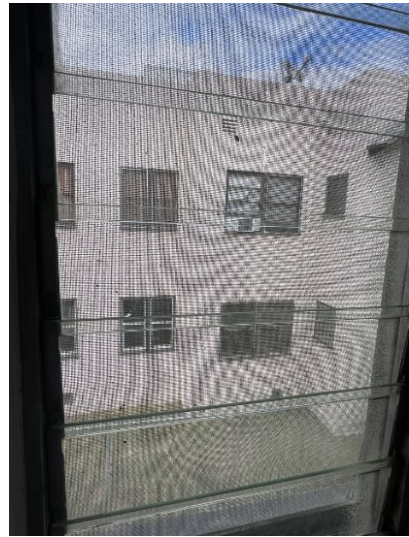
There are areas of deterioration to the exterior of the windows

Some of the older windows are sticking and difficult to open. This appears to be due in part to paint buildup and past building movement
