# First Shield Home Inspections

**12345 Anyplace, Lancaster, CA,**

**Date of Inspection: 1/10/2024**

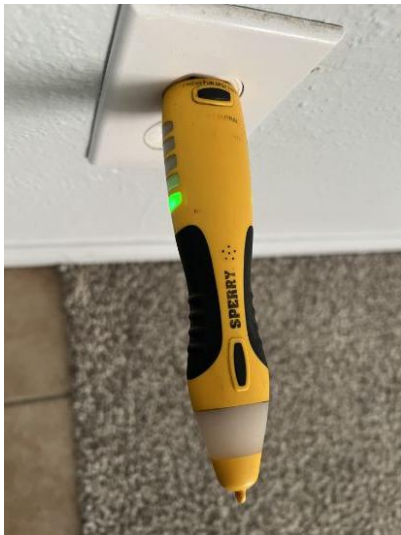
Entry

**There is one or more outlets that have no power to them and are not working in areas of the home.**

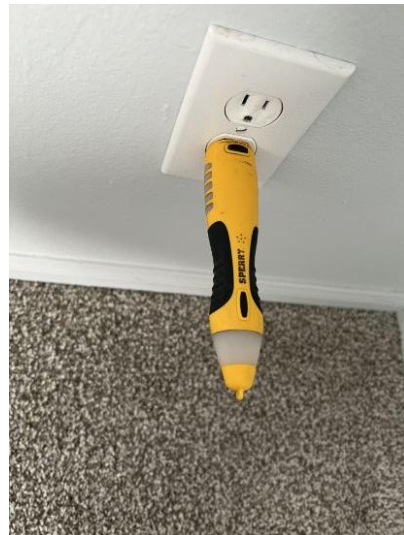
Living room - NOT WORKING

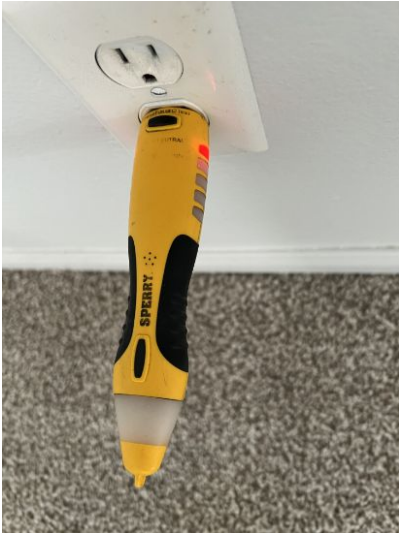
**There is one or more outlets that had the wires reversed in them (this is called reversed polarity). These outlets are still live and will work but could potentially harm any device or appliance that is plugged into them.**

Living room - HOT / NEUTRAL REVERSED

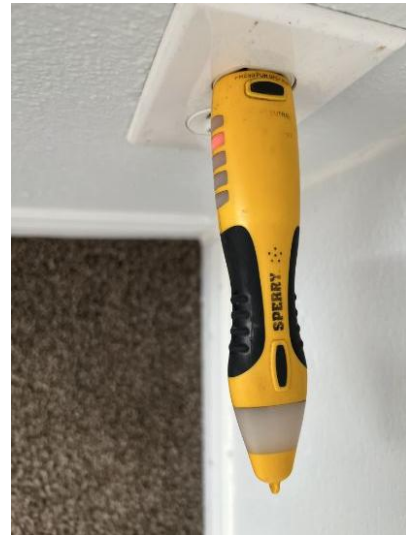
**There is one or more outlets that have 3 prongs, but there was no ground in them. Repair to the existing wires or upgrade to new wiring may be needed.**

Bedroom 1 - NOT GROUNDED

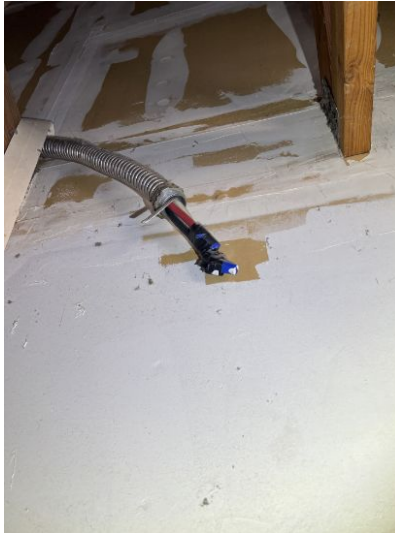
Wires in the garage. It is unknown where they go. It is recommended to have a licensed electrician follow these to determine their source.

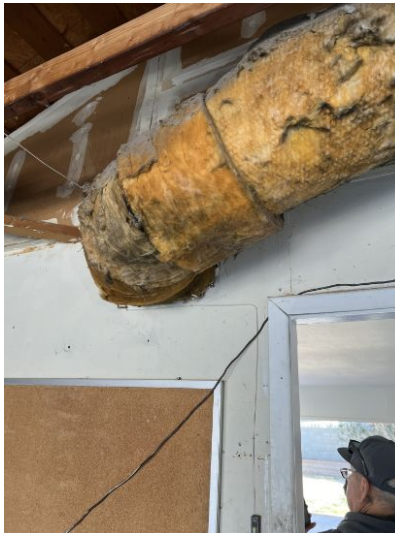
There are some deteriorated and worn areas of duct insulation.

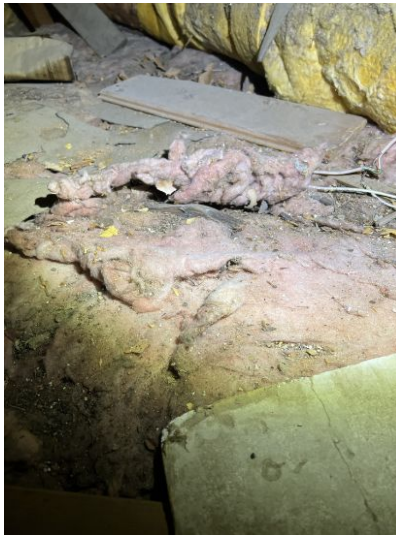
Debris

The attic has wood shingle debris in it. This occurred when the old wood roof was removed and pieces of it fell in the attic and were not cleaned up. Ideally this should be removed as this can extra food for "termites".

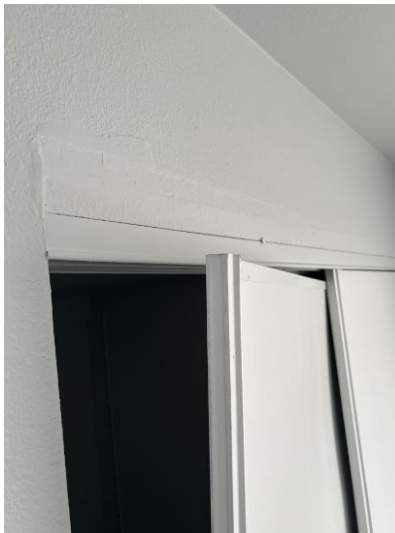
Bedroom 1 - closet doors

There are closet doors that are damaged, not hung properly, and missing rail guides.

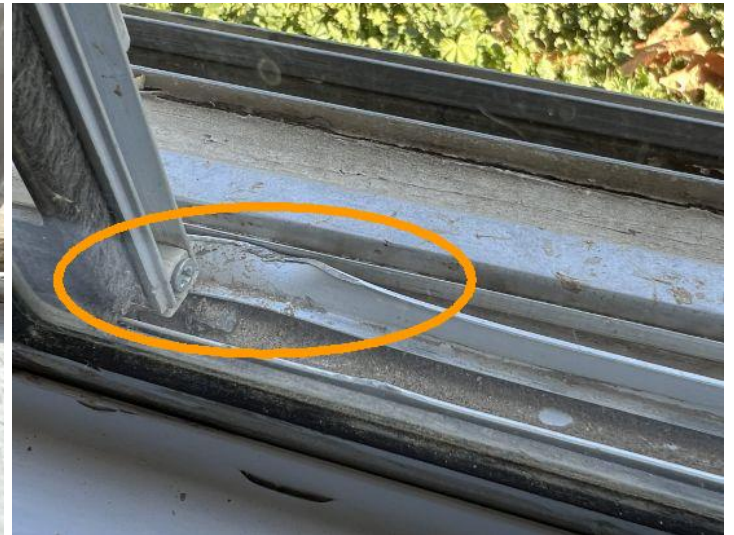
Bent frame

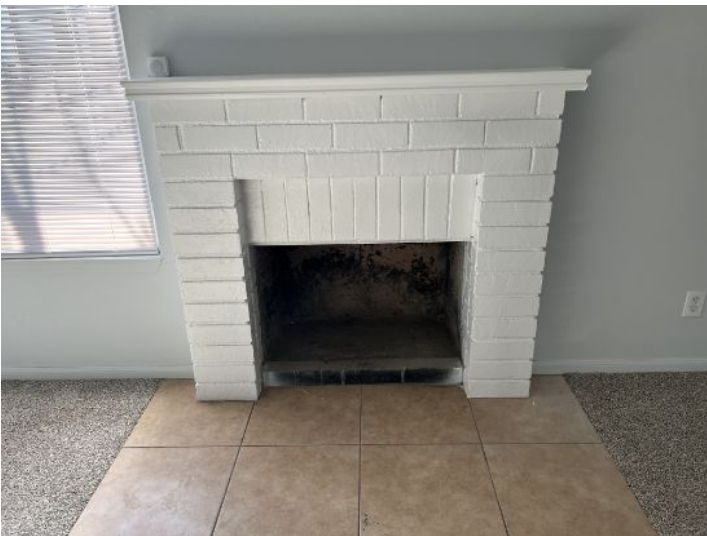
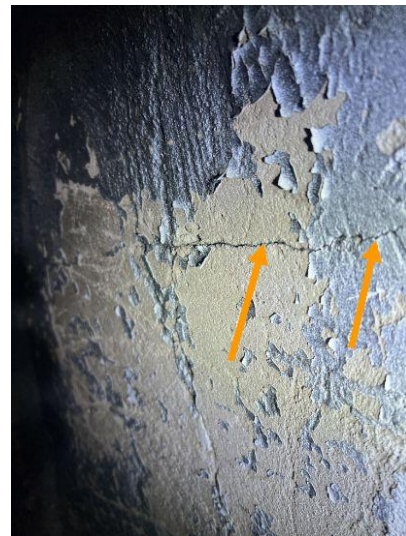
There is some deterioration to the firebox back wall area, this does not appear to be a fire safety concern at this time. Some re grouting and filling of cracks with a fire rated grout is advised to ensure future fire safety.

There is a crack at the side wall of the firebox that needs minor maintenance.

It is advised to consult a chimney/fireplace specialist regarding the condition of the system.

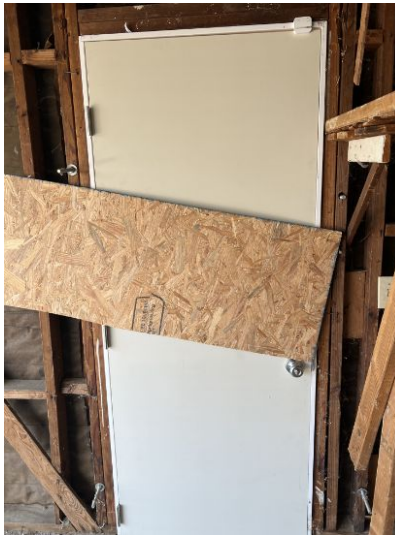
The exterior side door has a board screwed across it, possibly as a security / locking measure.

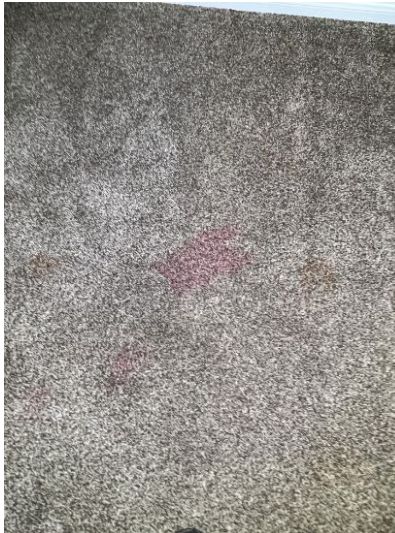
The carpet is stained in areas.

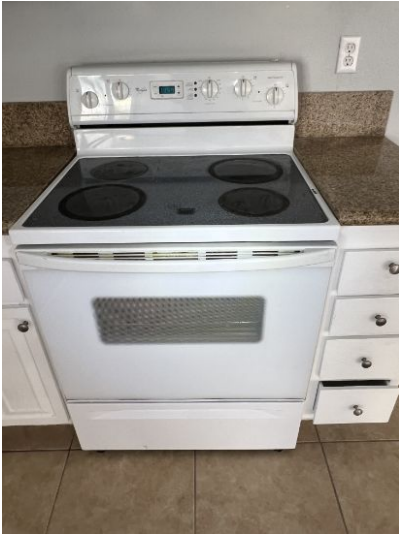
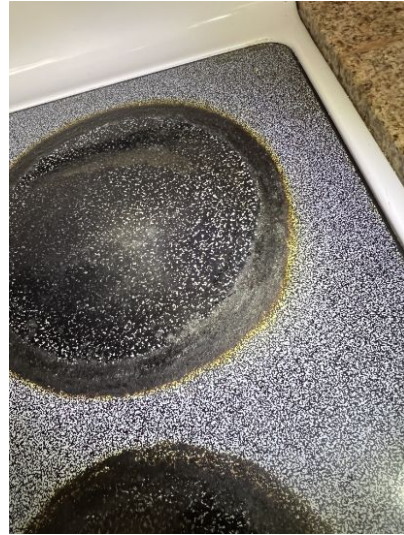
The kitchen has an electrical stove (cooktop and oven).  
The stove is an older model.

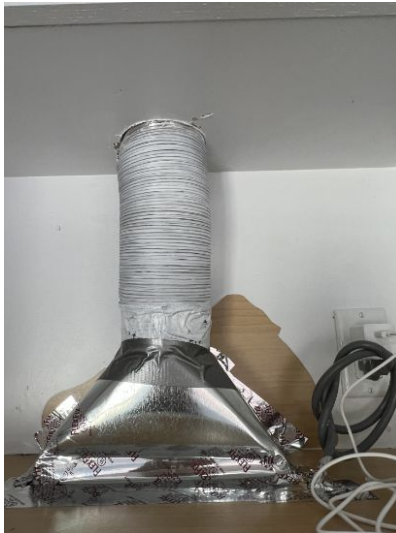
Non-standard corrugated flexible materials are being used as the range hood exhaust vent pipe. Typically, a smooth wall material should be used.
