First Shield Home Inspections

3300 Somewhere Lane, Los Angeles, CA,

Prepared For: Mr and Mrs Buyer

Date of Inspection: 1/1/2024

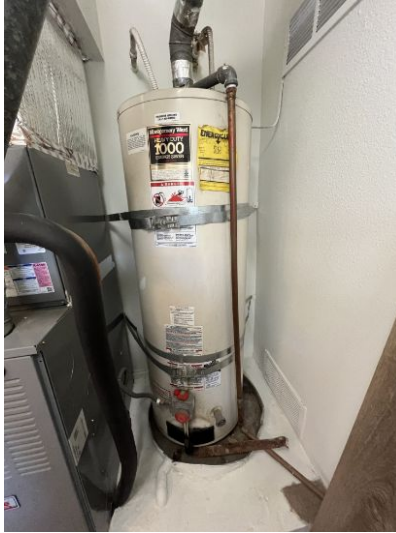
Photo

The water heater is very old. It may need to be replaced soon.

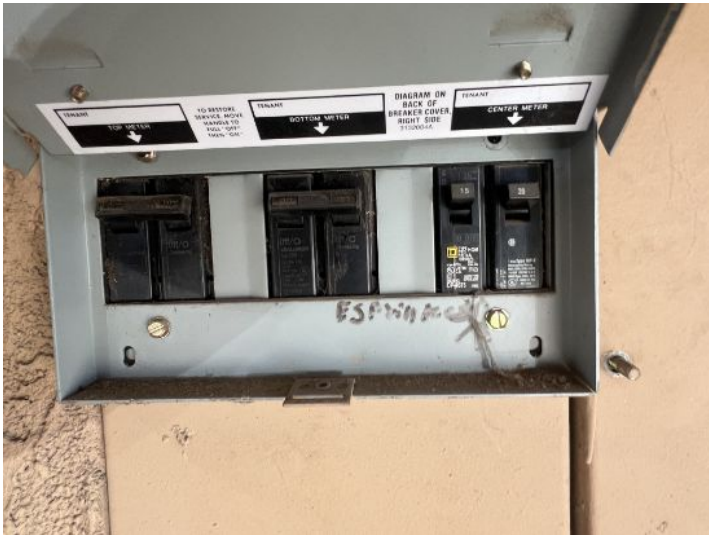
There is 90 amps for this building from the main panel.

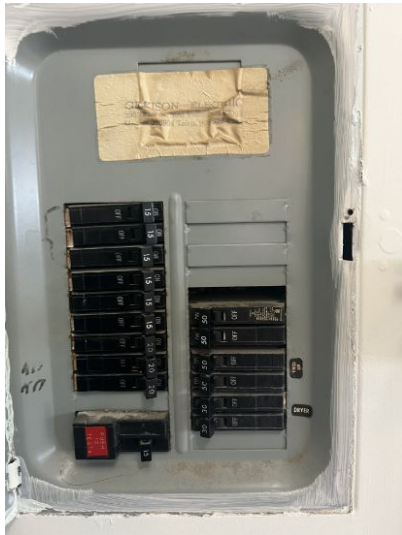
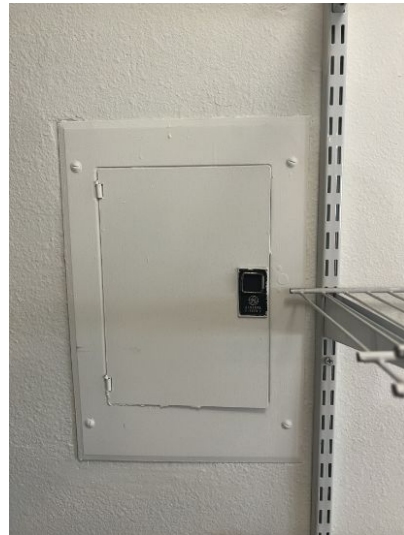
The circuit breakers in the sub panel are not labeled. It is not known which circuit goes with which breaker. This could pose a problem in case there is an emergency reason comes up to shut off power to a specific area of the home.

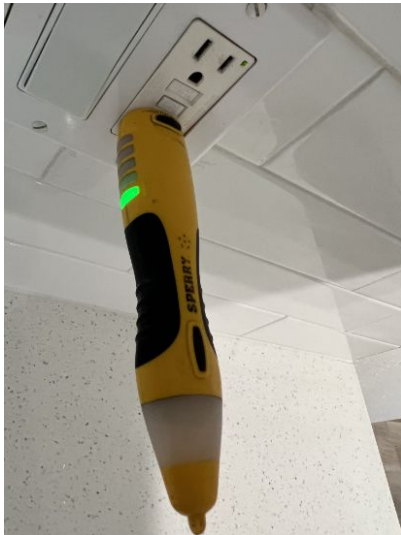
Kitchen

There is one or more missing cover plates in areas of the home.

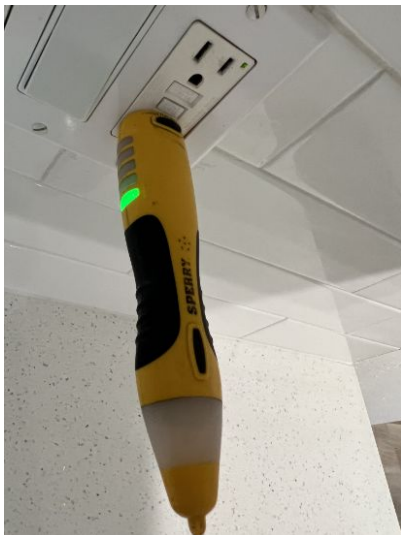
Kitchen

There is one or more missing cover plates in areas of the home.

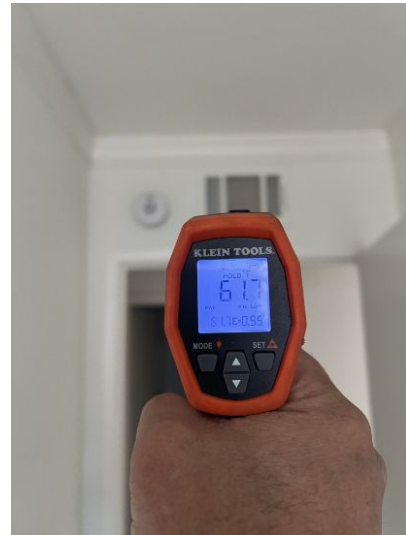
61 deg F

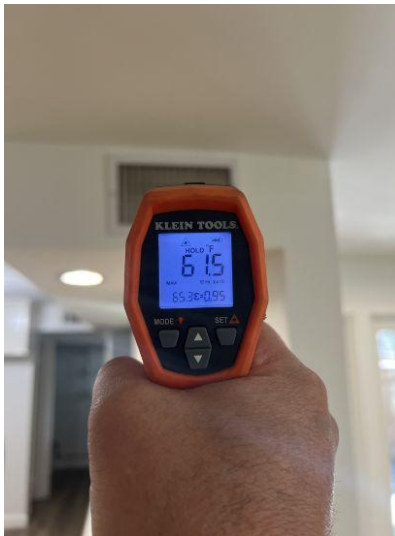
61 deg F

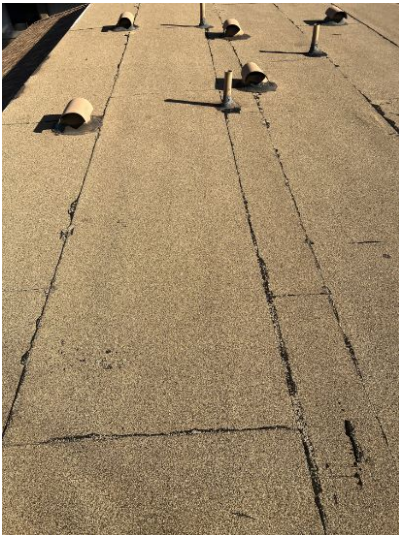
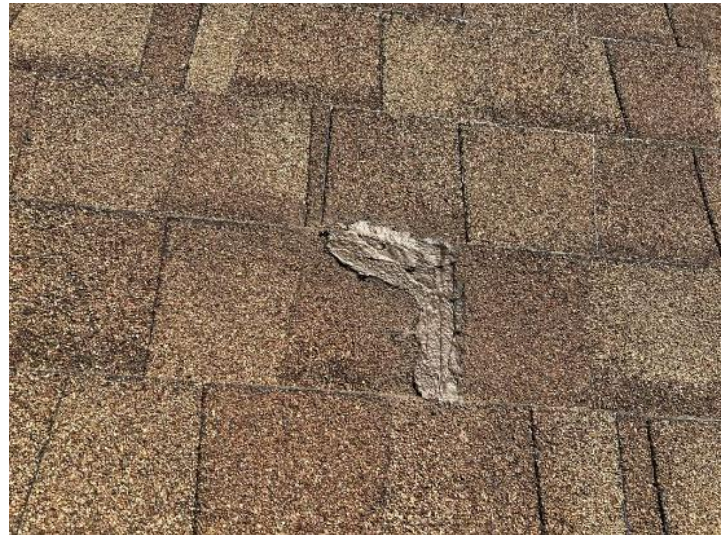
Small patch
